## Investigation of Extensive Cracking of a Swimming Pool from Petrographic Examinations of Four Composite Cores of Pool Plaster and Shotcrete

U-Center on Turner  
625 S 4th Street  
Columbia, MO 65203

September 12, 2023  
CMC 0823176

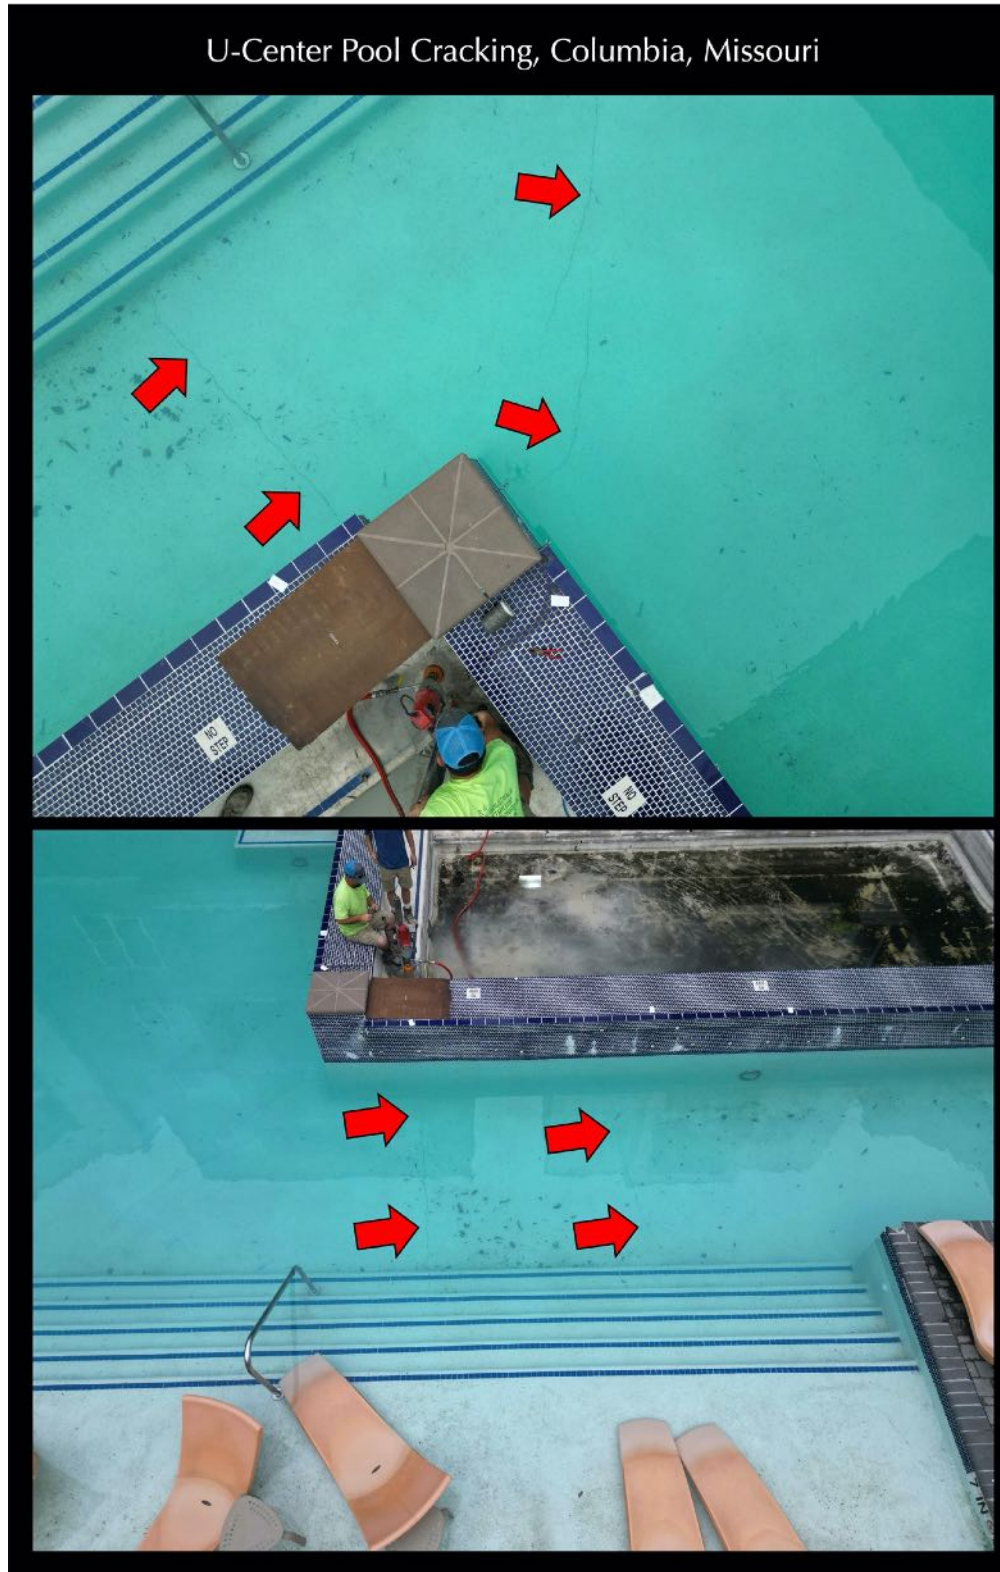
Figure 3: Cracks (marked by red arrows) on pool floor seen under water. Cracks are long, continuous and occurred at various locations as shown in subsequent field photos.

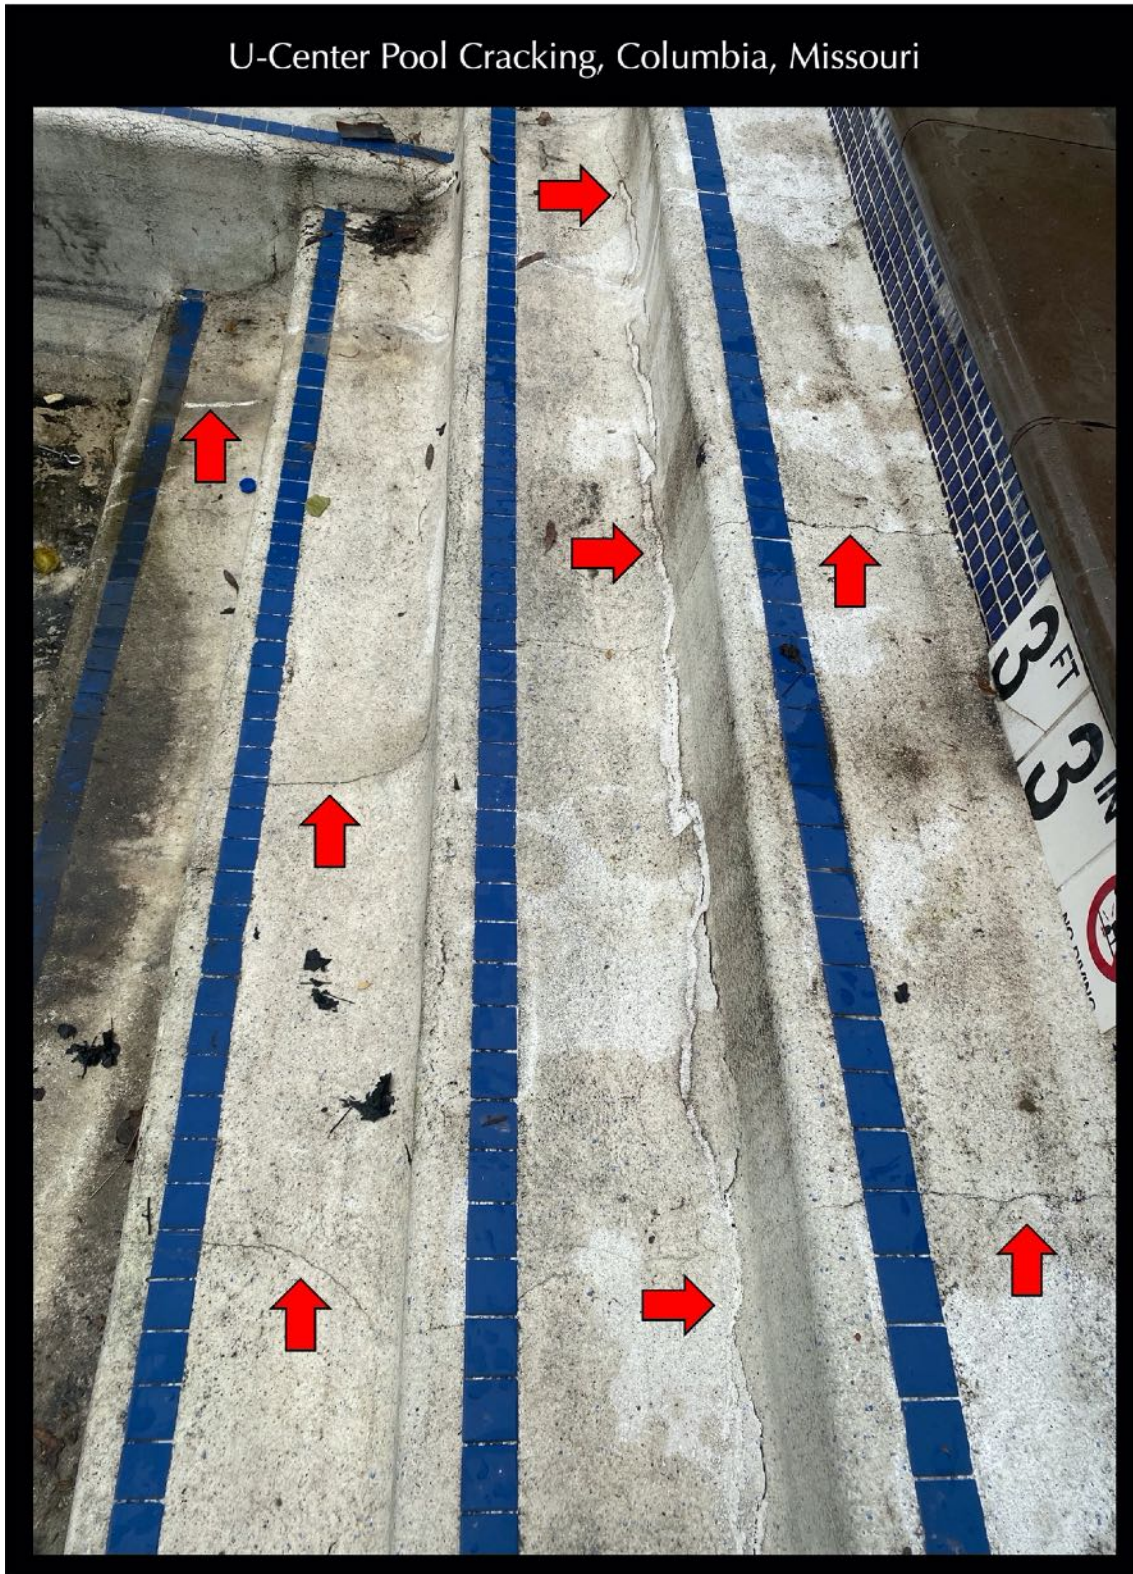
Figure 4: Long, parallel longitudinal and transverse through-steps cracks marked by red arrows. Notice many wider cracks were previously attempted to seal with elastomeric crack sealant, yet further development of finer-width unsealed cracks for steady penetration of pool water into the shotcrete.

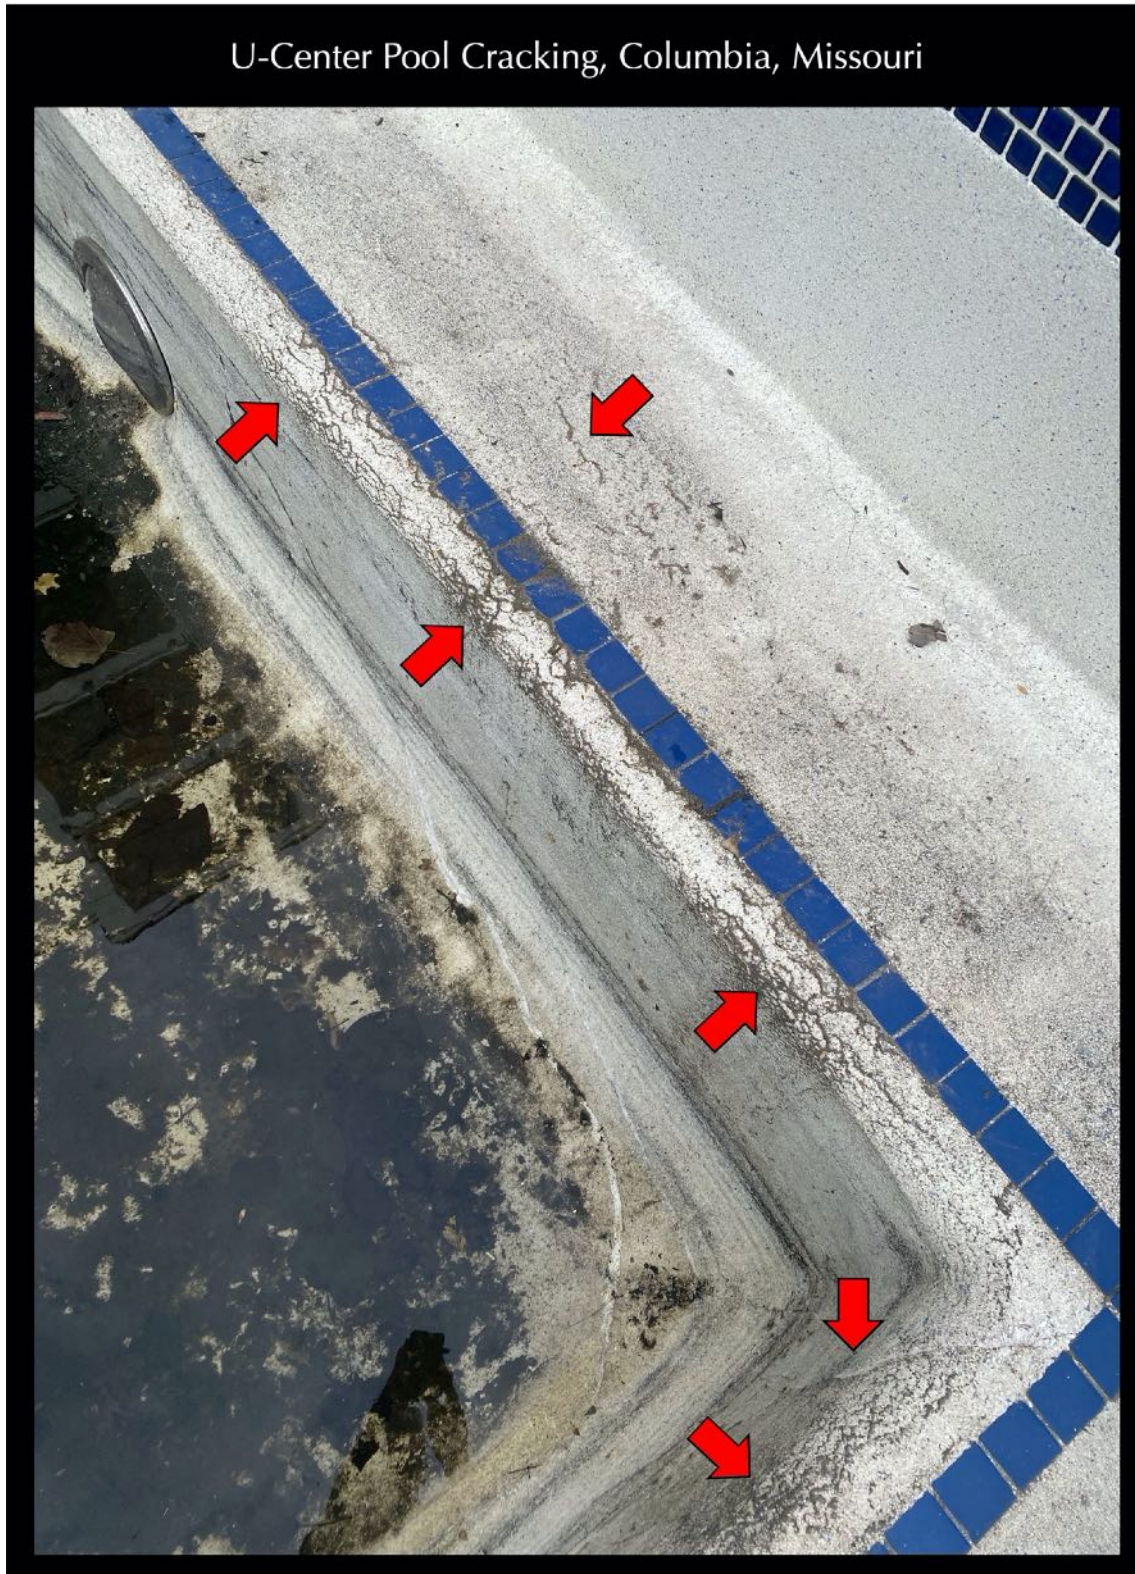
Figure 5: Both long, continuous, and short discontinuous cracks marked by red arrows. Many cracks have traversed through the steps and walls to the floor.

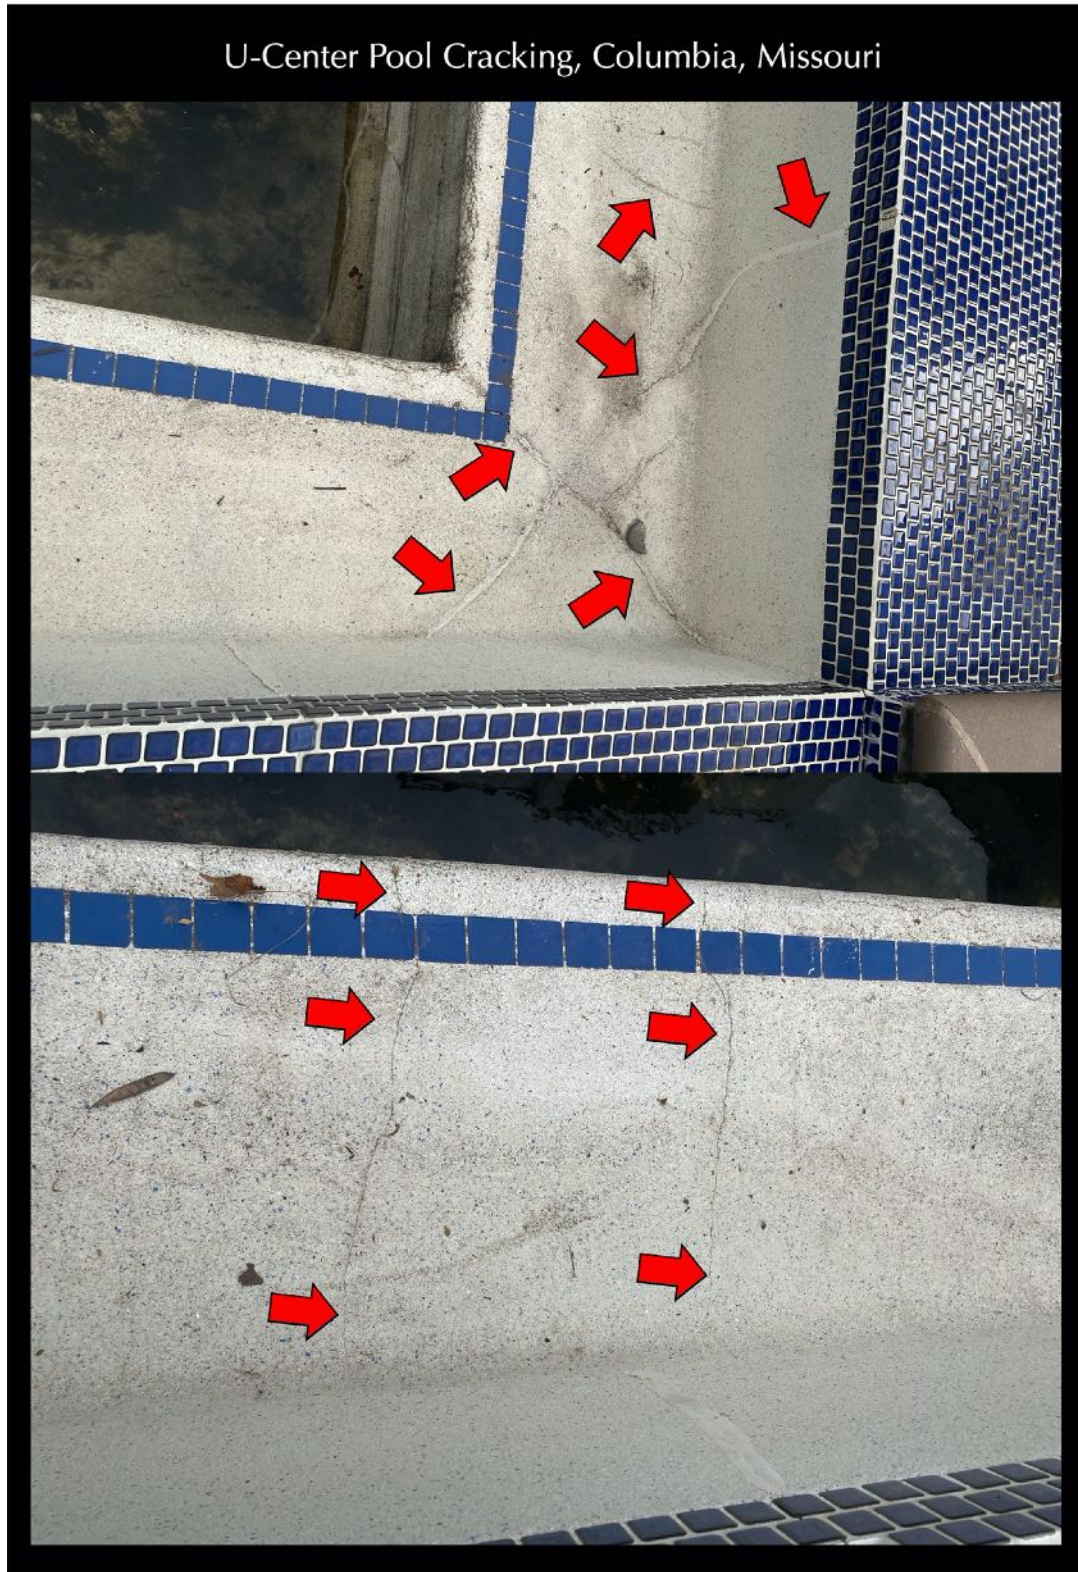
Figure 6: X-shaped intersecting cracks at the corners (top) along with long, vertical cracks on the plaster walls (bottom) marked by red arrows.

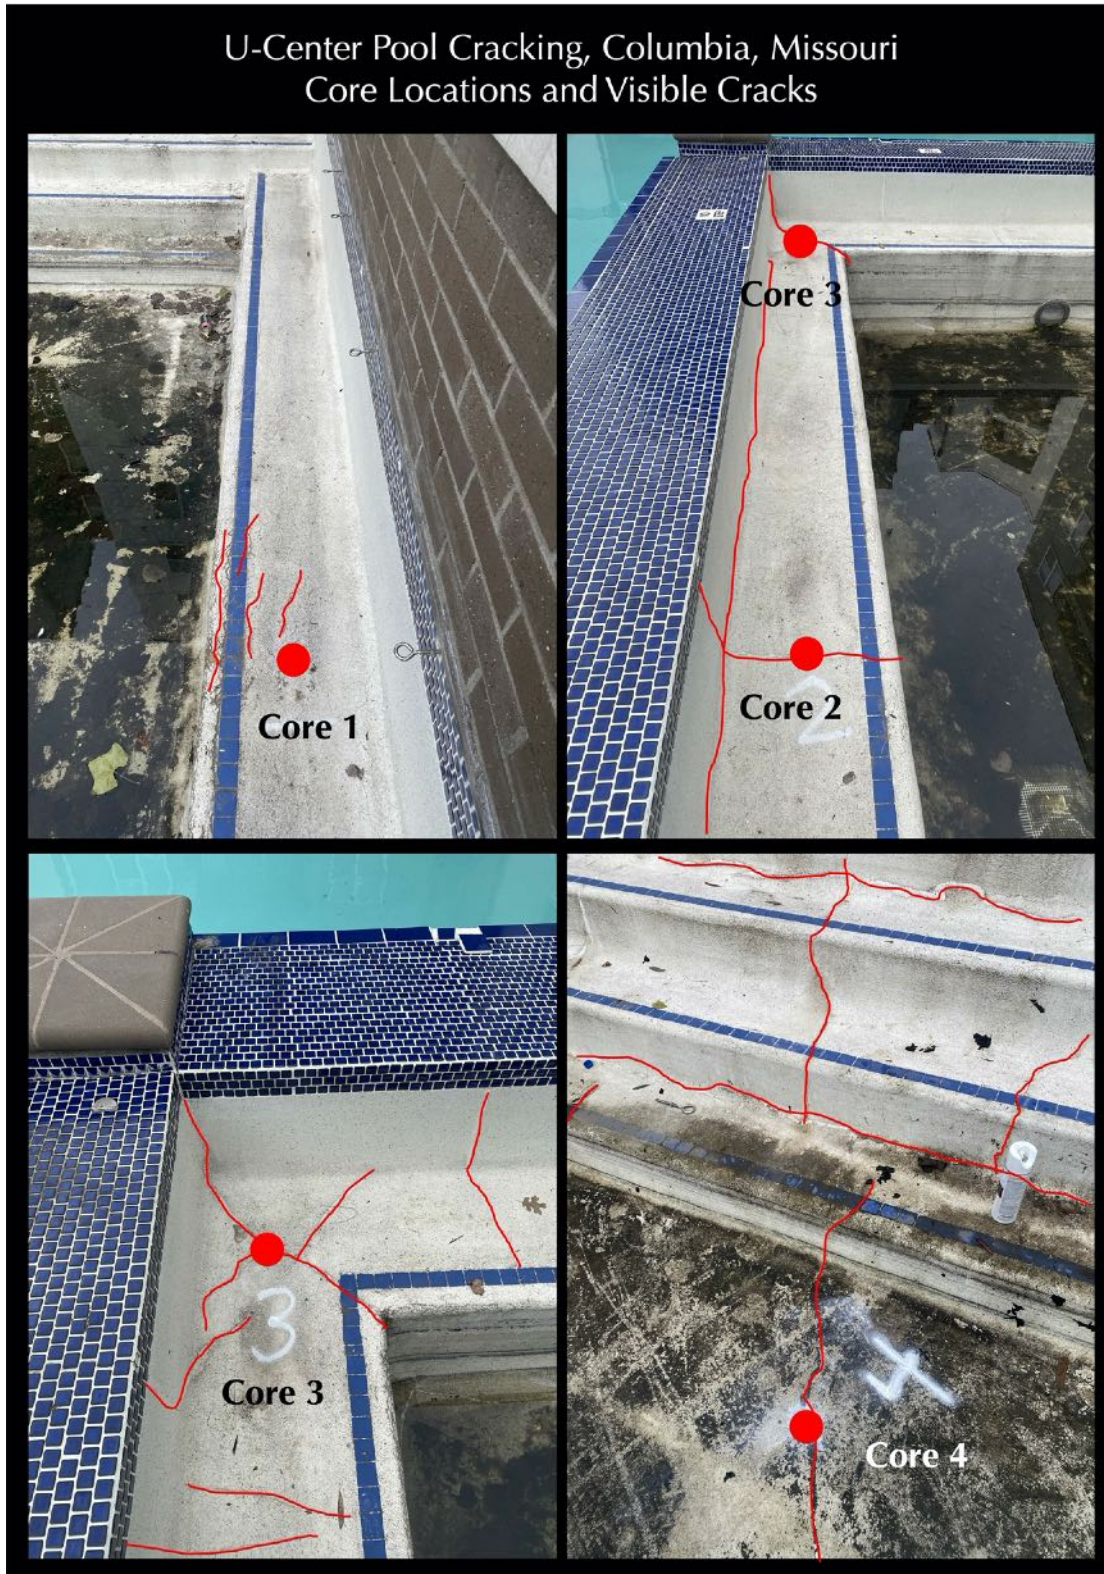
Figure 8: Locations of four cores in relation to visible cracks. Core 1 was collected from an area of short, discontinuous cracks where the core itself showed no visible cracks on the plaster's exposed surface, when received. Core 2 was over a long, continuous crack that has traversed through the pool wall and steps to the floor. Core 3 was from X-shaped intersecting cracks at a corner. Core 4 was from a visible crack on the floor.

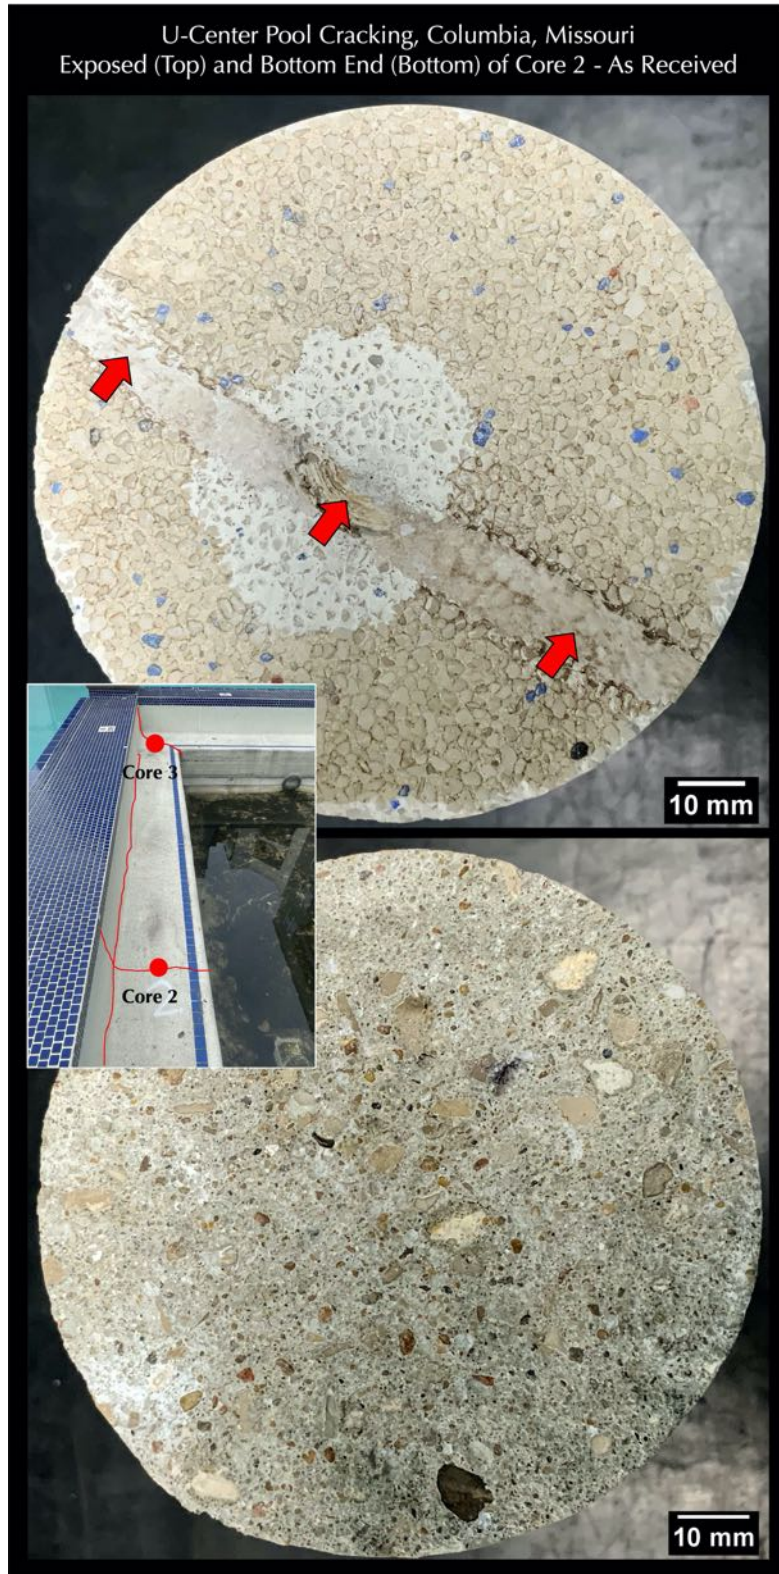
Figure 11: Shown are the top exposed surface of pool plaster with a crack that has been sealed with a repair caulk (top) and fresh fractured surface of shotcrete (bottom) in Core 2. Inset photo shows location of Core 2.

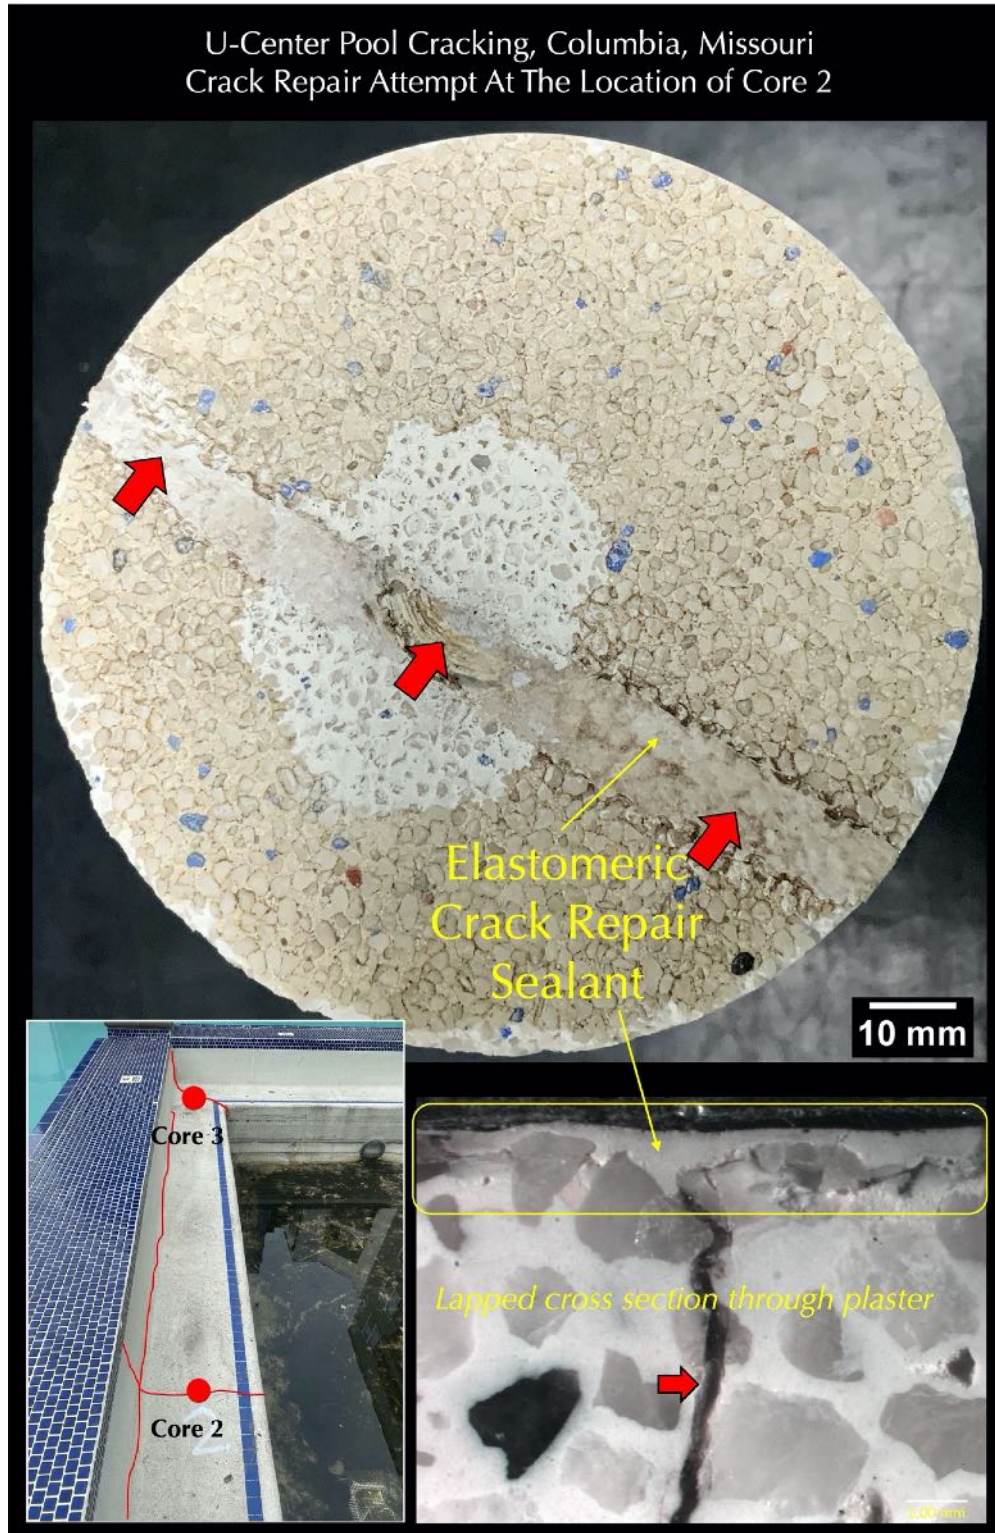
Figure 12: Elastomeric repair sealant on crack at the location of Core 2. Lapped cross section of plaster at the bottom right photo shows an apparent well bond of repair sealant to the plaster at the area of examination but ineffective penetration of crack filler into the crack where most of the crack beneath the sealant/filler is empty.

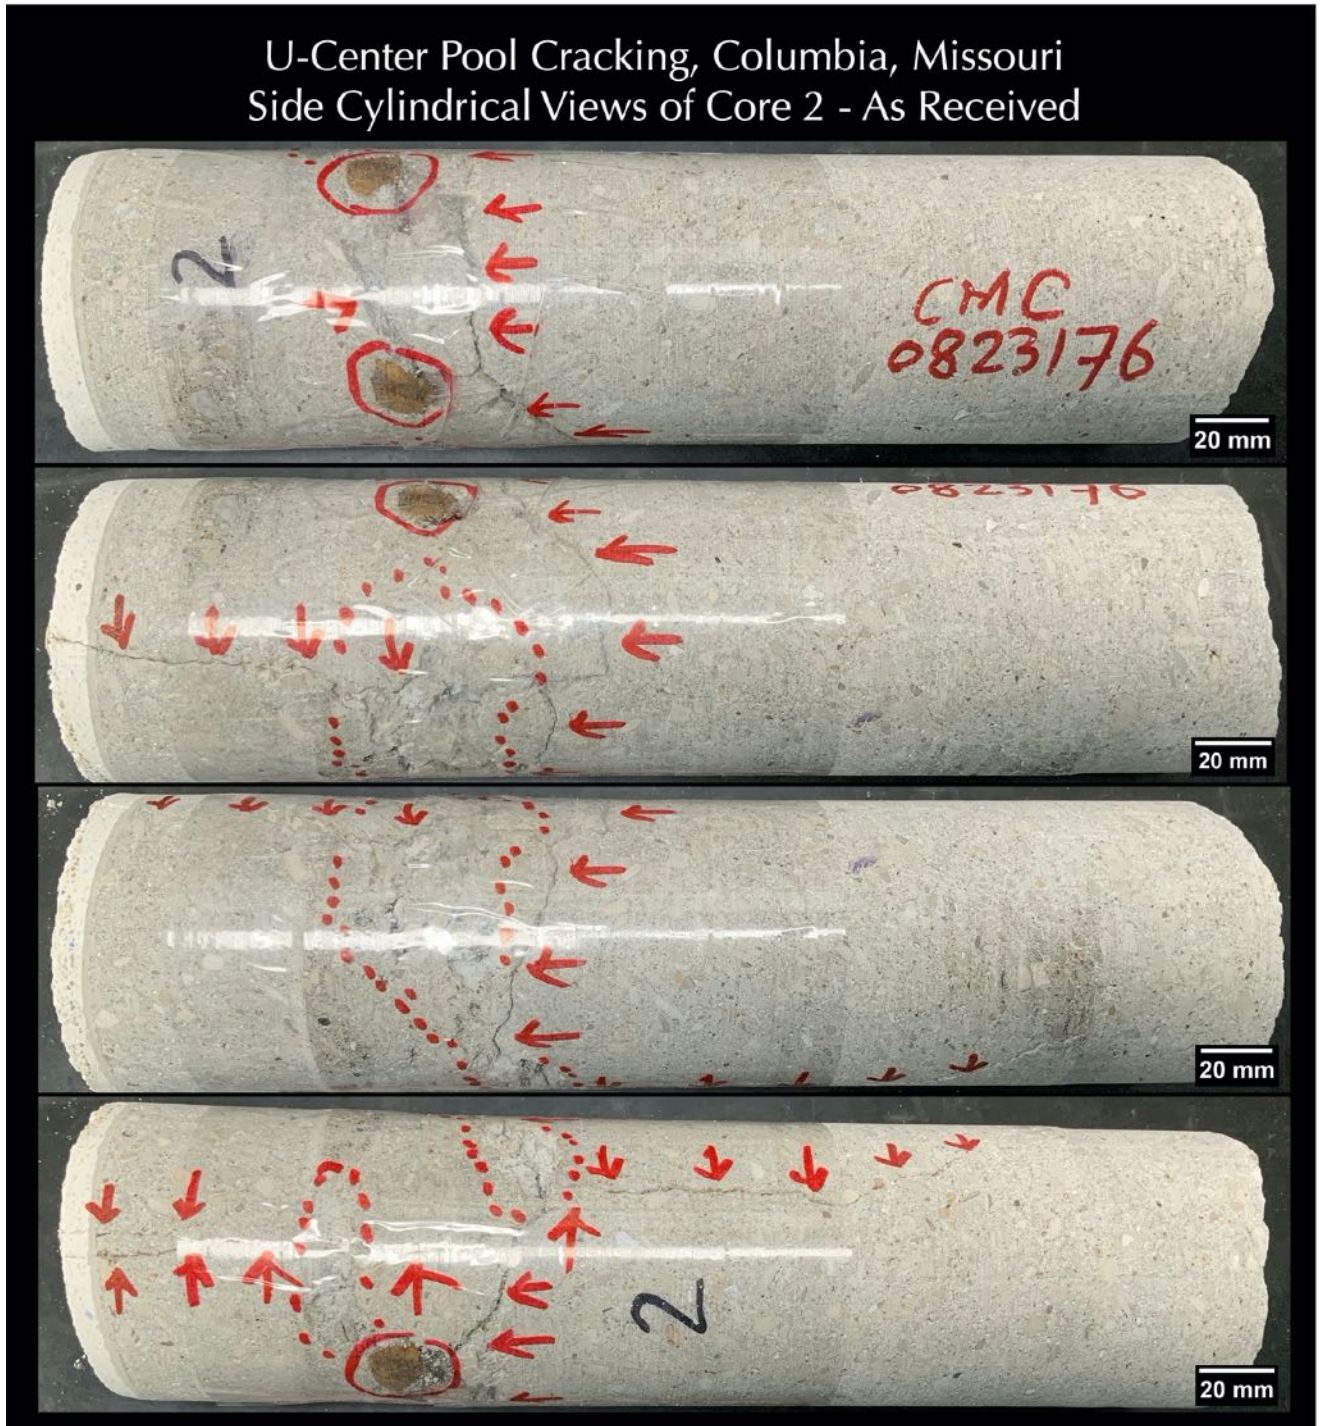
Figure 13: Shown are cylindrical surfaces of Core 2 where dotted lines enclose areas exhibiting coarse voids (honeycombing), solid lines enclose steel reinforcement in shotcrete, and arrows show visible cracks.

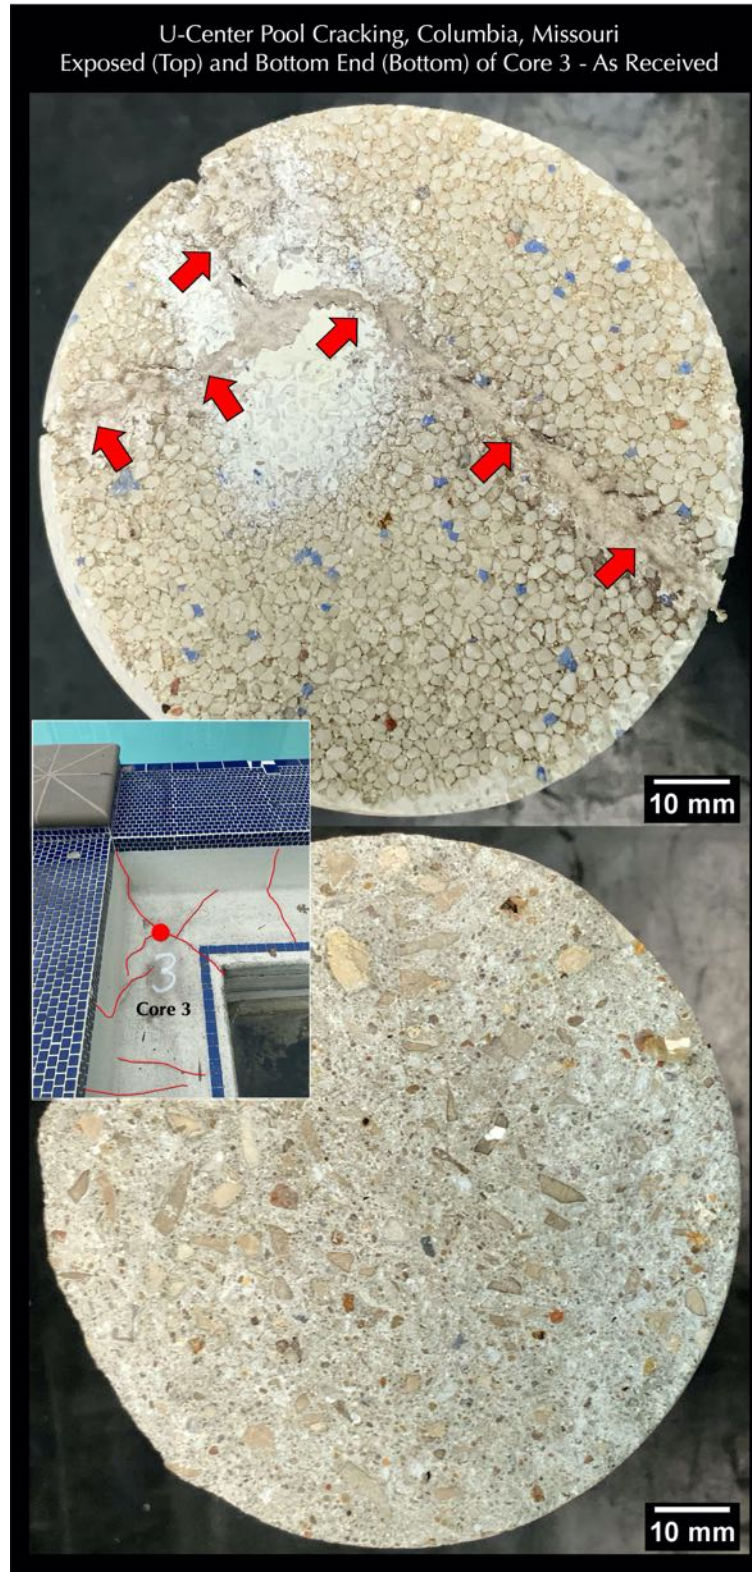
Figure 14: Shown are the top exposed surface of pool plaster with two intersecting X-shaped cracks seen at the corners that have been sealed with elastomeric repair caulk (top) and fresh fractured surface of shotcrete (bottom) in Core 3. Inset photo shows location of Core 3.

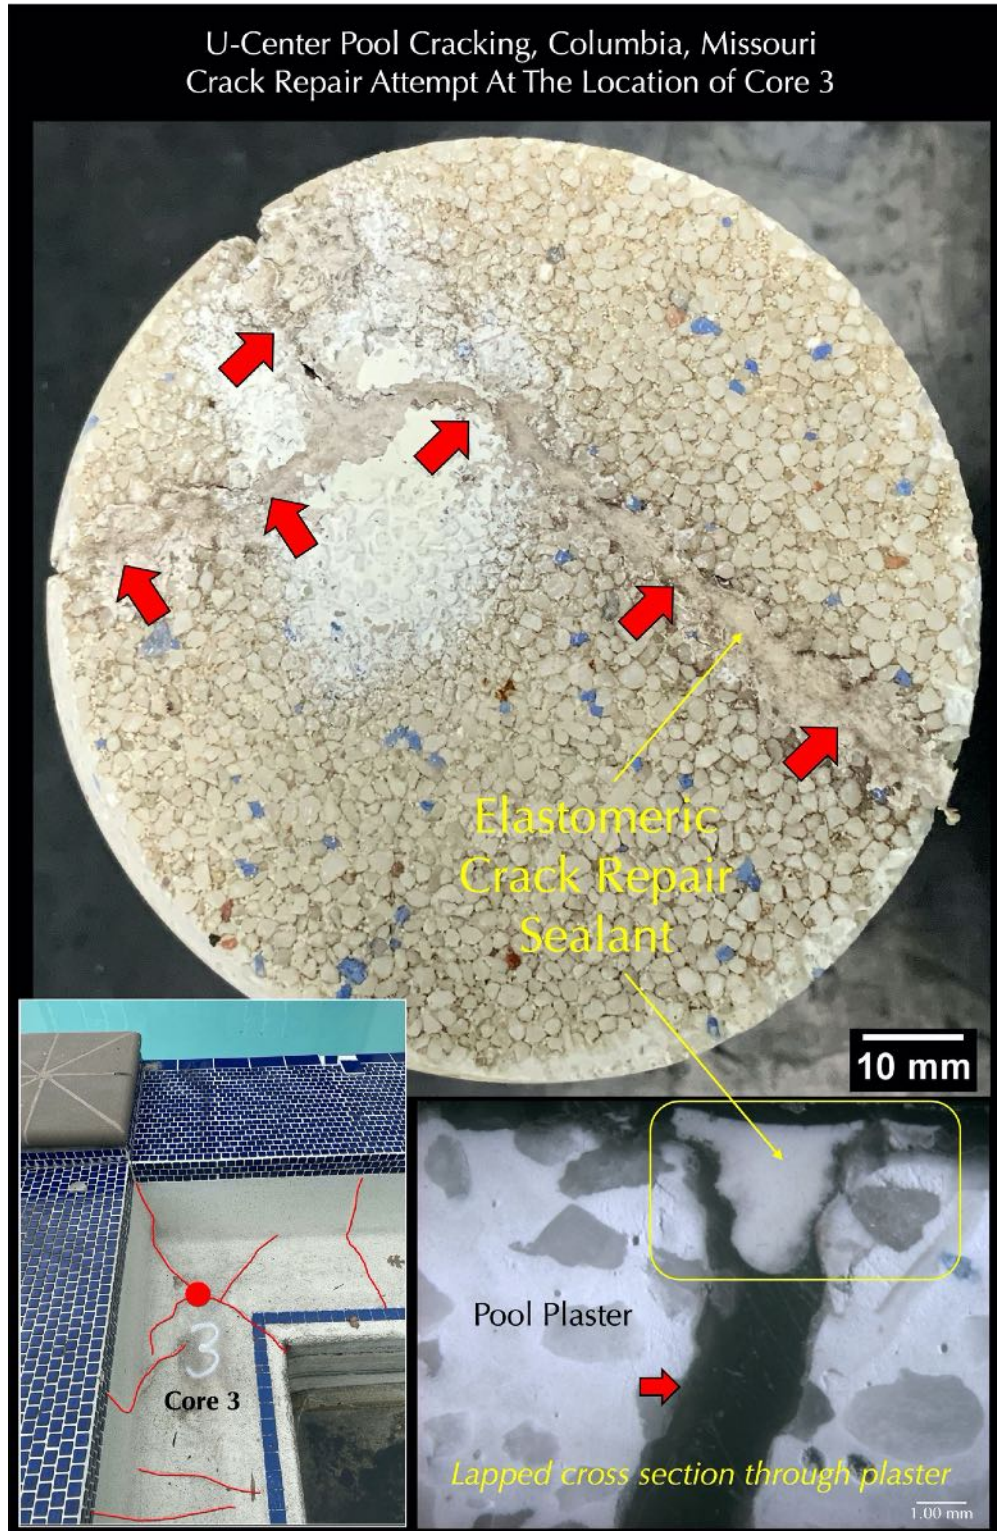
Figure 15: Elastomeric repair sealant on crack at the location of Core 3. Lapped cross section of plaster at the bottom right photo shows an apparent well bond of repair sealant to the plaster at the area of examination but ineffective penetration of crack filler into the crack where most of the crack beneath the sealant/filler is empty.

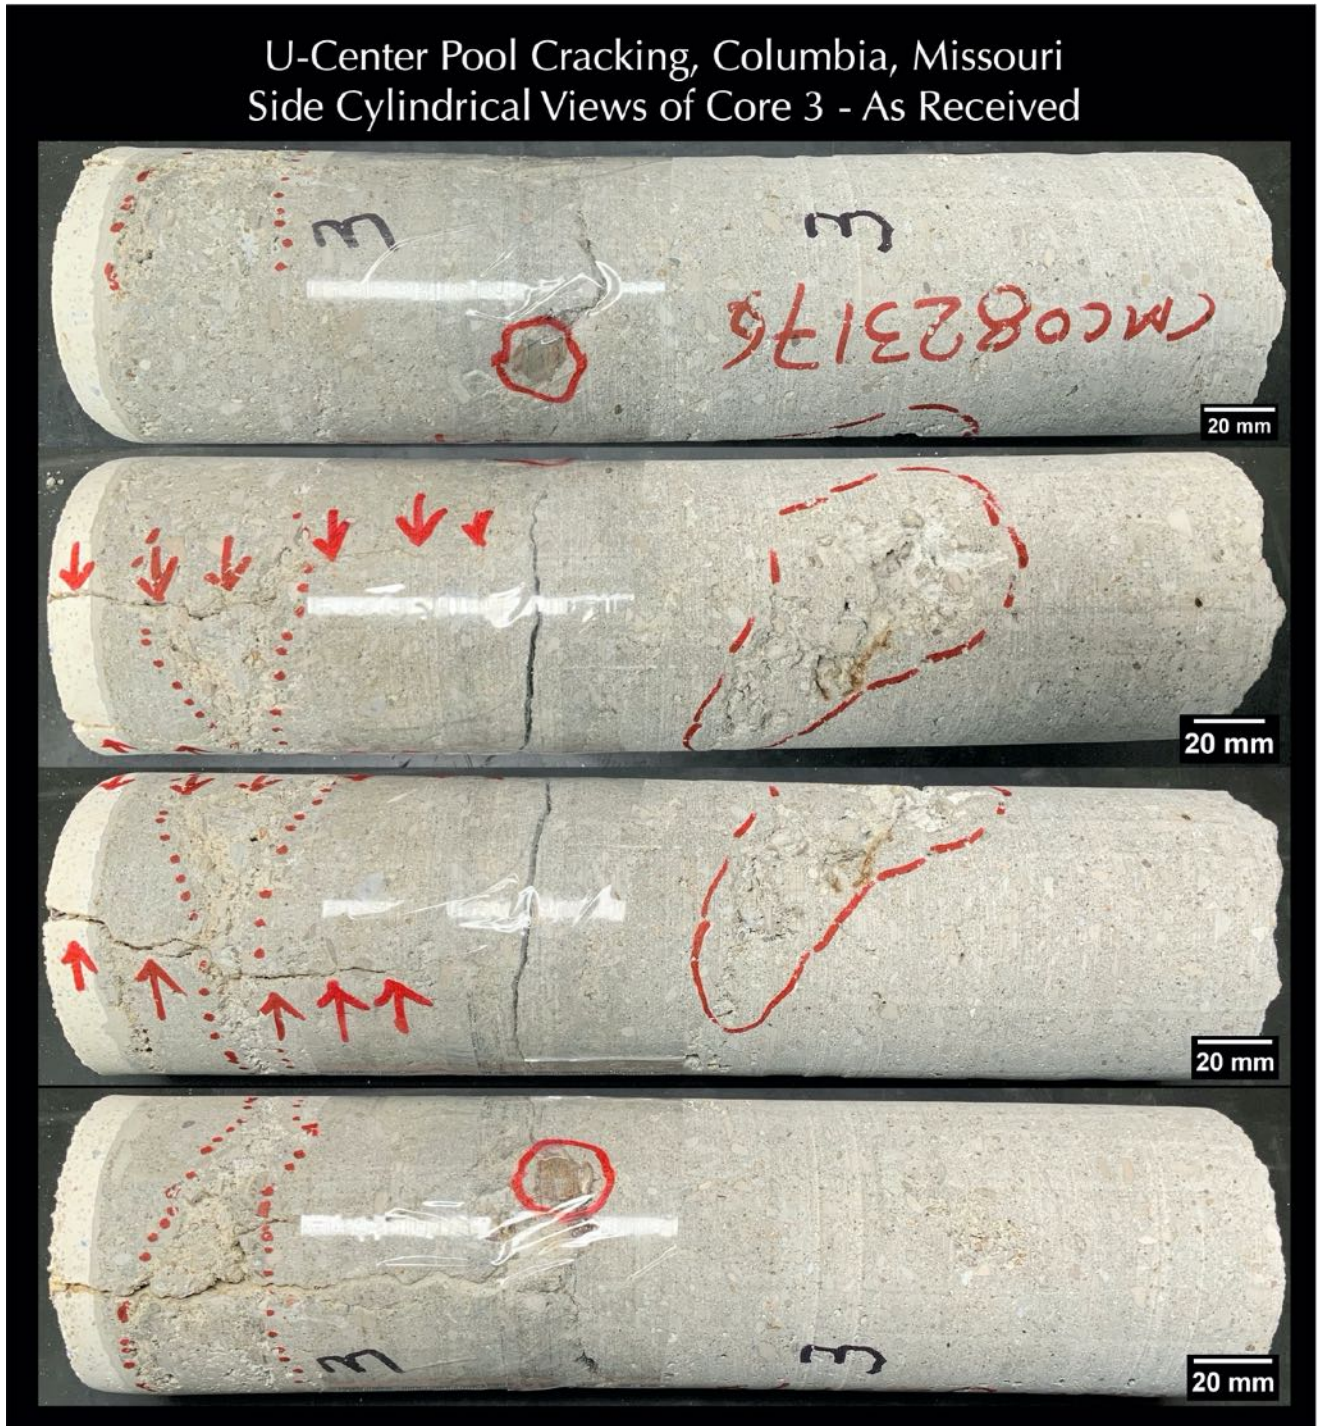
Figure 16: Shown are cylindrical surfaces of Core 3 where dotted lines enclose areas exhibiting coarse voids (honeycombing), solid lines enclose steel reinforcement in shotcrete, and arrows show visible cracks.

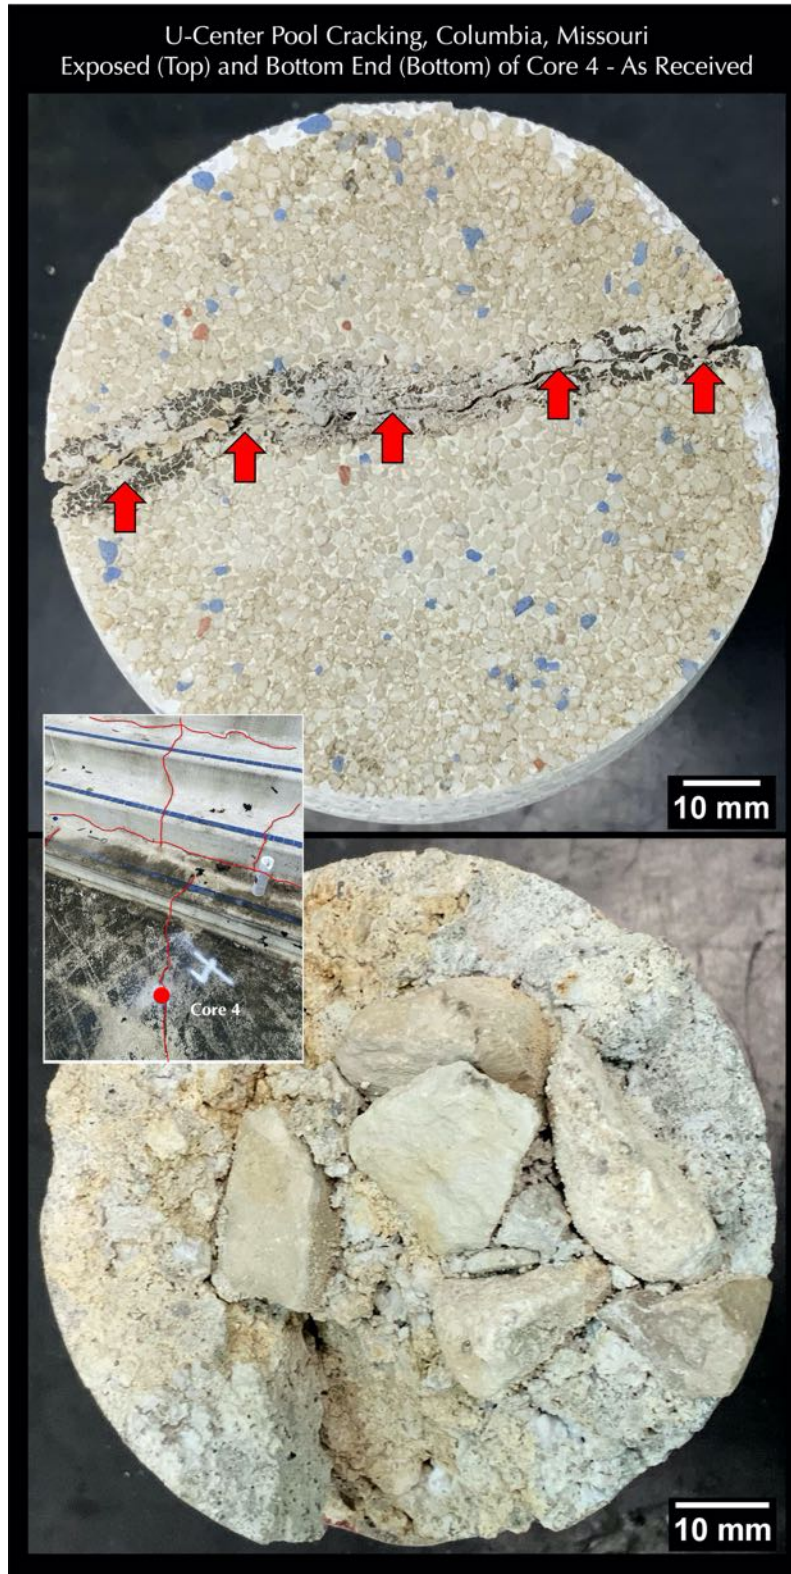
Figure 17: Shown are the top exposed surface of pool plaster with a crack that has been attempted to seal with a repair caulk but has cracked again through the seal (top) and underside of shotcrete with adhered crushed stone beneath the pool floor slab (bottom) in Core 4. Inset photo shows location of Core 4 on the floor of pool.

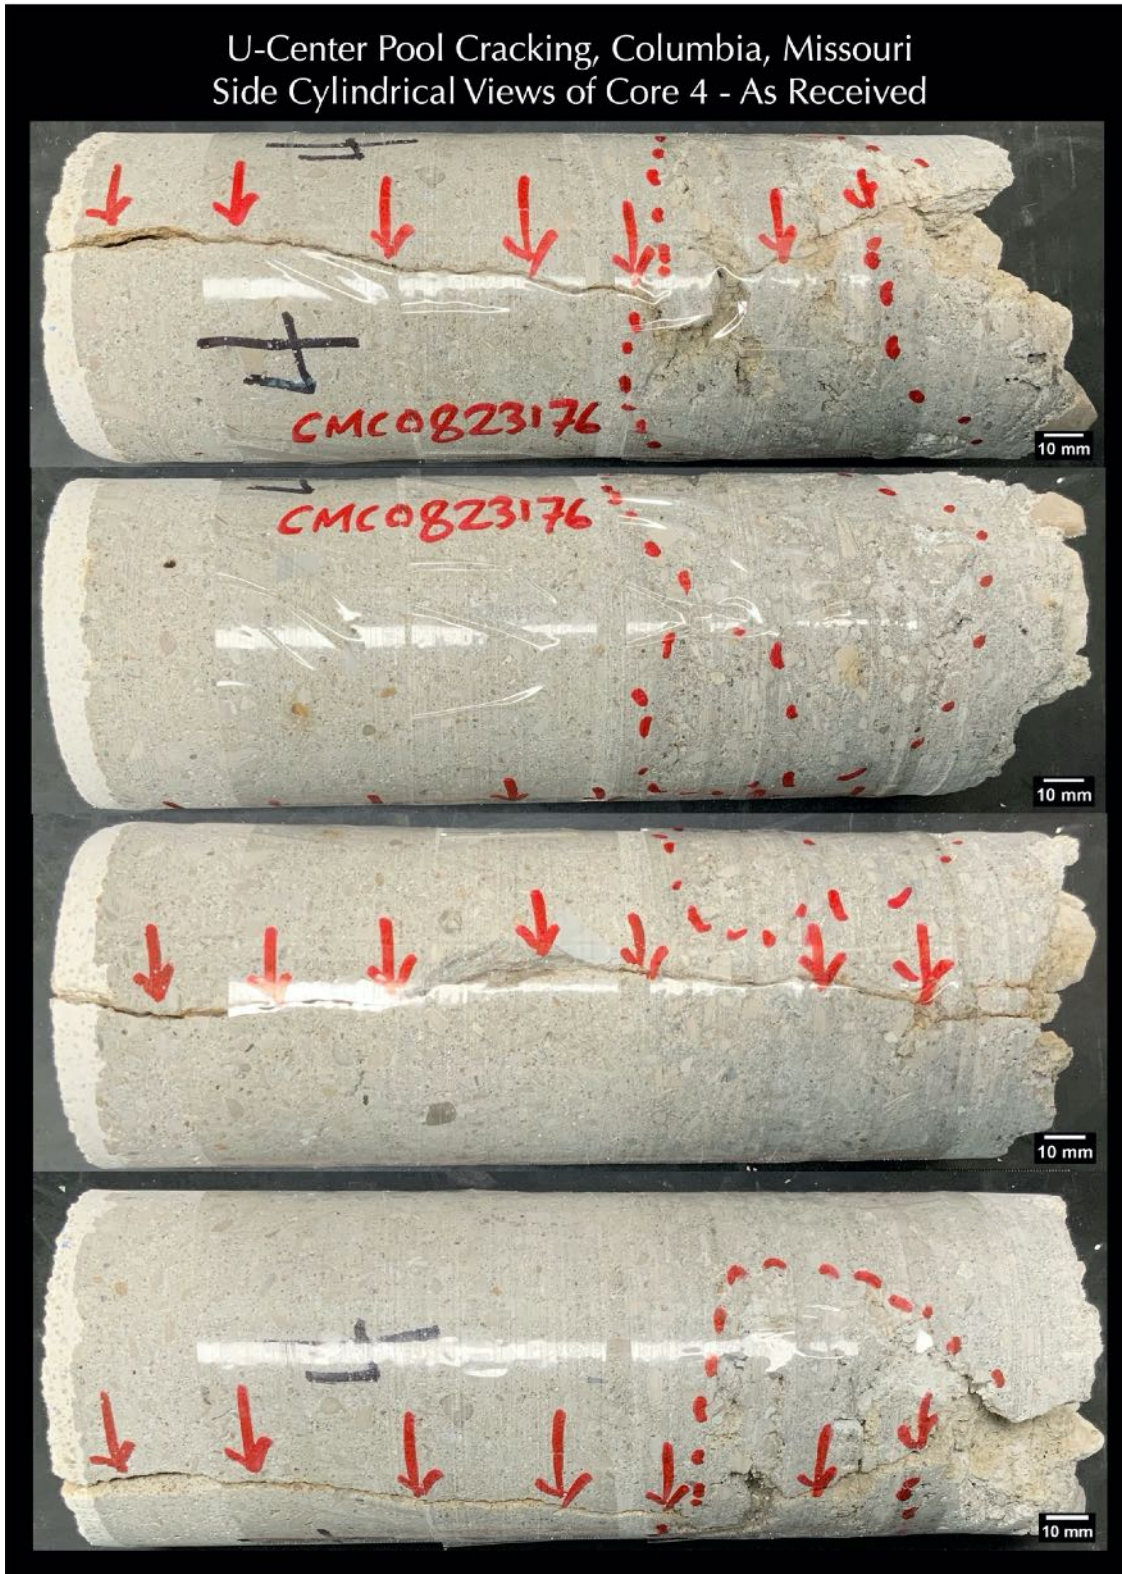
Figure 18: Shown are cylindrical surfaces of Core 4 where dotted lines enclose areas exhibiting coarse voids (honeycombing), and arrows show visible cracks.
