## Investigation of Extensive Cracking of a Swimming Pool from Petrographic Examinations of Four Composite Cores of Pool Plaster and Shotcrete

U-Center on Turner  
625 S 4th Street  
Columbia, MO 65203

September 12, 2023  
CMC 0823176

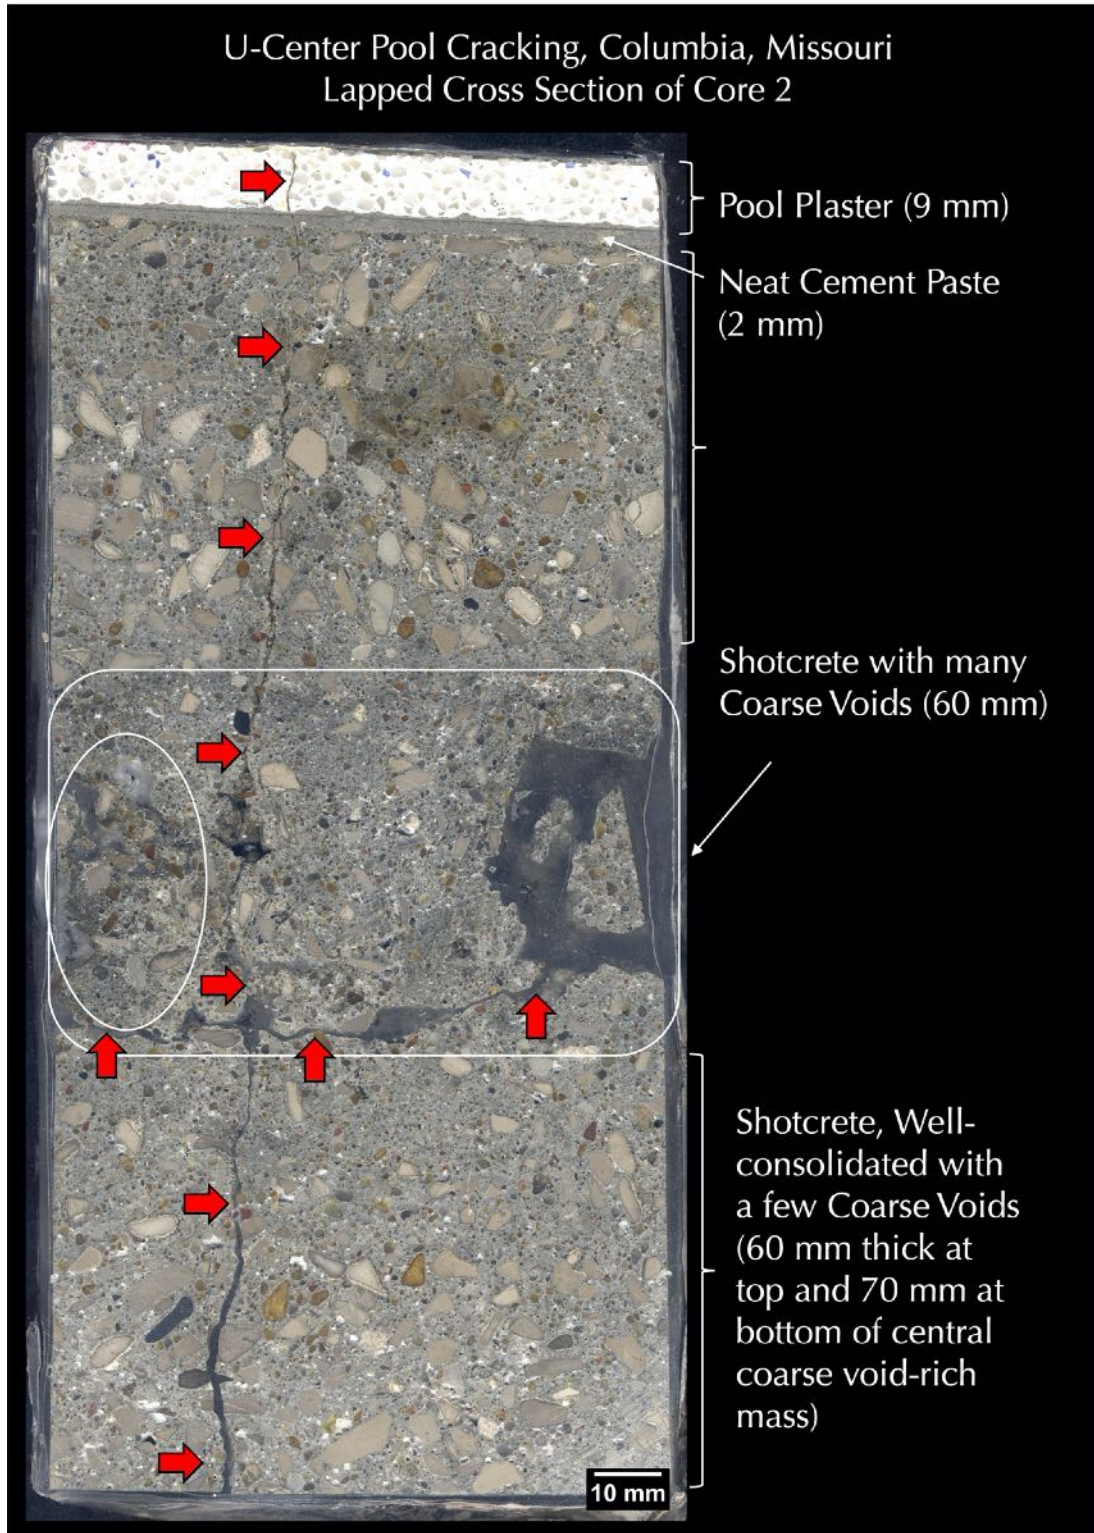
Figure 24: Lapped cross section of Core 2 showing: (a) 9 mm thick dense, white pool plaster, which is intimately bonded to (b) a medium to dark gray 2 mm thin paste-rich layer applied as a leveling coat on shotcrete prior to the installation of plaster, and (c) the main body of shotcrete consisting of areas rich in coarse voids as well as denser areas free of visible voids and have variable water-cementitious ratios due to the manner of pneumatic applications of shotcrete through a nozzle. Notice thin dark reaction rims around many crushed stone aggregate particles, which are described later. The entire core is transected through a major vertical crack that has transected and circumscribed the aggregate particles along path, as well as a surface-parallel crack in the body.

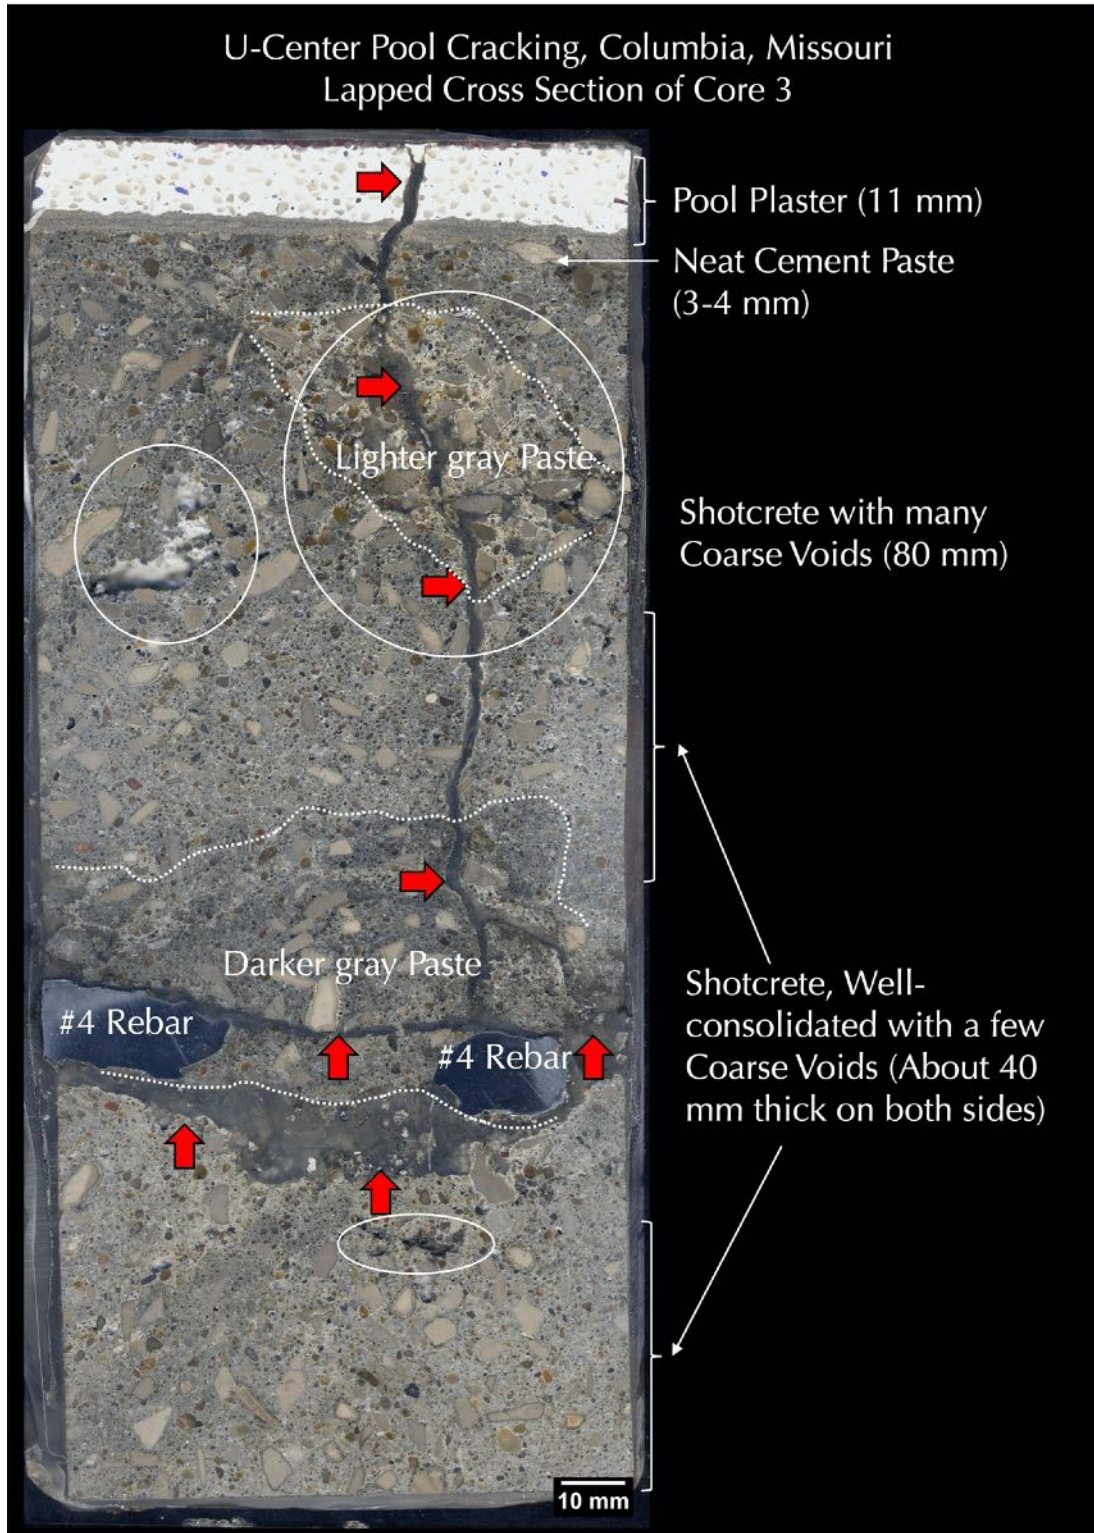
Figure 26: Lapped cross section of Core 3 showing: (a) 11 mm thick dense, white pool plaster, which is intimately bonded to (b) a medium to dark gray 3 to 4 mm thin paste-rich layer applied as a leveling coat on shotcrete prior to the installation of plaster, and (c) the main body of shotcrete consisting of areas rich in coarse voids as well as denser areas free of visible voids and have variable water-cementitious ratios due to the manner of pneumatic applications of shotcrete through a nozzle. Notice thin dark reaction rims around many crushed stone aggregate particles, which are described later. The entire core is transected through a major vertical crack that has transected and circumscribed the aggregate particles along path, as well as a surface-parallel crack in the body.

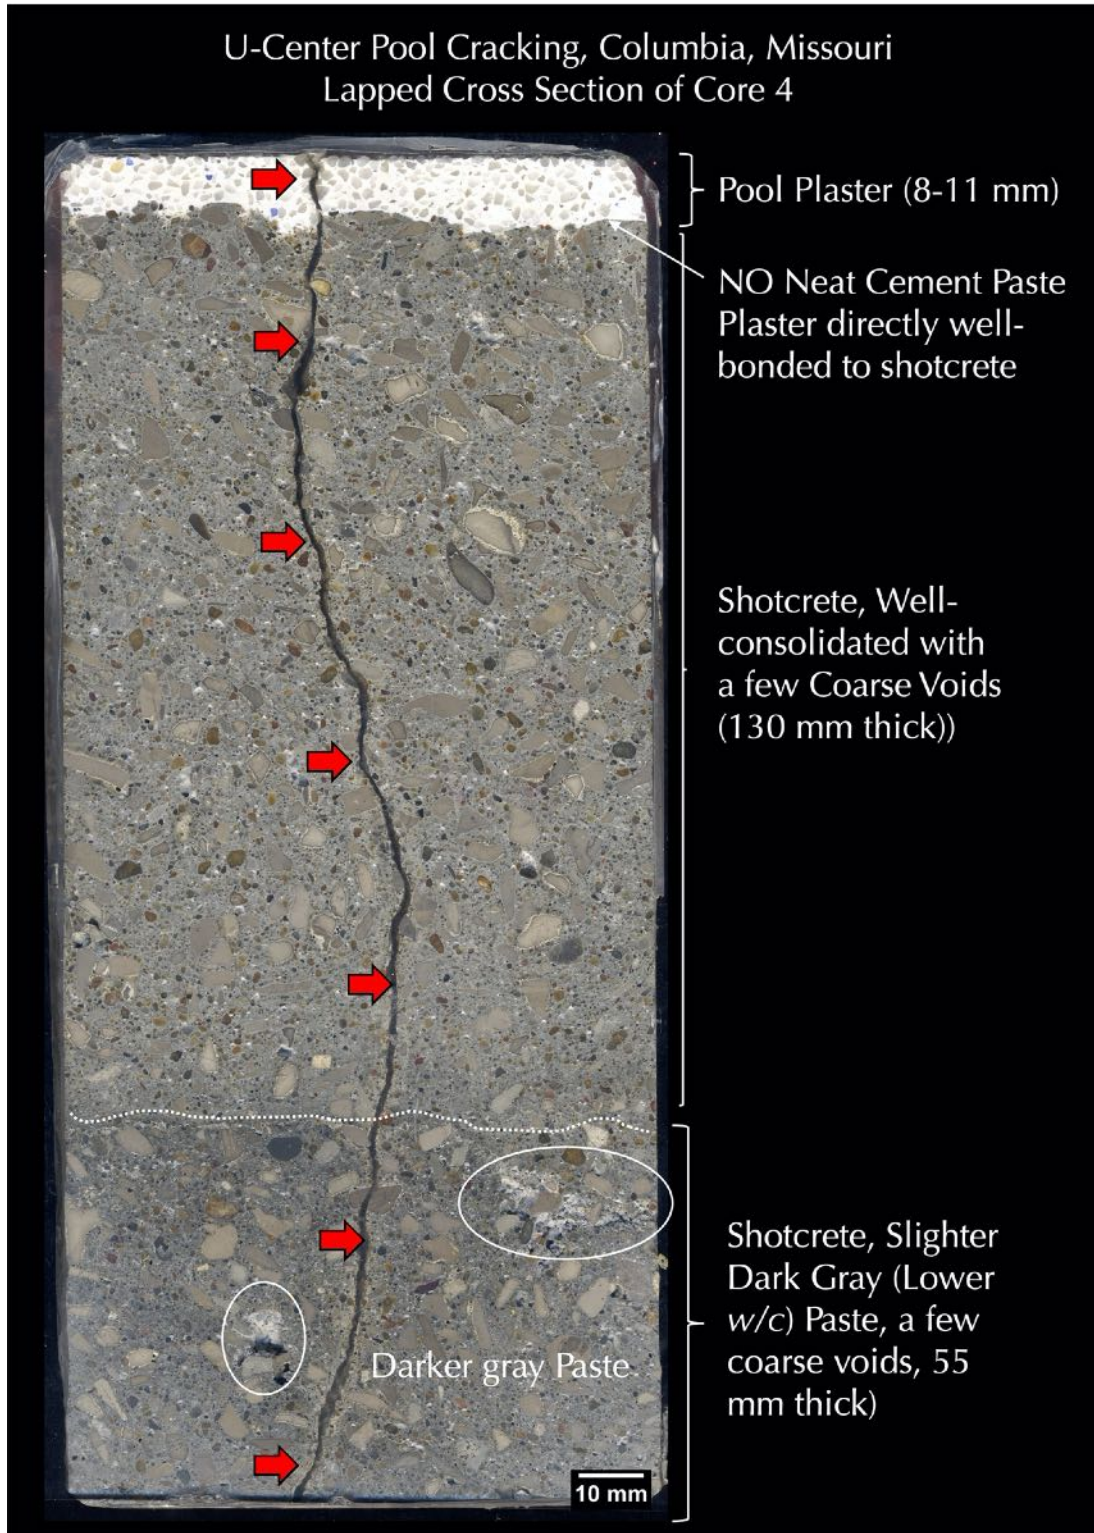
Figure 28: Lapped cross section of floor Core 4 showing: (a) 8 to 11 mm thick dense, white pool plaster, which is intimately bonded to (b) the main body of shotcrete without any intermediate leveling coat where shotcrete consists of areas rich in coarse voids as well as denser areas free of visible voids and have variable water-cementitious ratios due to the manner of pneumatic applications of shotcrete through a nozzle. Notice thin dark reaction rims around many crushed stone aggregate particles, which are described later. The entire core is transected through a major vertical crack that has transected and circumscribed the aggregate particles along its path.

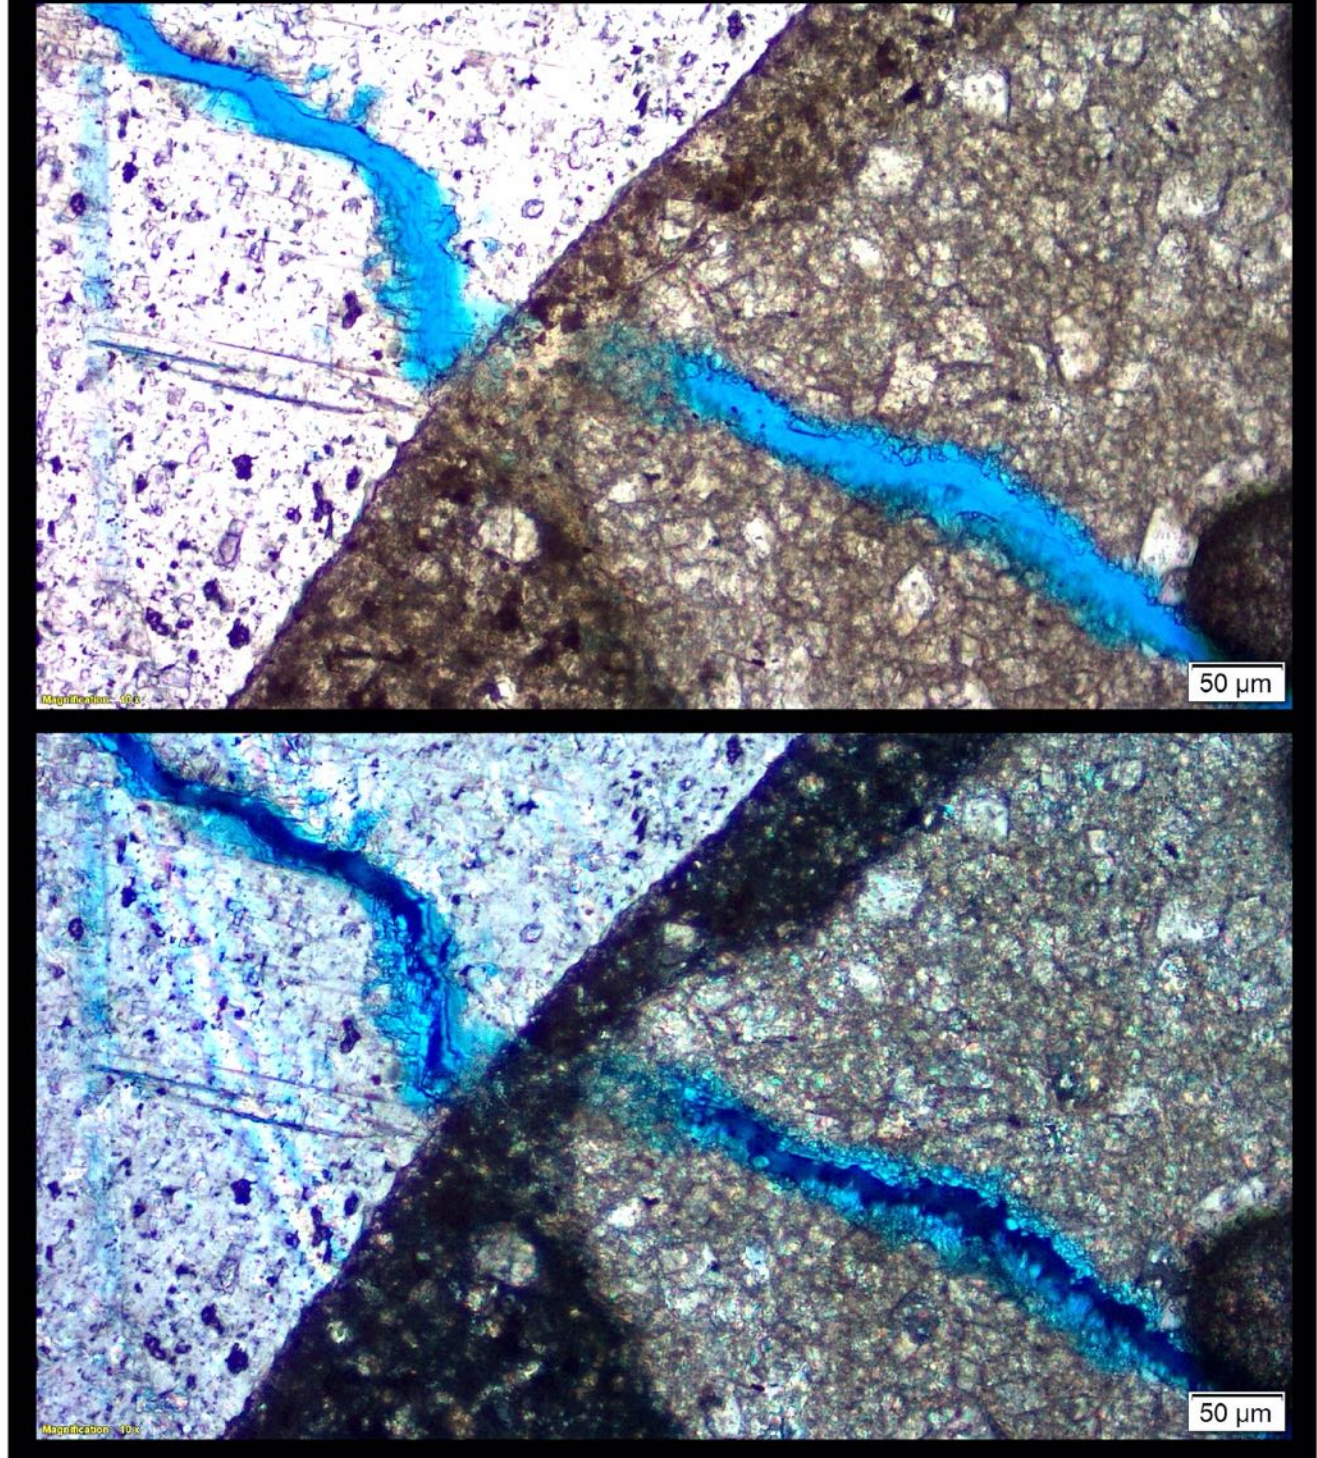
Figure 51: Micrographs of thin section of Core 1 showing a microcrack extending from a potentially alkali-carbonate reactive dolomitic limestone aggregate particle at right, through interstitial mortar fraction to another coarse calcite particle at left. Images were taken in plane (top, PPL) and corresponding cross (bottom, XPL) polarized light modes in a petrographic microscope.

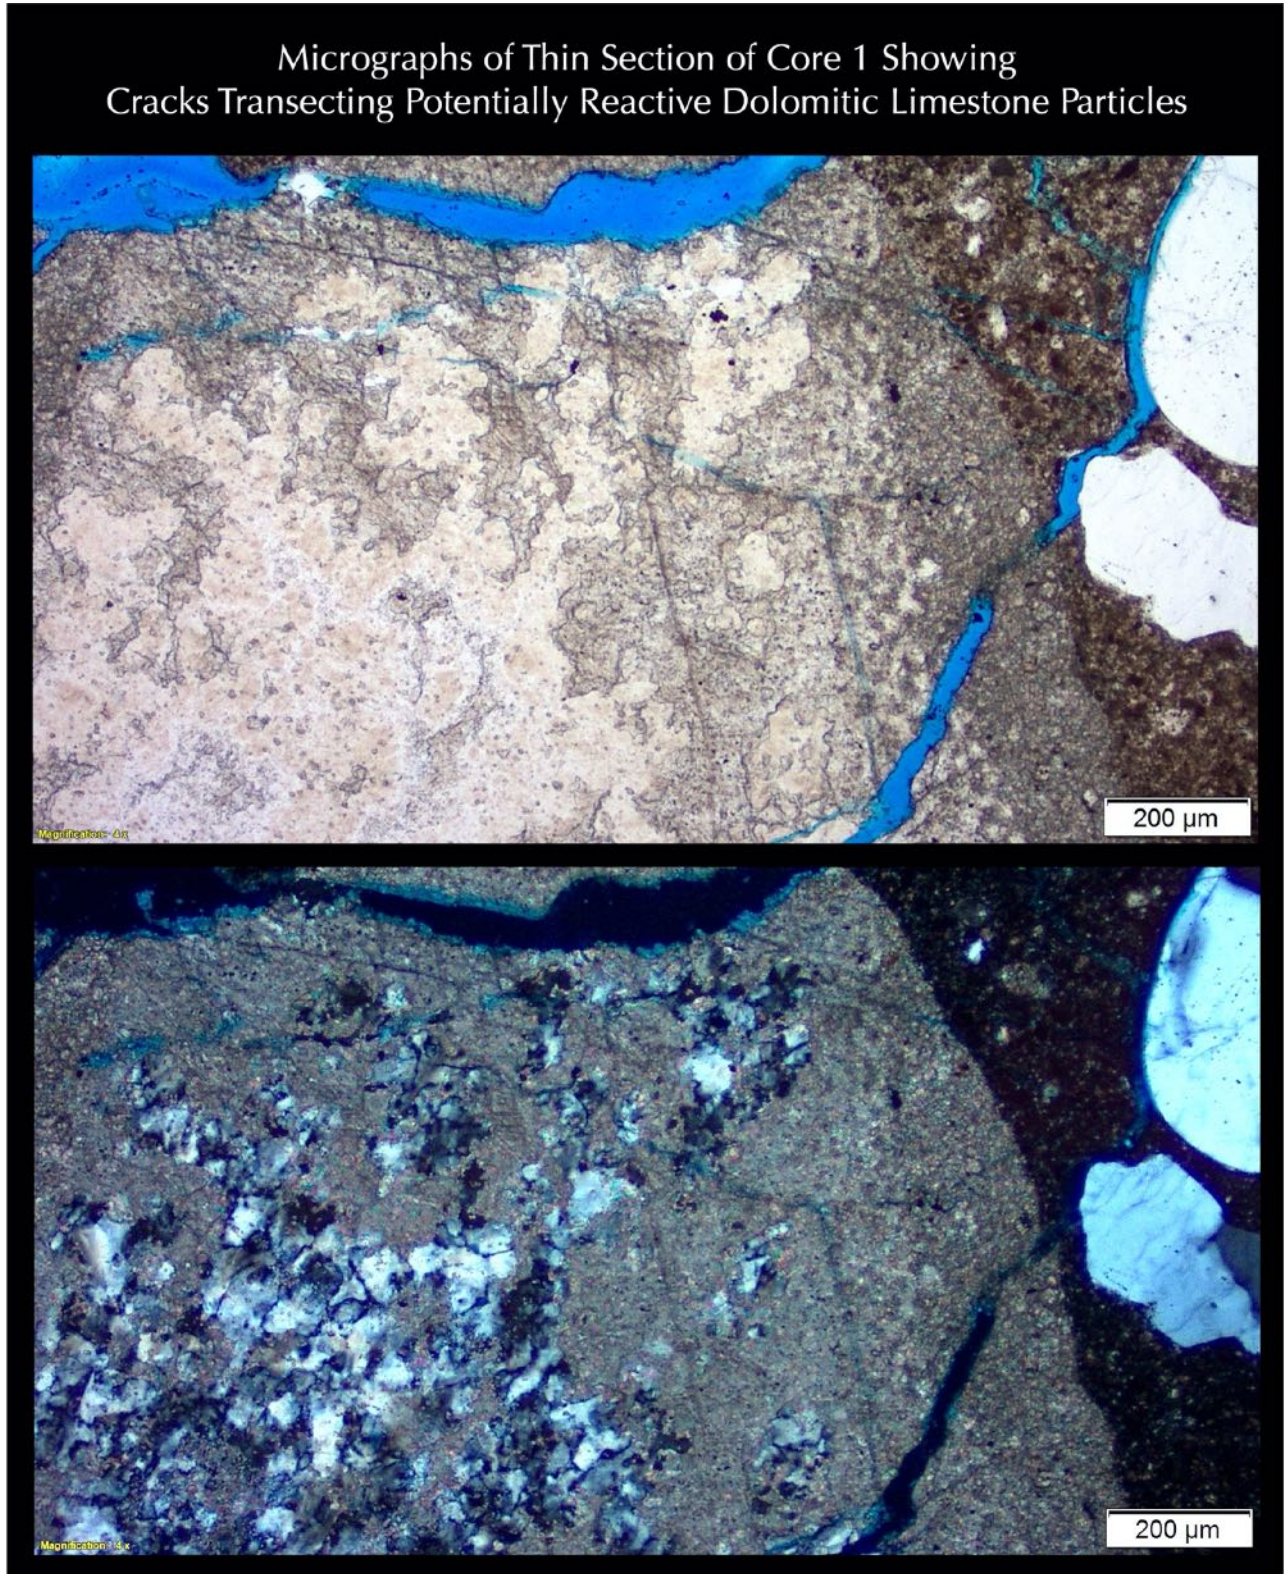
Figure 52: Micrographs of thin section of Core 1 showing a microcrack from a potentially alkali-carbonate aggregate (having alkali reactive inclusions within a dolomitic limestone aggregate particle) to neighboring paste. Notice many strained quartz particles in the core of dolomitic limestone aggregate are potentially alkali-silica reactive. Images were taken in plane (top, PPL) and corresponding cross (bottom, XPL) polarized light modes in a petrographic microscope.

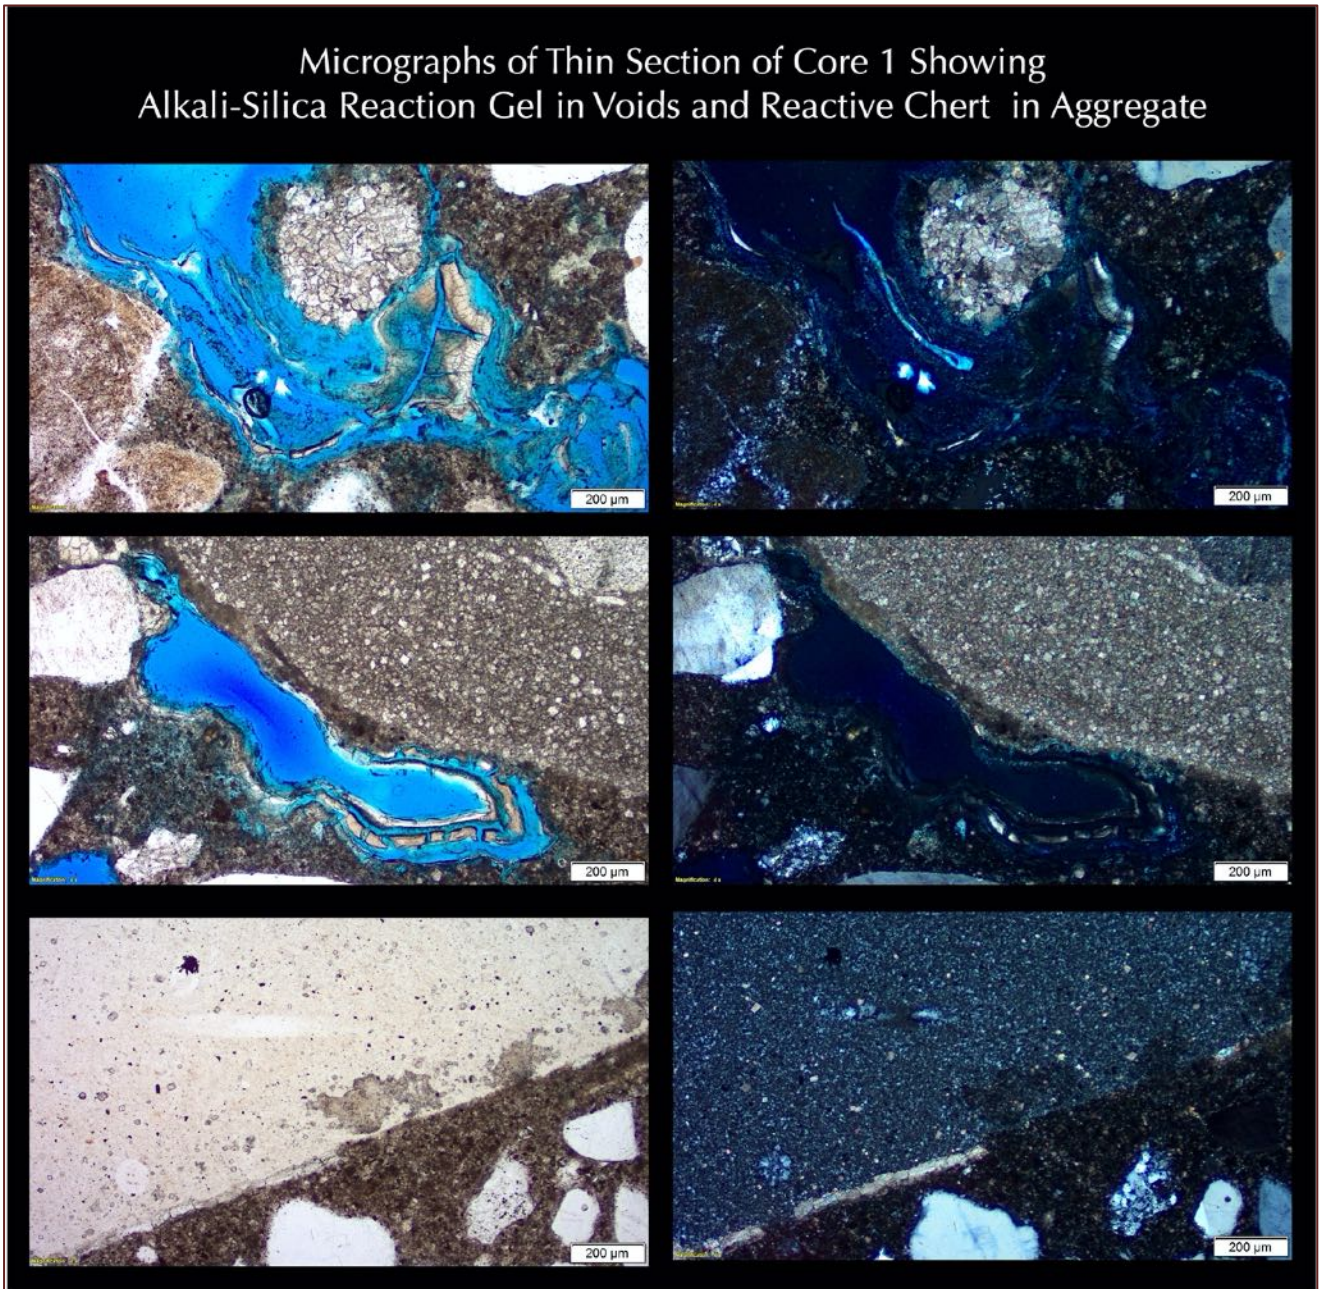
Alkali-Silica Reaction of Potentially Unsound Crushed Dolomitic Limestone Aggregate: Along with ACR, also detected are isotropic to birefringent alkali-silica reaction gel in the walls of main vertical cracks and in some coarse voids, which are judged to be the result of alkali-silica reaction (ASR) of reactive silica inclusions in some of crushed argillaceous dolomitic limestone particles and alkaline pore solutions in shotcrete. Despite its detection in rather meager amounts, similar to ACR, however no cracking was detected from ASR of reactive silica components in crushed dolomitic limestone aggregate. Like ACR, ASR too is present at a very early stage.

Figure 53: Evidence of alkali-silica reaction gel deposits lining walls of coarse voids where potentially reactive components may have derived from reactive silica particles within dolomitic limestone aggregate and/or reactive silica (chert, microcrystalline silica component in dolomitic limestone, strained quartzite, etc.) in fine aggregate. Images were taken in plane (PPL, left) and corresponding cross (XPL, right) polarized light modes respectively, in a petrographic microscope.

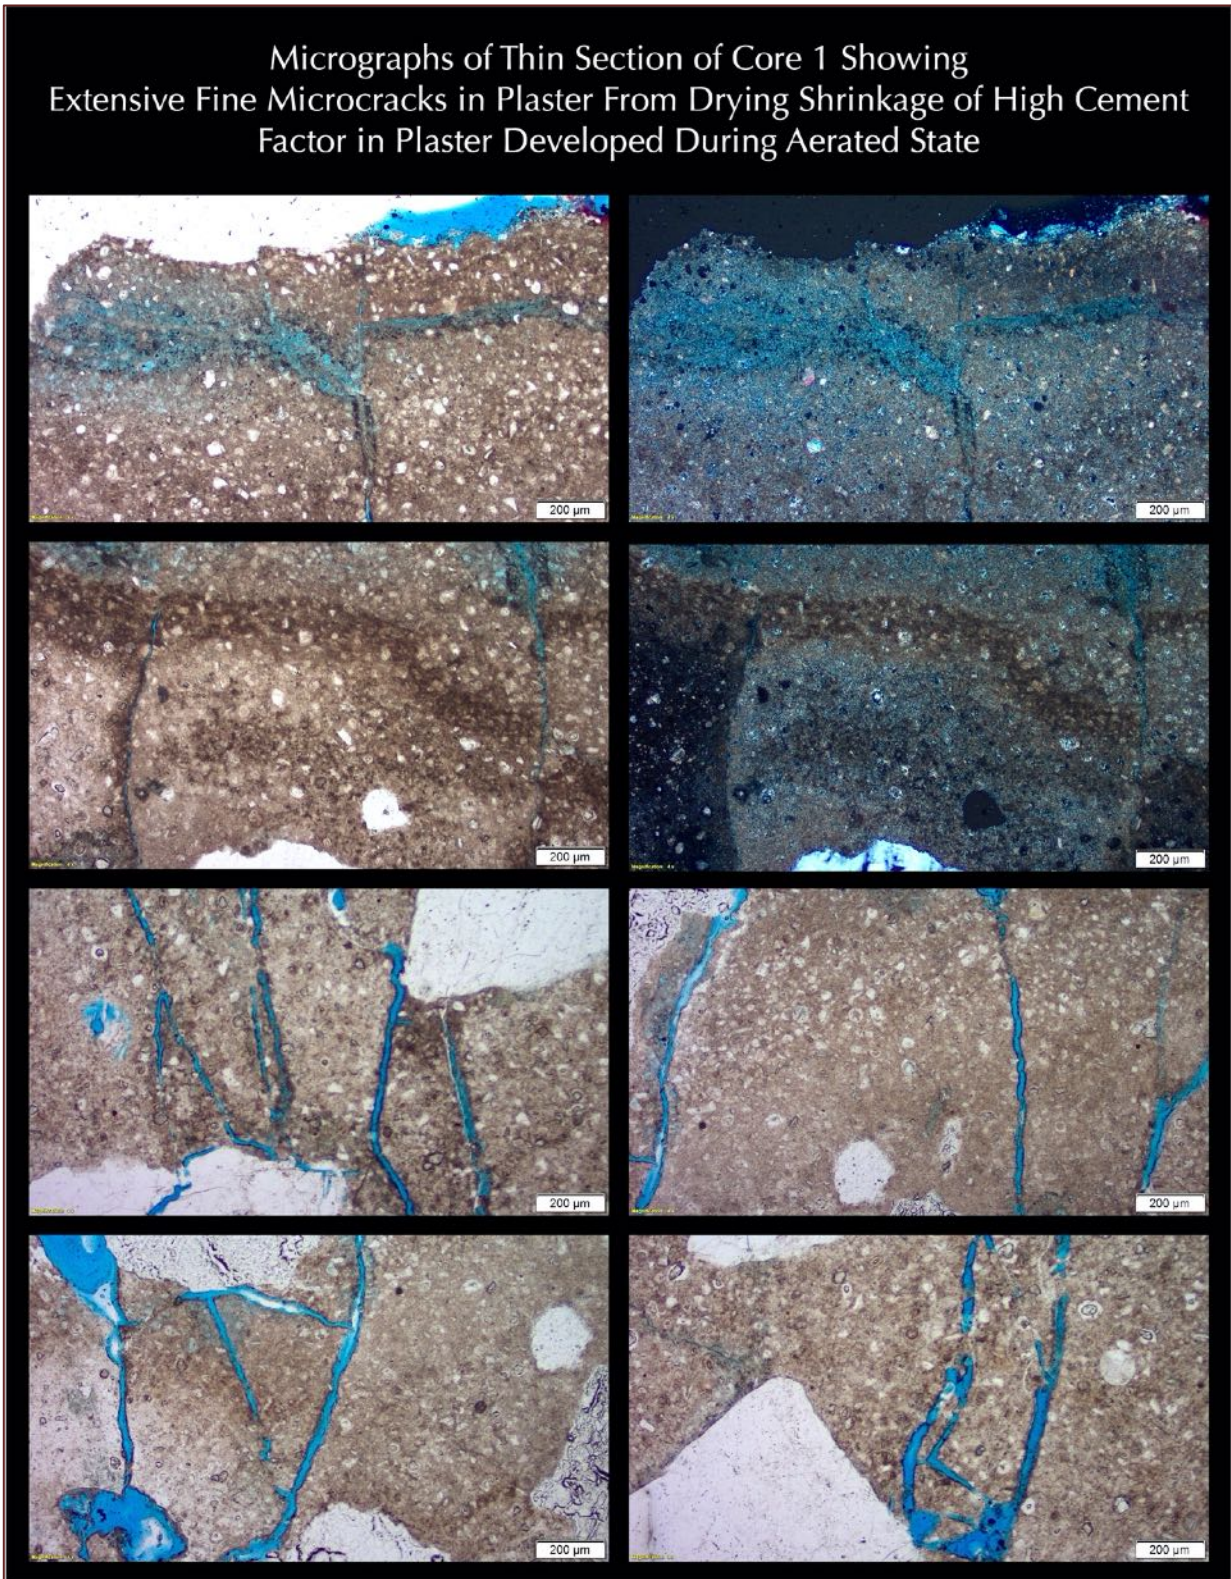
Figure 54: Micrographs of thin section of Core 1 showing: (a) extensive fine shrinkage microcracks within the white pool plaster, and (b) altered zone of plaster at the very top from interactions with pool water and air (top two rows). Images were taken in plane (PPL) and cross (XPL) polarized light modes in a petrographic microscope.

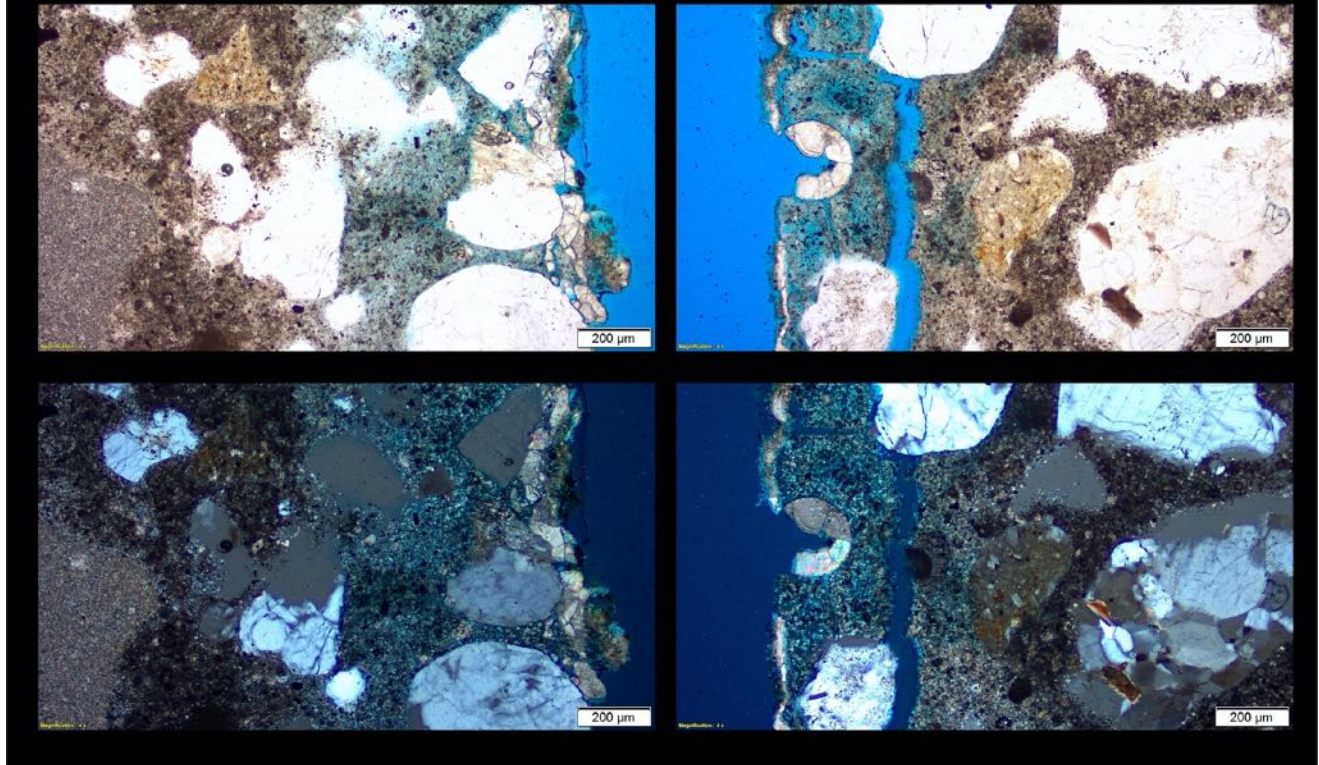
Figure 73: Micrographs of thin section of Core 4 showing alteration of paste along the walls of major vertical crack due to pool water penetration along the cracks. Images were taken in plane (top, PPL) and corresponding cross (bottom, XPL) polarized light modes respectively, in a petrographic microscope.

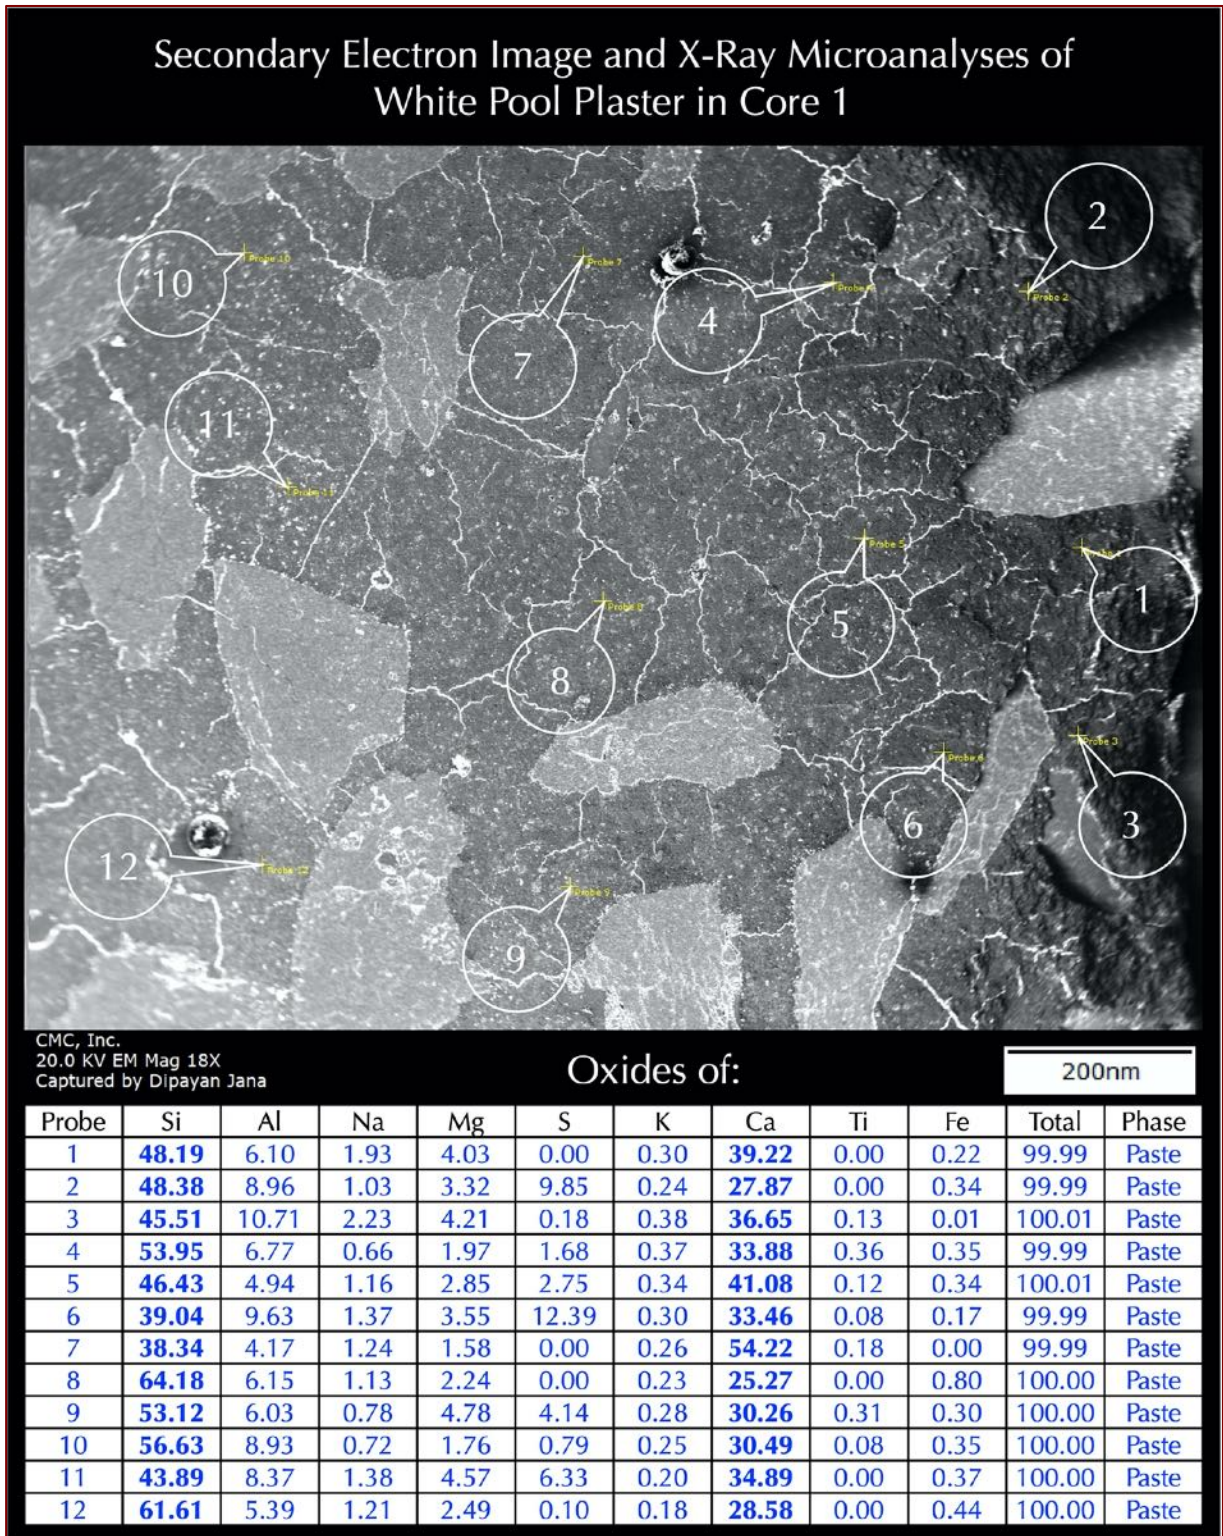
Figure 74: Backscatter electron image (top) and X-ray microanalyses at the tips of callouts of paste in the pool plaster in Core 1. Image shows extensive shrinkage cracking of plaster due to use of a high volume of white Portland cement paste relative to silica sand filler.

Pool plaster is compositionally similar cementitious plaster coat across all four cores and consist of: (a) white Portland cement, minor limestone fines, and 2 to 3 mm nominal size well-sorted, well-distributed lightly crushed siliceous (quartz, quartzite) filler (Figures 30, 32, 34, 36, 38 to 45). In all four cores, plaster showed extensive shrinkage cracking in the paste fractions (Figures 46, 54, 55, 63, 65, 761, 74, 75, and 77) due to high paste volume relative to silica fillers where cracks are confined within the plaster and did not extend into the underlying leveling coat or shotcrete. These extensive fine, hairline shrinkage cracks in plaster paste are invisible on the exposed surface of plaster relative to the major visible cracks that have transected through plaster into the shotcrete body and formed entirely due to shrinkage of a high paste-volume cementitious plaster.

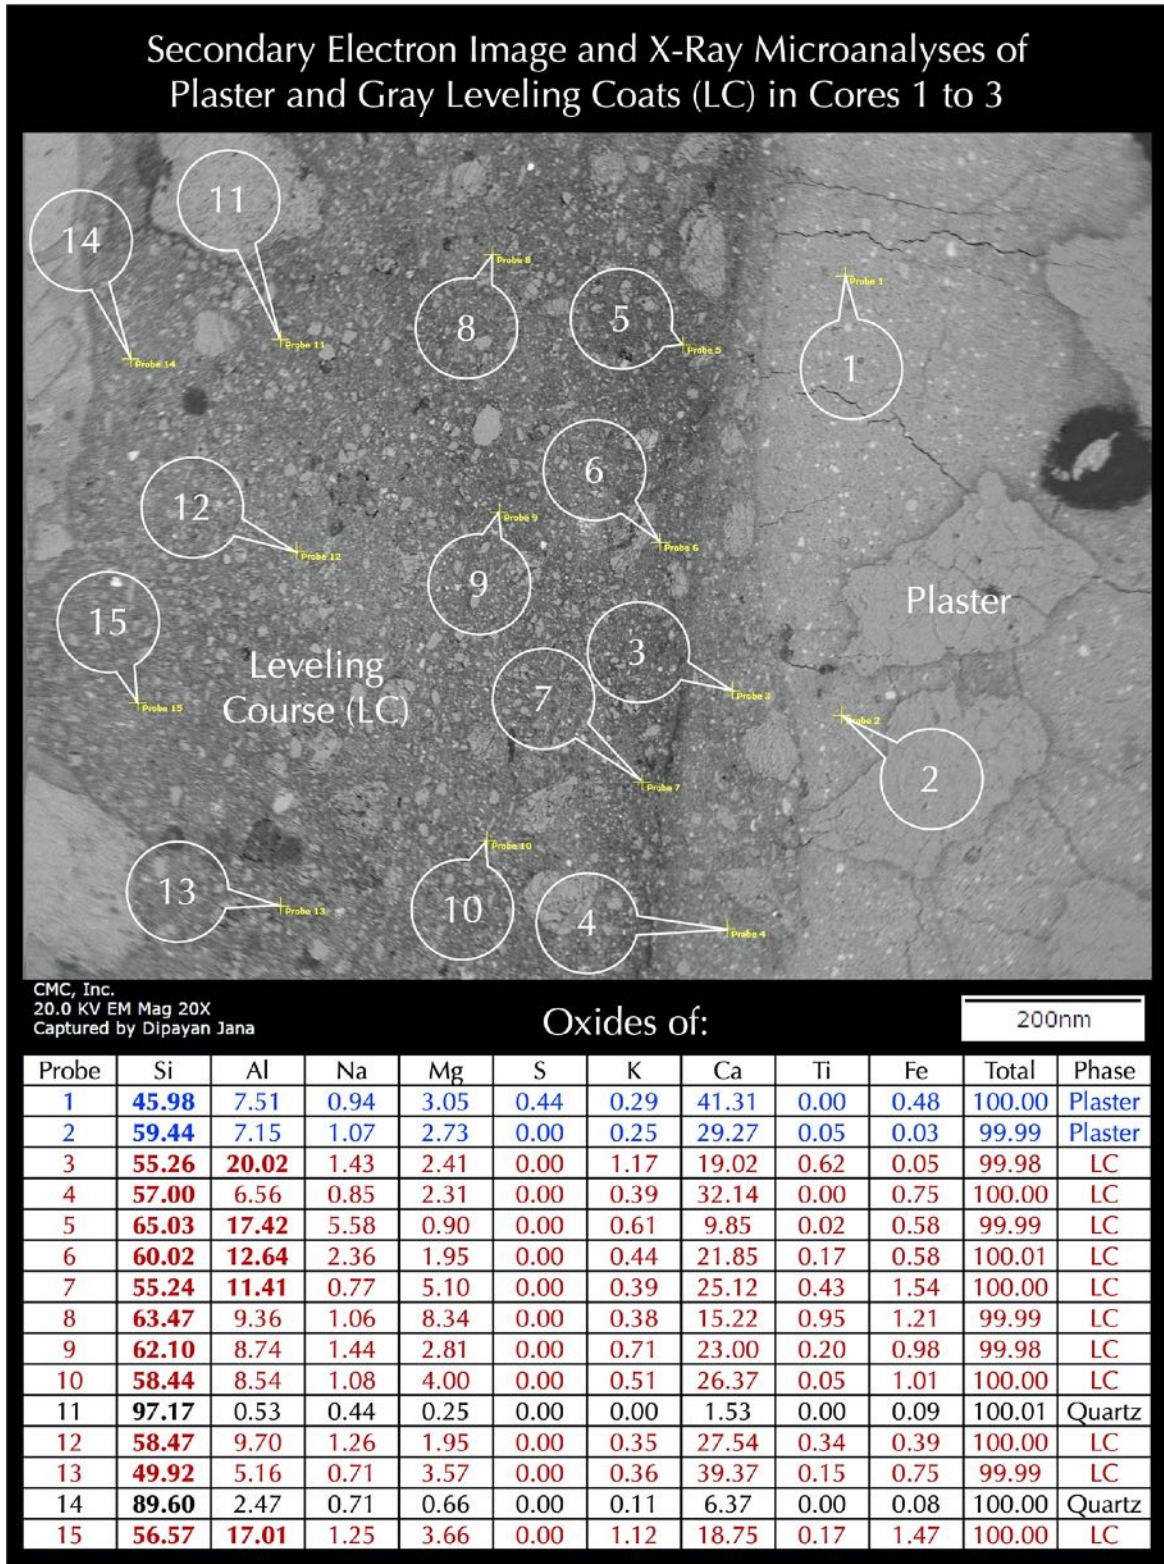
Figure 75: Backscatter electron image (top) and X-ray microanalyses at the tips of callouts of paste in the pool plaster at right and underlying calcium aluminate based leveling course at left. Notice extensive shrinkage cracking in pool plaster from the use of a high-volume white Portland cement relative to sand compared to no such cracking in the gray calcium aluminate cement based leveling course.

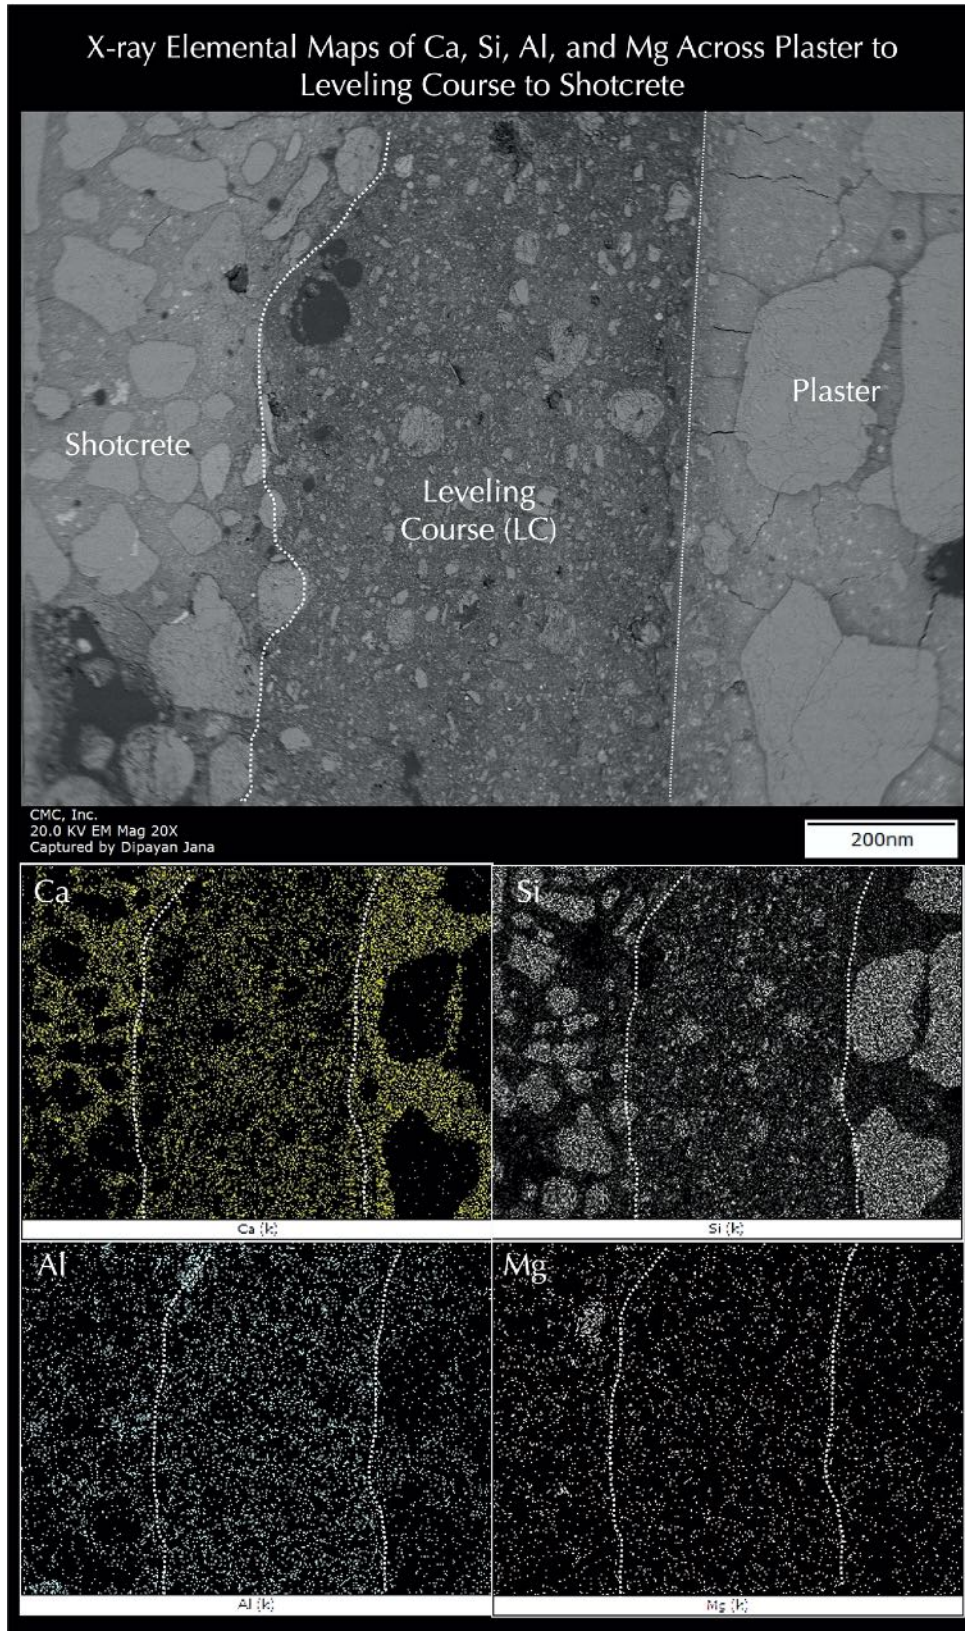
Figure 77: Backscatter electron image (top) and X-ray elemental maps of Ca, Si, Al, and Mg showing the pool plaster with extensive cracking at right, calcium aluminate based leveling course in the middle, and the main shotcrete body at left.
