CONSTRUCTION MATERIALS CONSULTANTS, INC.

Laboratory Investigation of Delamination of a Concrete Slab

RE: DELAMINATION OF CONCRETE SLAB

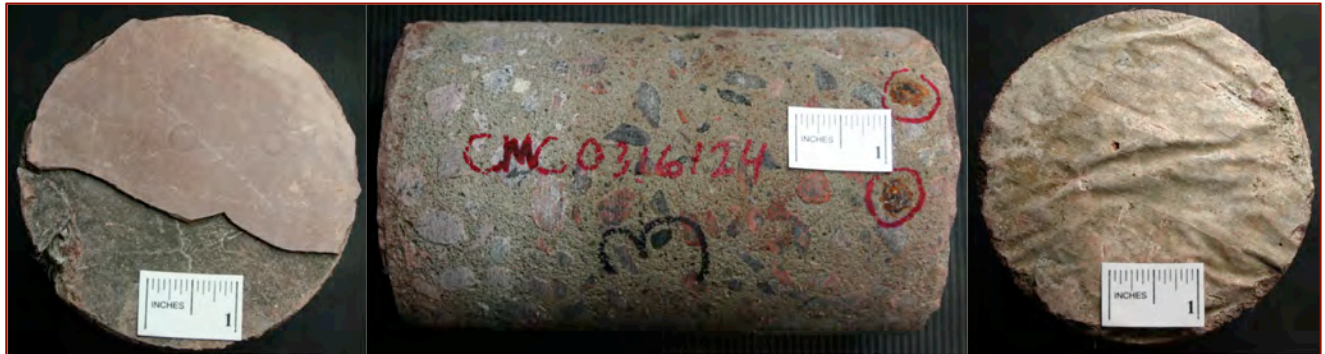
Figure 2: The top surface with remains of sulfur cap over a machine trowel-finished surface (left photo), the side view with identification (center photo), and the bottom surface (right photo) of Core No. 3 with impression of placement on a plastic vapor retarder, as received.

The top exposed surface (beneath sulfur capping) of Core No. 3 is a smooth, flat, hard, dense, shiny, machine trowel-finished surface with remains of sulfur capping. The bottom surface is smooth, formed, and wavy with impression of placement of slab on a plastic vapor retarder, which indicates that the core represents the full thickness of the slab at this location.

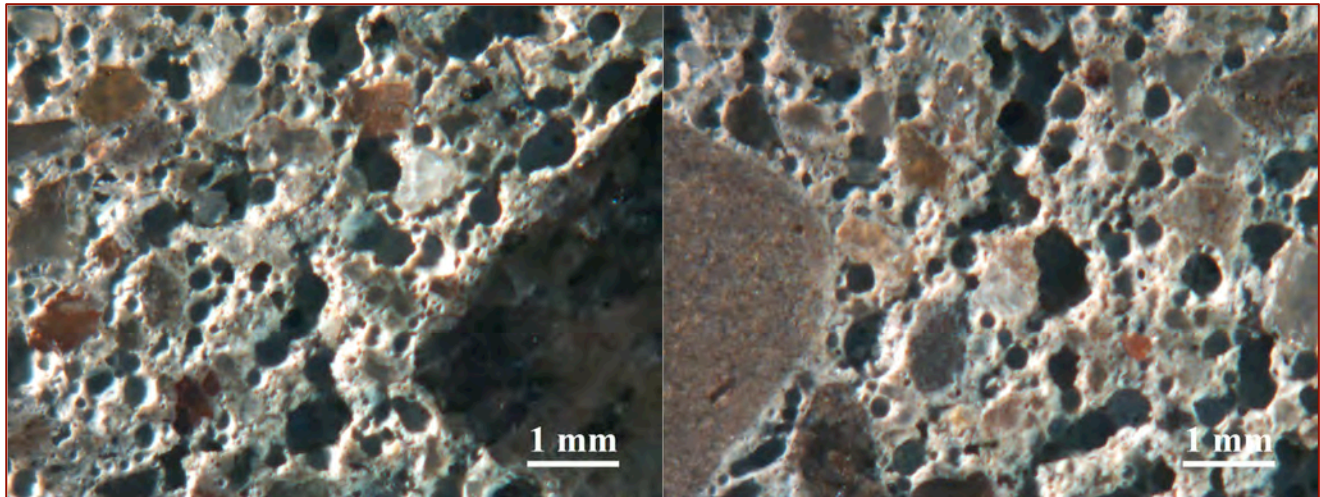
Figure 4: Photomicrographs of lapped cross section of Core No. 3 showing size, shape, grading, and distribution of fine aggregate particles in the core. Notice excessive air entrainment in the concrete (discussed later).

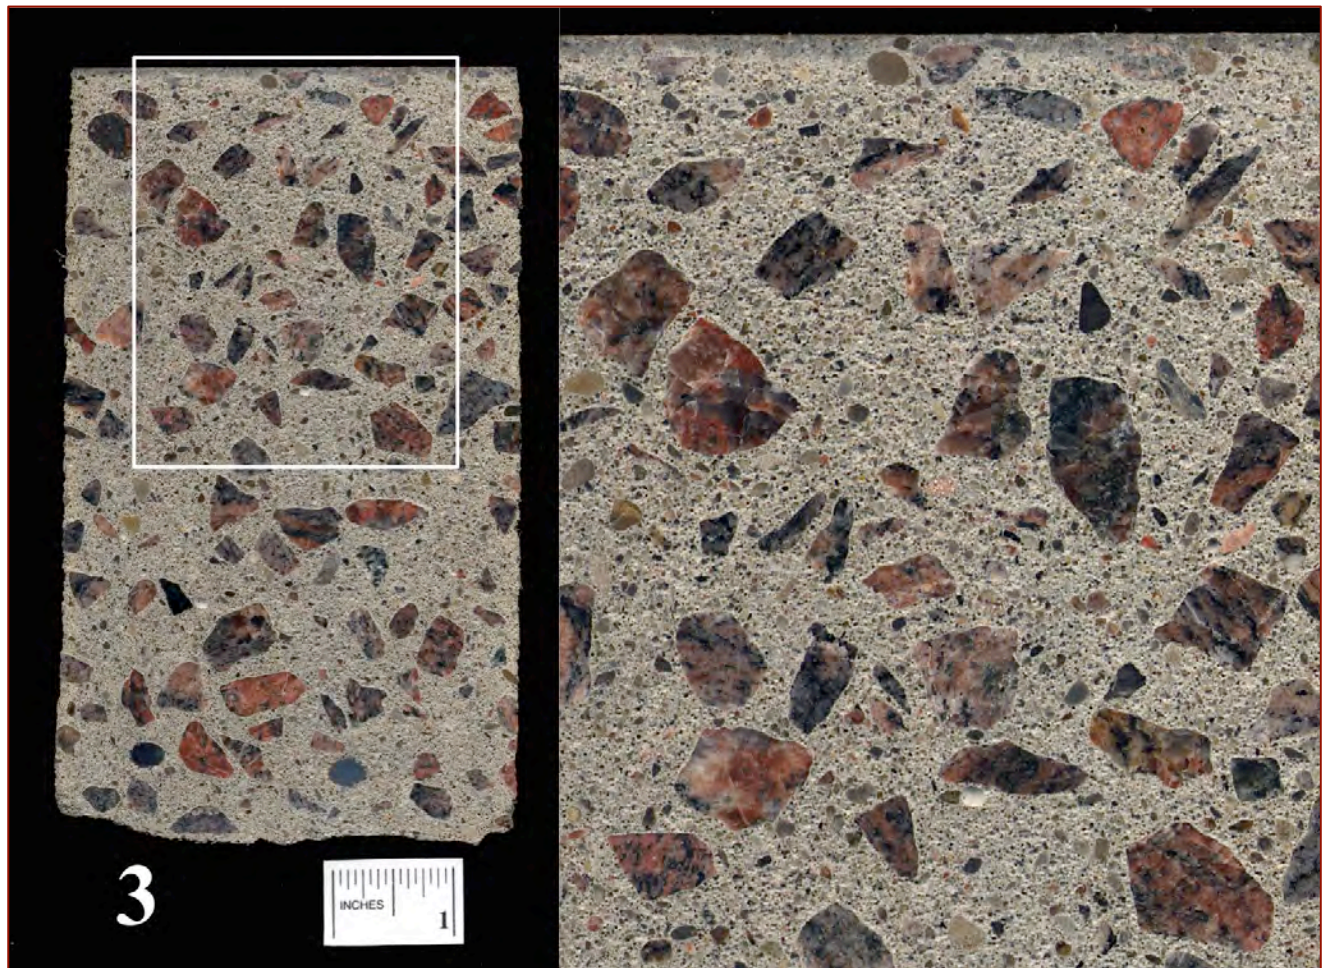
Figure 5 shows the overall good grading and well-distribution of coarse and fine aggregates on a lapped cross section of the core. The boxed area in the left photo is enlarged in the right to show an uplifted appearance of the crushed granite coarse aggregate particles relative to the mortar fraction – due to excessive air-entrainment in the mortar fraction that has reduced the density of mortar fraction significantly from too much air and gave a frothy-texture to the mortar fraction (discussed later).

Figure 5: Lapped cross section (left) and an enlarged view of the boxed area of lapped cross section (right) showing the overall good grading and well-distribution of coarse and fine aggregates and frothy nature of mortar-fraction of the concrete from excessive air entrainment.

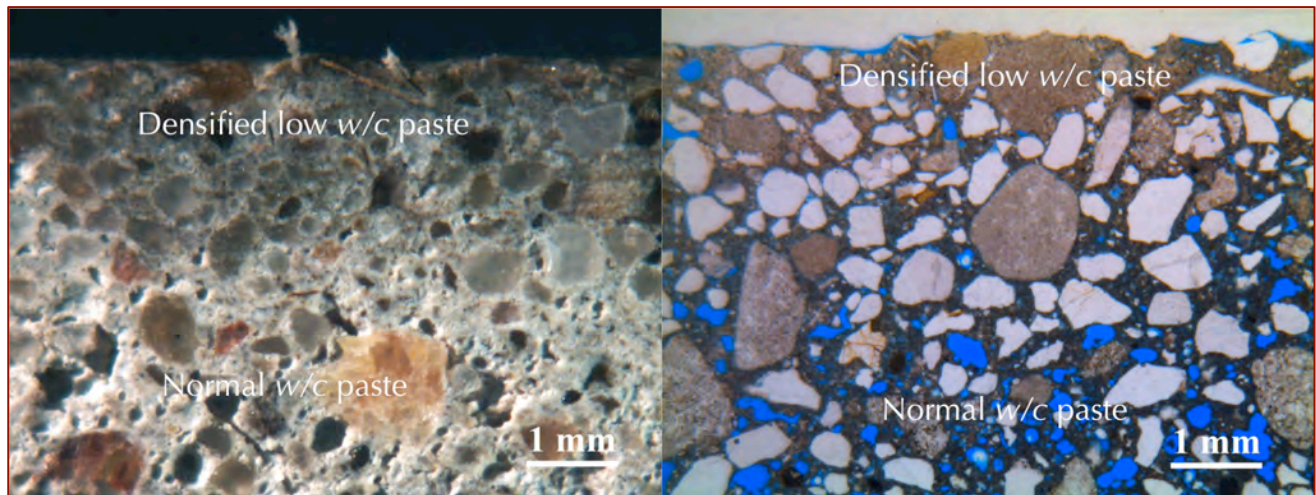
The textural and compositional features of the paste are indicative of a Portland cement content estimated to be 6¹/₂ to 7 bags per cubic yard. The core has a water-cement ratio (w/c) estimated to be from 0.45 to 0.50 in the main body, and a lower w/c at the very top surface-region (top 1/16 to 1/8 in.) of concrete immediately beneath the trowel-finished surface, where concrete has a densified mortar fraction compared to the less dense (excessively air-entrained) interior body.

Figure 7: Normal w/c (0.45-0.50) paste in the interior concrete but noticeably denser, harder, darker gray paste immediately beneath the finished surface where w/c is lower (<0.40) than that in the interior.

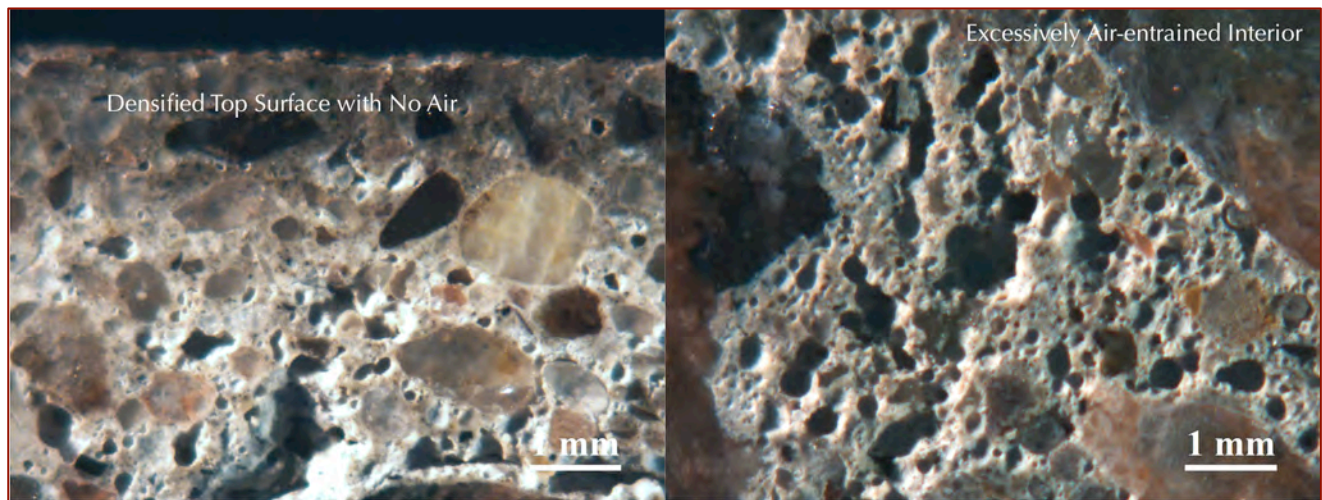
The very top surface region, i.e. the top $\frac{1}{16}$ to $\frac{1}{8}$ in. (1.59 mm), however, shows a significantly reduced air content (estimated to be less than 2 percent) compared to the main body due to hard trowel-finishing and finishing-induced densification of surface. The following photomicrographs of lapped cross section of the core show the excessively air-entrained nature of the interior concrete in the right photo, as well as noticeably reduced air content within the top surface region compared to the main body in the left photo:

Figure 8: Photomicrographs of lapped cross section of Core No. 3 showing the densified top surface region with little to no air voids (left photo), and the excessively air-entrained nature of the concrete in the main body (right photo).

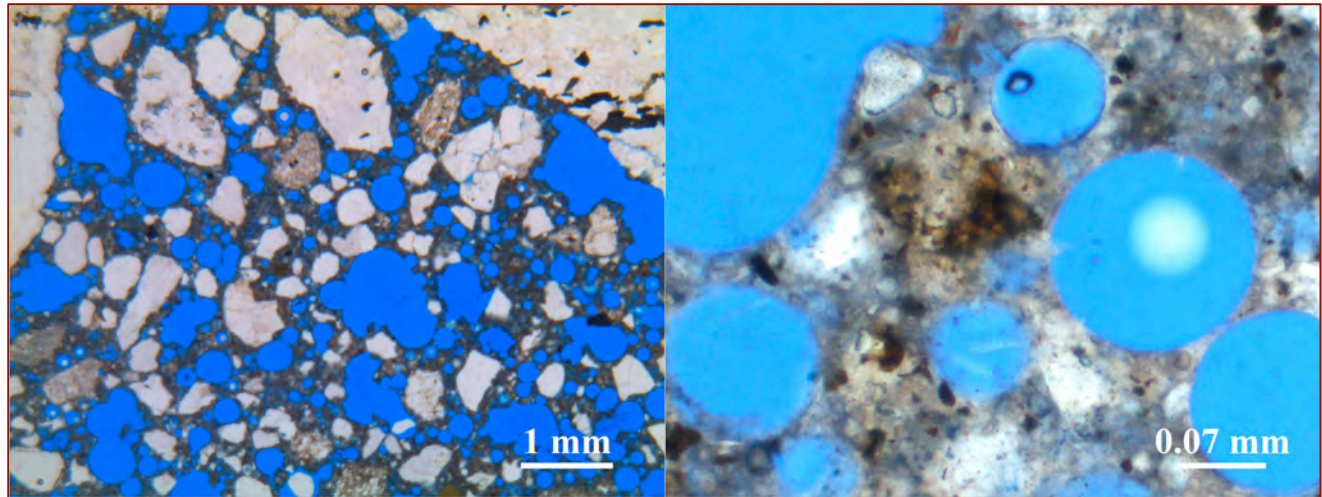
The following blue dye-mixed epoxy-impregnated thin section of concrete shows excessive air-entrainment as air bubbles that are highlighted by the dyed epoxy – notice excessive air entrainment in the left photomicrograph in Figure 9.

Figure 9: Photomicrographs of blue dye-mixed epoxy-impregnated thin section of Core No. 3 showing the excessively air-entrained nature of the concrete.

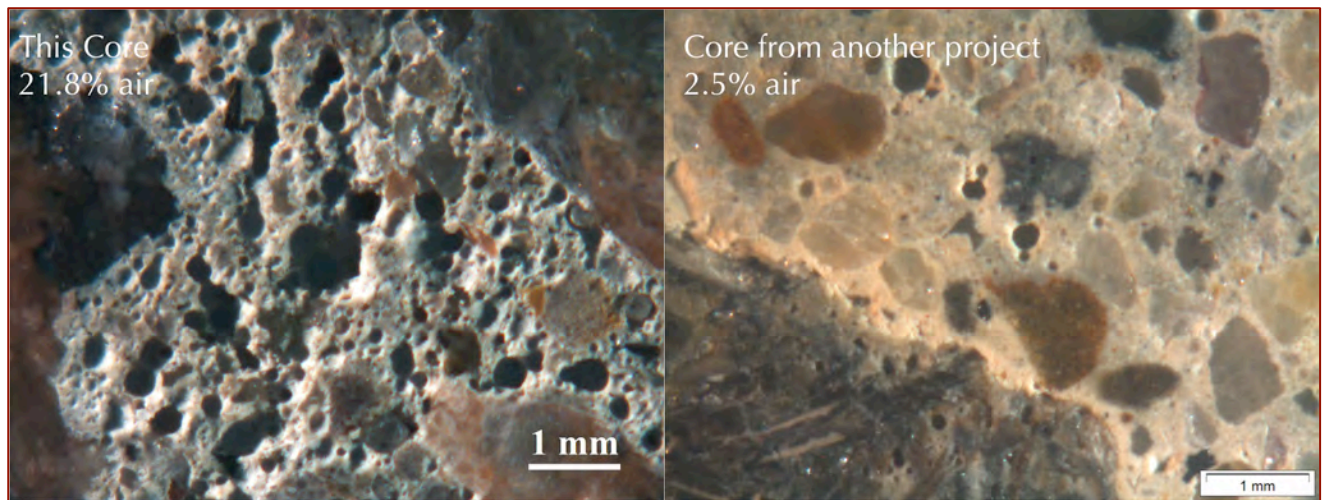
In order to explain how excessive air content is compared to common industry-recommended maximum air content of 3 percent for an indoor slab to receive a hard trowel finish, the following two photomicrographs of two different concrete from this project (on left) and an entirely different project (on right) show 20+ percent air in the concrete in this project versus 2.5 percent air in a concrete from a different project, which should be the air for the present indoor concrete slab to receive a hard trowel finish.

Figure 10: Another view of the right photo of Figure 8 shown here again in the left, showing excessive air entrainment in the interior concrete i.e. from a depth of approximately 5 mm from the top surface through the rest of the core. This left photo clearly shows an air content of at least 20 percent, far higher than the recommended maximum air content of 3 percent. For a comparison, also shown on right is another concrete from a different project where air content was measured by ASTM C 457 to be 2.5 percent i.e. to show how less than 3 percent concrete looks like. These two comparison photos of air contents clearly show the inherent high air problem of this concrete, which should have been questioned during plastic air measurements, or from the reported “stickiness” of concrete during placement and finishing, which was from this too much air, and is also the cause of the reported low strength results of companion cores.

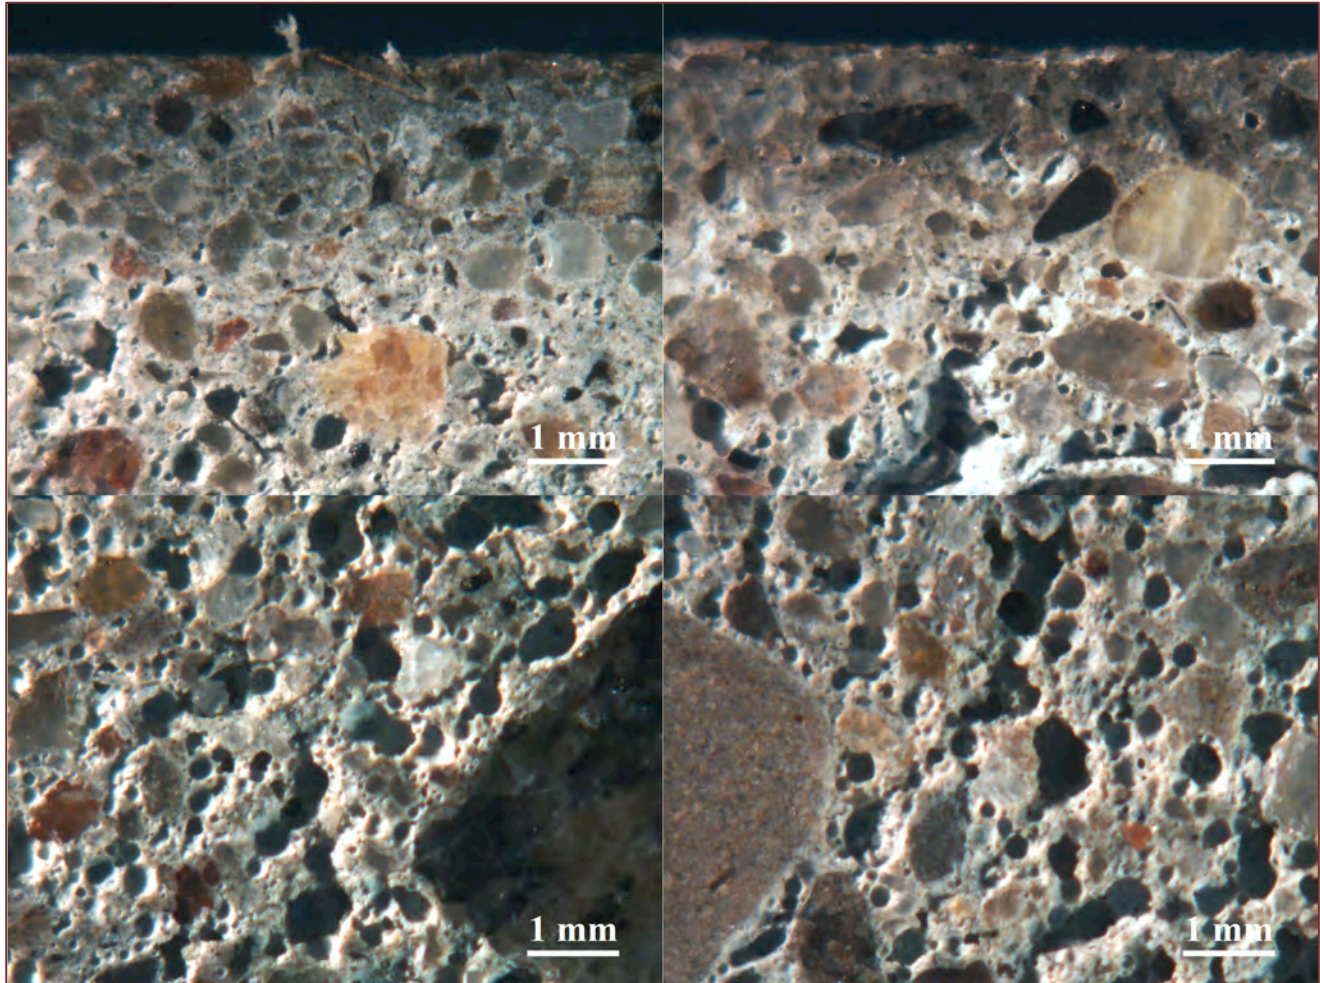
Figure 11 clearly shows excessive air entrainment in the interior concrete beyond 5 mm depth from the top, as opposed to almost no air at the very top 5 mm due to finishing-induced loss of air from the surface. The following photomicrographs, thereby, show two distinct microstructural zones –

- i. Finished-induced densified low to no-air, low w/c near-surface densified zone; and
- ii. Interior excessively air-entrained concrete.

Figure 11: Photomicrographs of lapped cross section of core showing two distinct microstructural zones – (i) finished-induced densified low to no-air, low w/c near-surface densified zone, and (ii) interior excessively air-entrained concrete.

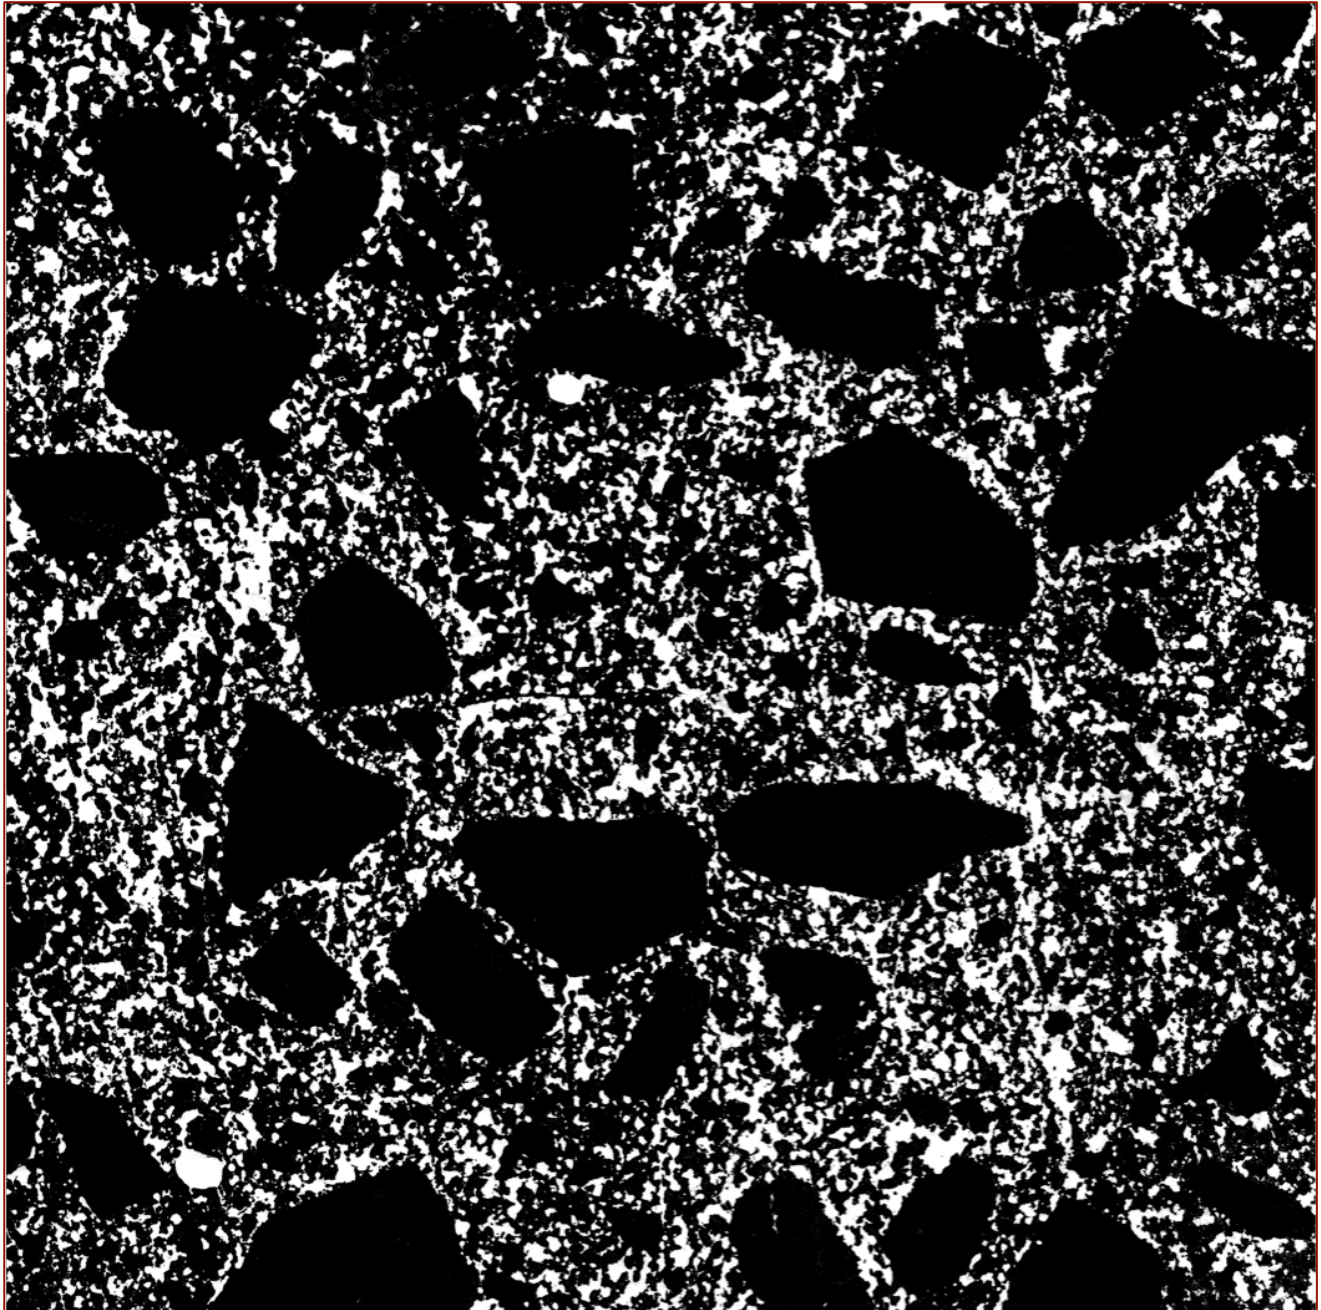
The following black-and-white photograph of lapped cross section of the core shows excessive air voids in white against everything else in black, which was prepared to scan on a flatbed office scanner and do an actual air measurement by using the flatbed scanner method for determining air-void parameters according to Peterson et al. 2002.

Calculated Air Content (%):	21.8
Given Paste Content (%):	27.7
Paste/Air Ratio:	1.27
Void Frequency (Voids/mm):	0.78
Specific Surface (mm^2/mm^3) (Recommended $>25 \text{ mm}^2/\text{mm}^3$):	14.34
Powers Spacing Factor (mm) (Recommended $< 0.2 \text{ mm}$):	0.09

Figure 12: Measurements of air contents and air-void parameters in the core by flatbed scanner method of Peterson et al. 2002. The core shows excessive air entrainment, as high as almost 22 percent air.

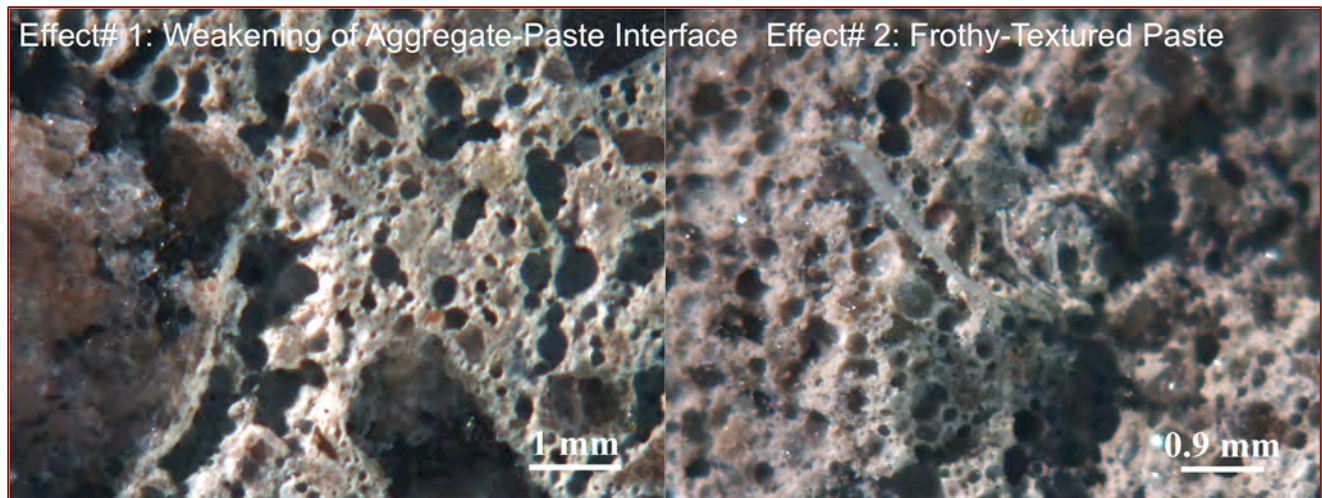
Another detrimental side effect of having too much air is clustering of air voids giving a frothy texture to the paste, and especially along aggregate-paste interfaces, which can weaken the interfacial bonds, and, thereby further reduce the compressive strength. Figure 13 shows such clustering of voids along coarse aggregate-paste interfaces that has significantly weakened the interfaces. Strength of concrete depends strongly on the strength of interfacial bonds (since concrete is weak in tension). The lapped surface and thin section examined show many such clustering, especially along coarse aggregate-paste interfaces.

High air, therefore, reduced the overall compressive strength both by: (i) increased porosity (for every one percent point increase in air above the design air content, at a given workability, can reduce compressive strength by 3 to 5 percent point), and (ii) by weakened aggregate-paste bond from clustering of excess air along the interfaces.

Figure 13: Two undesirable effects of excessive air entrainment that leads to loss of strength of concrete – weakening of aggregate-paste bond by air void clustering along the interface (left photo), and, frothy-textured paste from having too much air (right photo). Also note some fibers in the fresh fractured surface in the right photo.

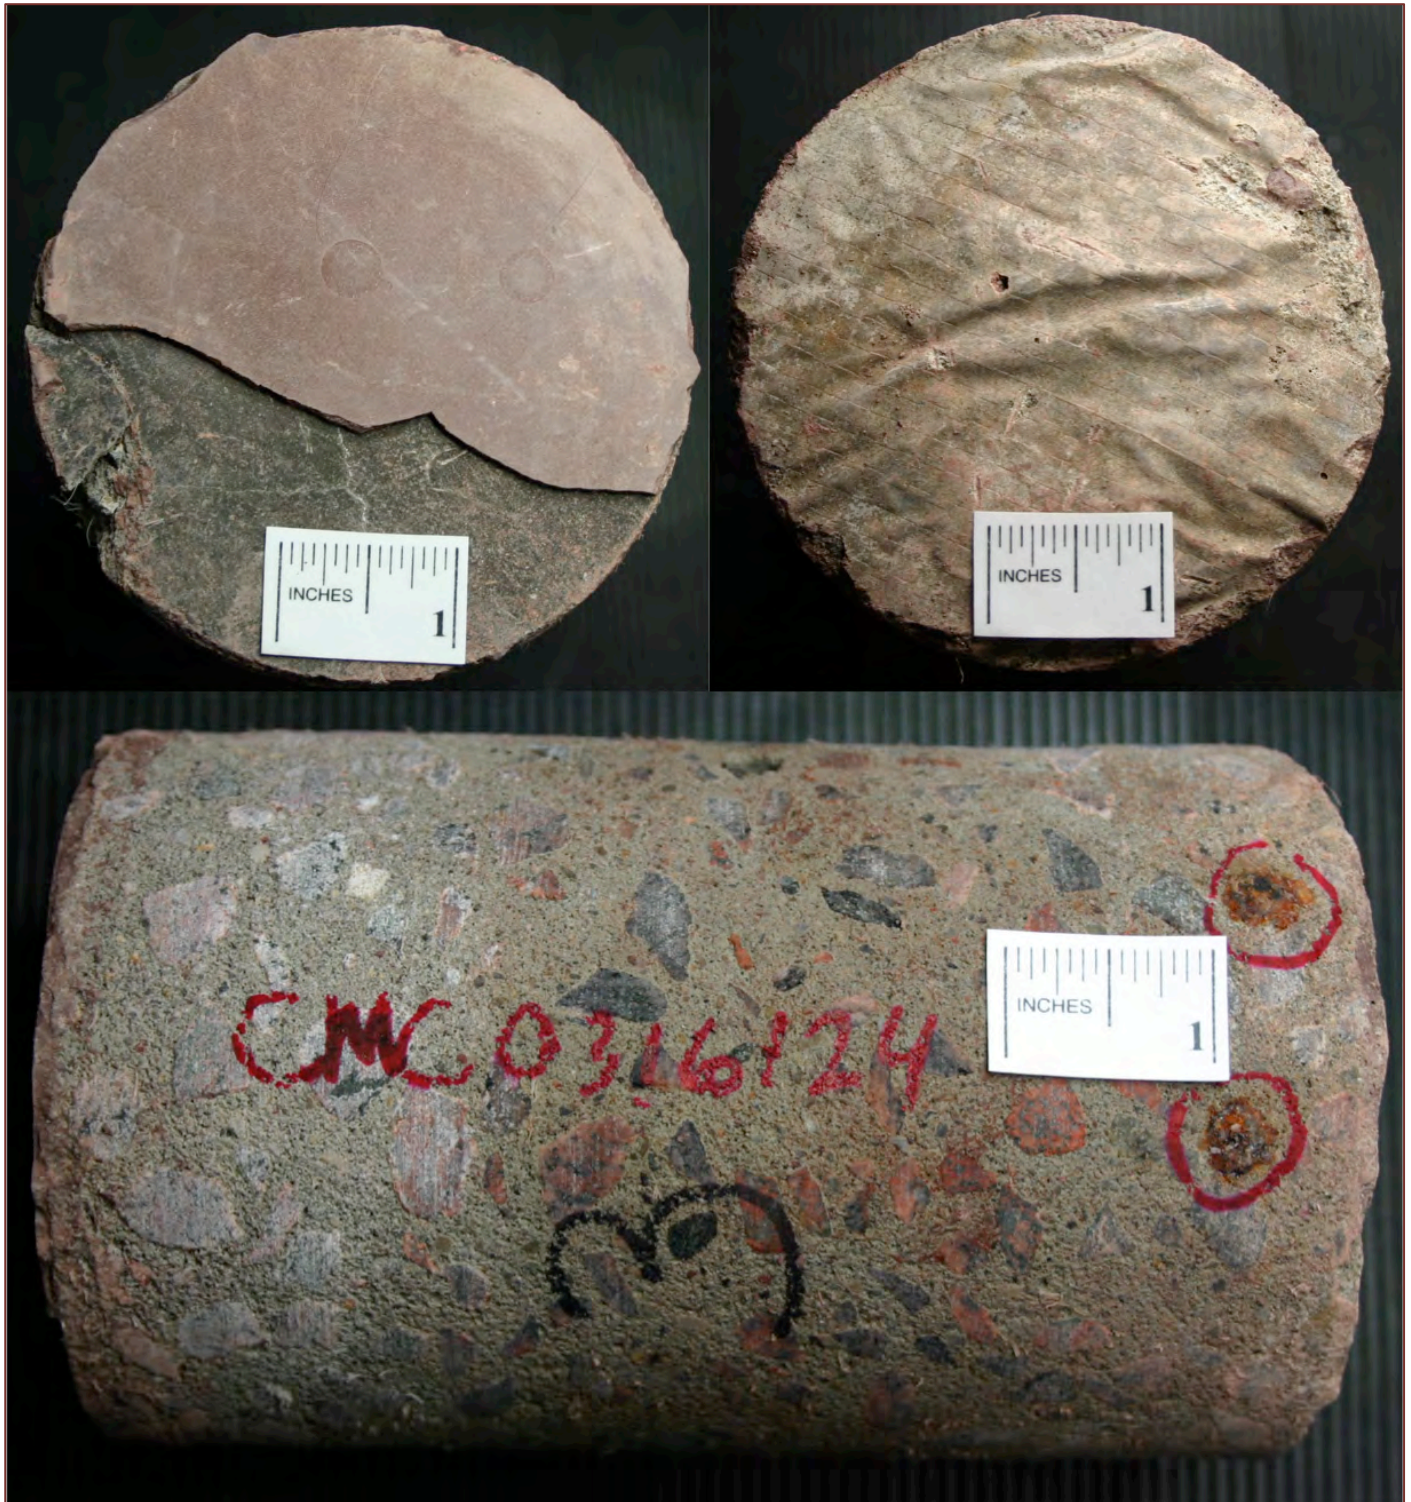
Figure A1: Shown are: (a) the smooth, flat, dense, hard, shiny, trowel-finished top surface with remains of sulfur capping (top left photo); (b) the smooth, formed, and wavy bottom surface with impression of placement of slab on a plastic vapor retarder (top right photo); and (c) side view of Core No. 3 (bottom photo), as received. Within the red circles in the bottom photo are No. 2 reinforcing steels at a depth of $5\frac{3}{4}$ in. from the top surface.

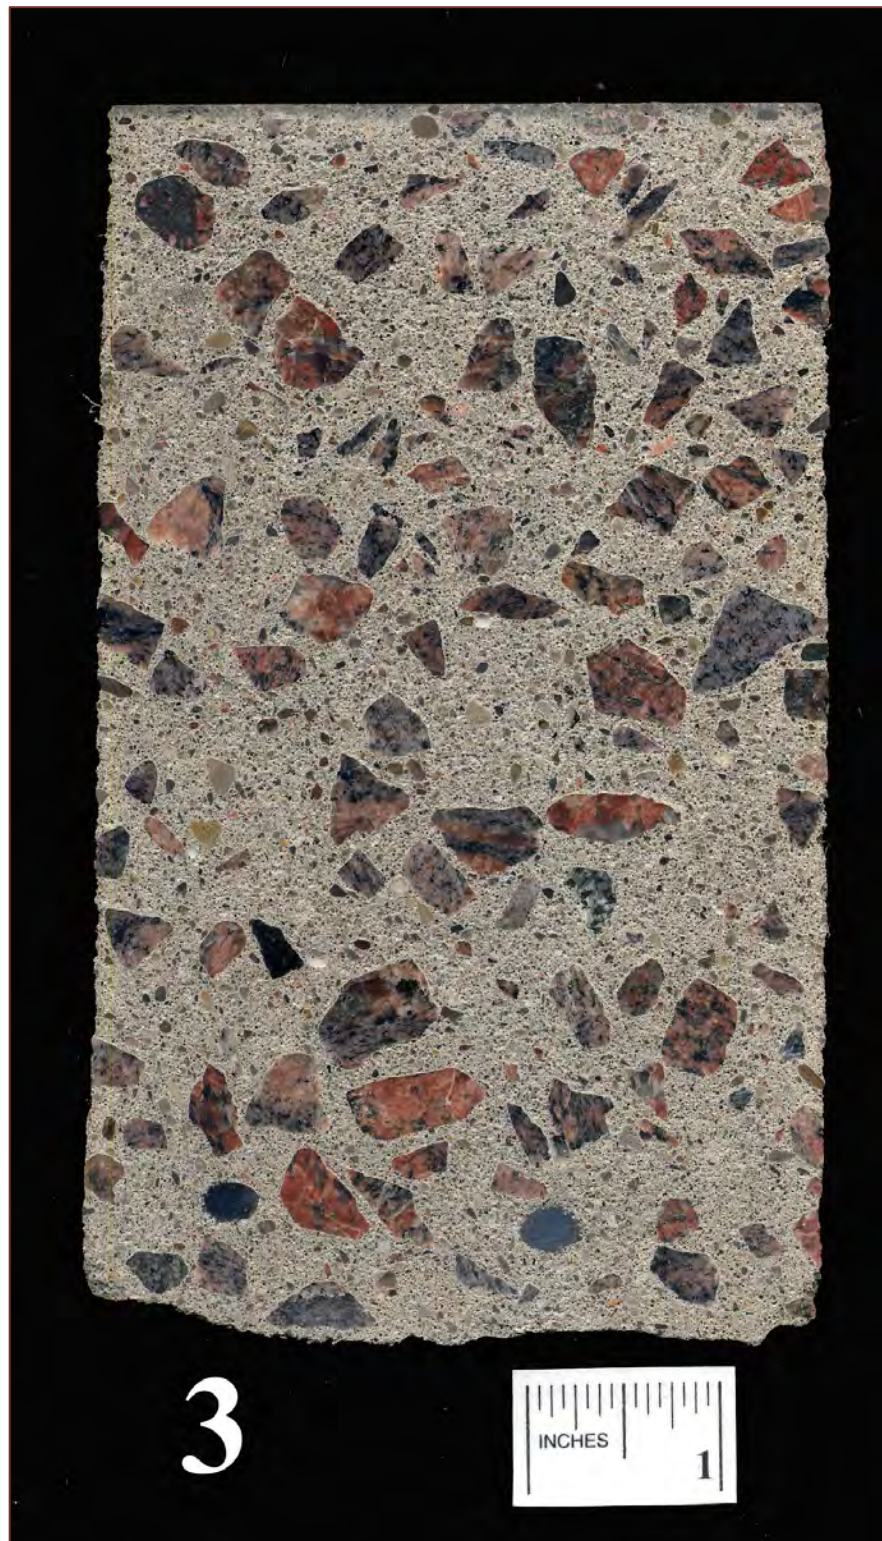
Figure A2: Lapped cross section of Core No. 3 showing: (a) the good grading and well-distribution of the aggregate particles; (b) the densified top surface region; and (c) the moderately dense nature of the interior concrete. Notice a lifting appearance of crushed granite coarse aggregate particles due to frothy texture of the mortar fraction from excessive air entrainment. Also notice the densified surface skin at the top 1/8 in. from trowel finishing.

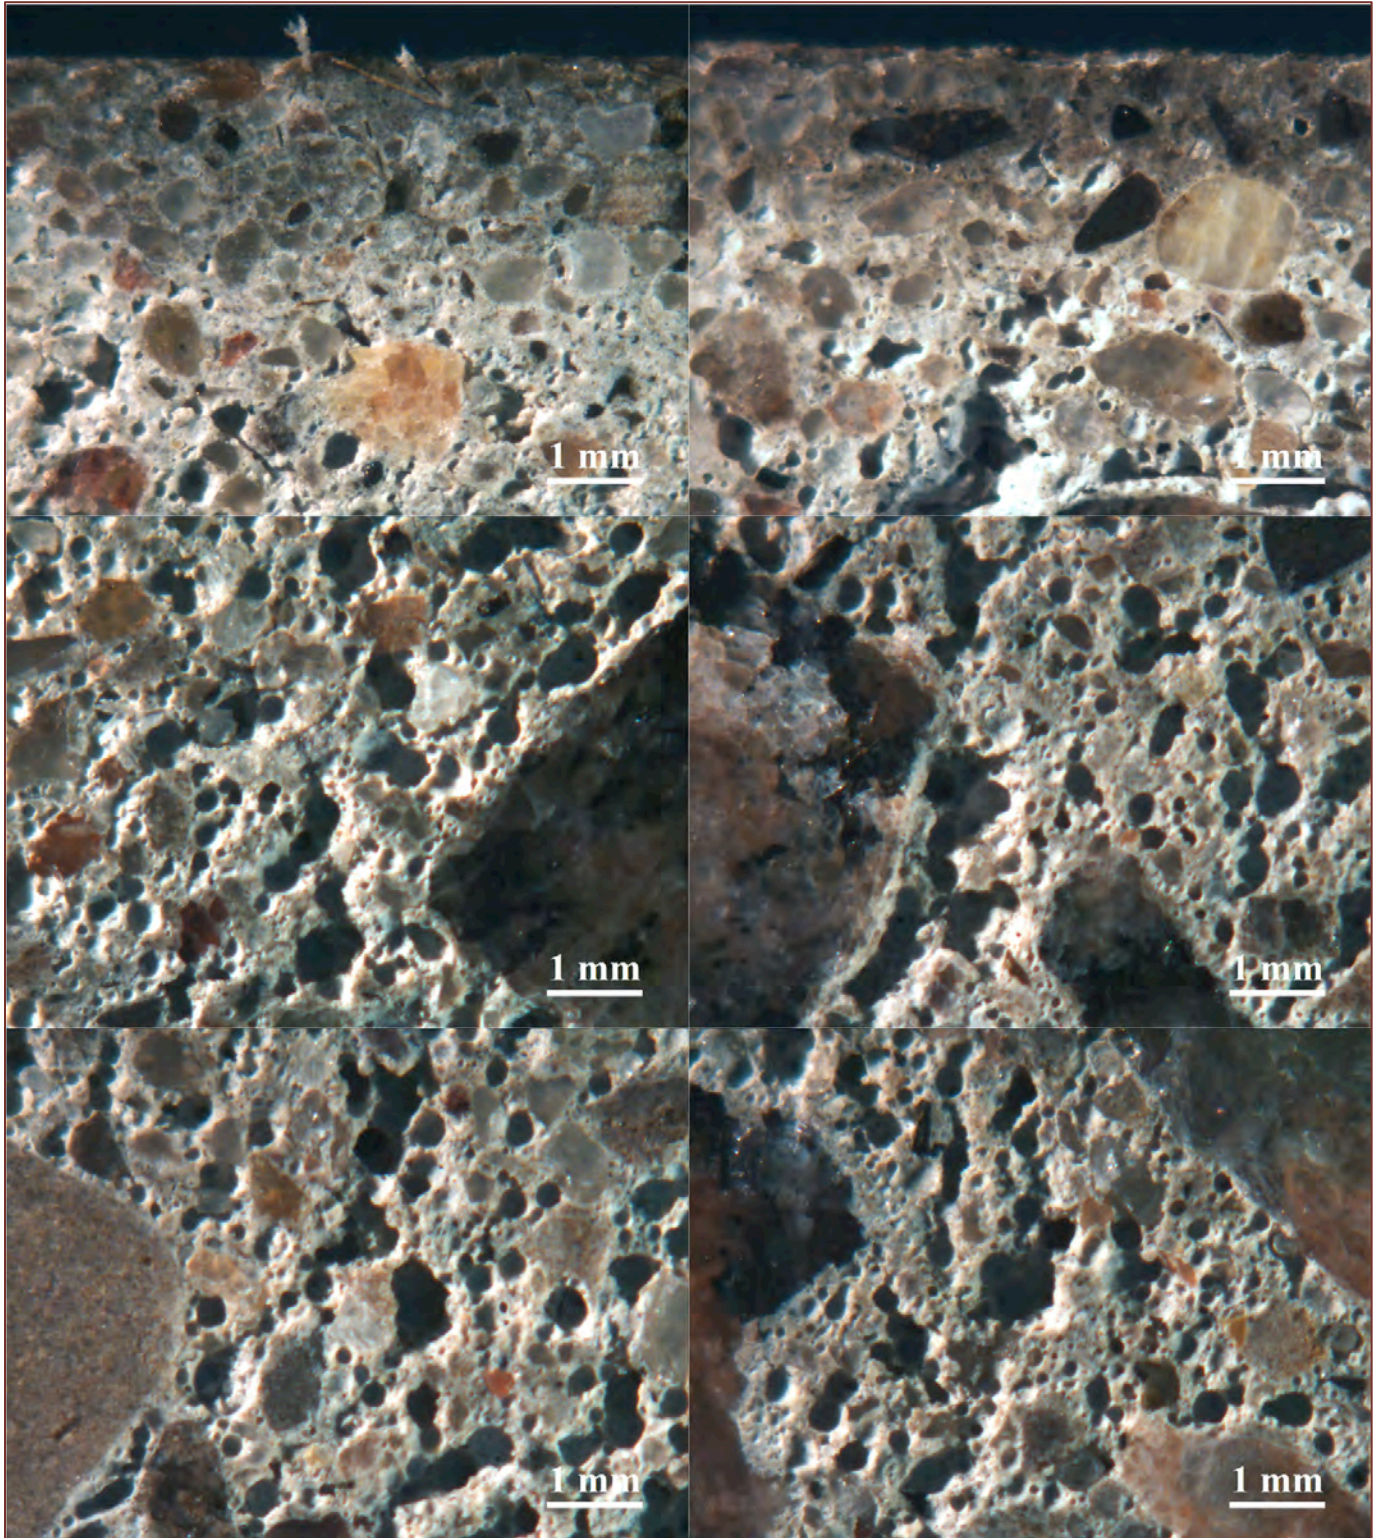
Figure A3: Photomicrographs of lapped cross section of Core No. 3 showing: (a) the densified top surface region with no air and a lower w/c denser and darker paste at the top few millimeters compared to the main body (top photos); and (b) the excessively air-entrained nature of the interior concrete with clustering of voids (middle and bottom photos).

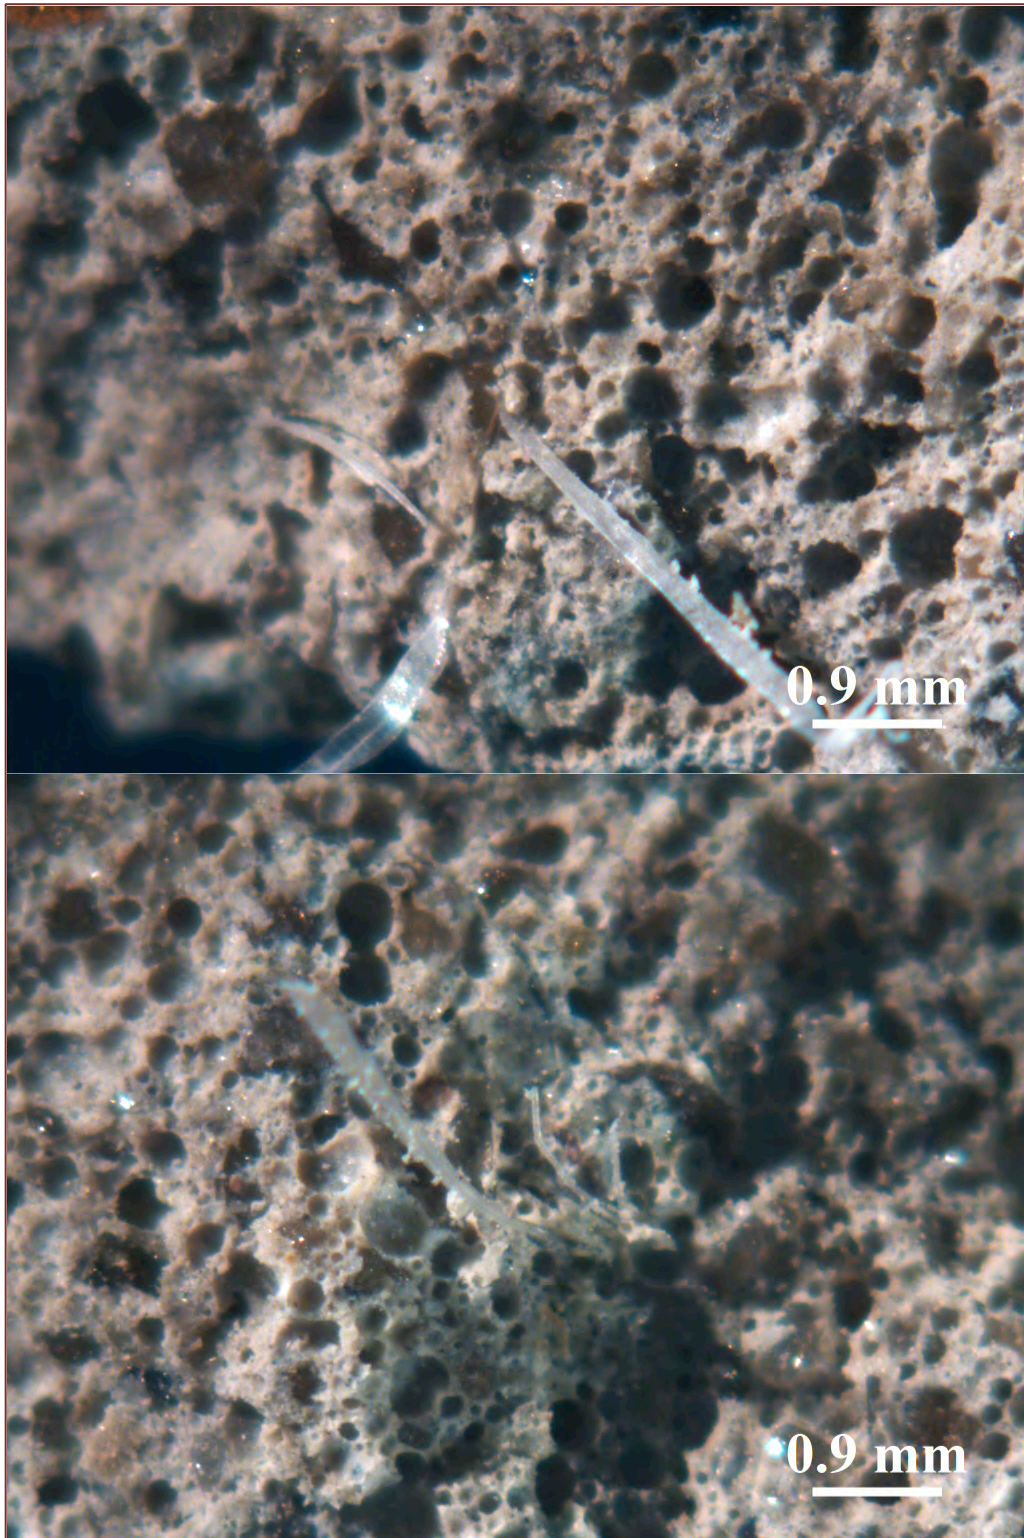
Figure A4: Photomicrographs of fresh fractured sections of the core showing: (a) the presence of fine polypropylene type fibers distributed throughout the concrete; and (c) the frothy texture of the paste due to excessive air entrainment.

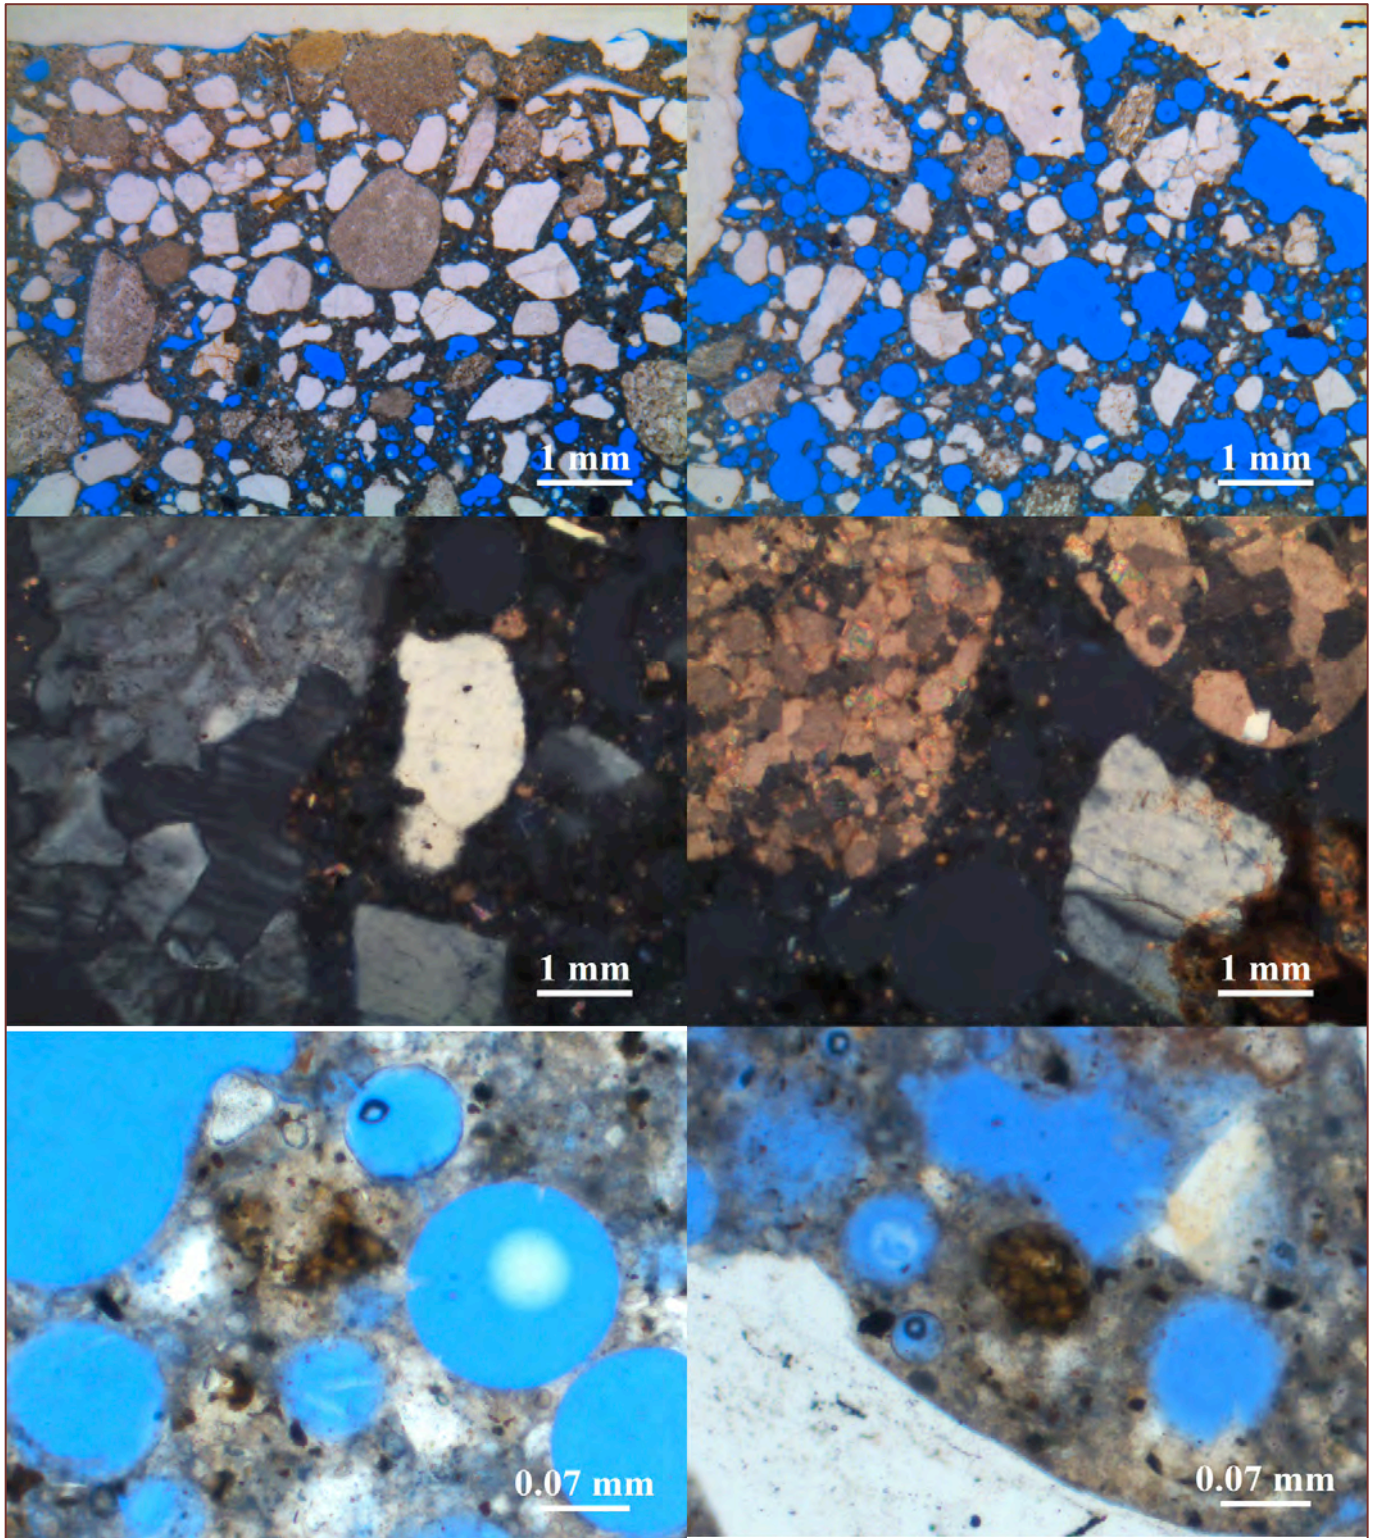
Figure A5: Photomicrographs of blue dye-mixed epoxy-impregnated thin section of Core No. 3 showing: (a) the excessively air entrained nature of the concrete (top photos); (b) the crushed granite coarse aggregate particles and natural siliceous-calcareous sand fine aggregate particles (middle photos); and (c) residual Portland cement particles in the paste (bottom photos).
