Surface Scaling of Residential Concrete Driveway – A Petrographic Study from Two Concrete Cores

71 Marvelle Road
Fayetteville, New York

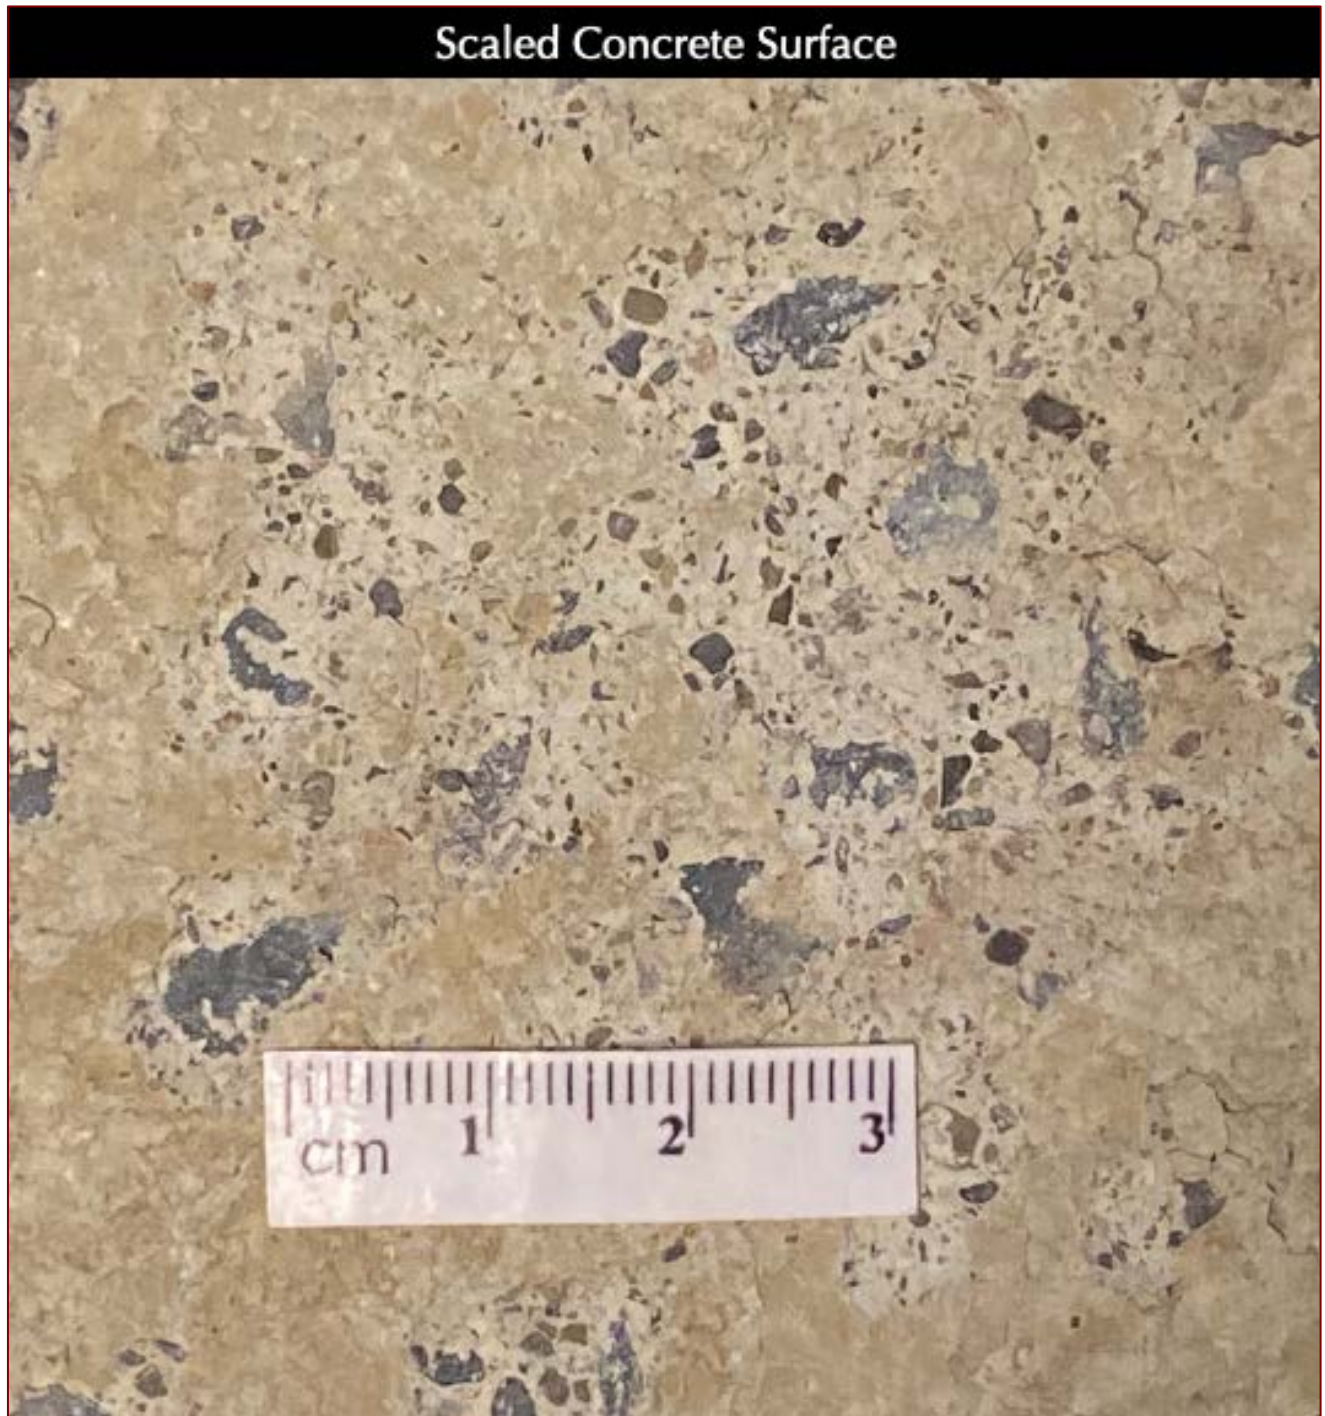
Figure 1: Enlarged view of the top exposed surface of the core collected from a scaled location. The surface shows losses of the original finished surface at isolated locations and exposures of near-surface coarse and fine aggregate particles from such losses. Remains of the original finished surface are still seen at some places, which show a light shiny appearance under reflected light indicating a possible application of a cure-seal compound after finishing.

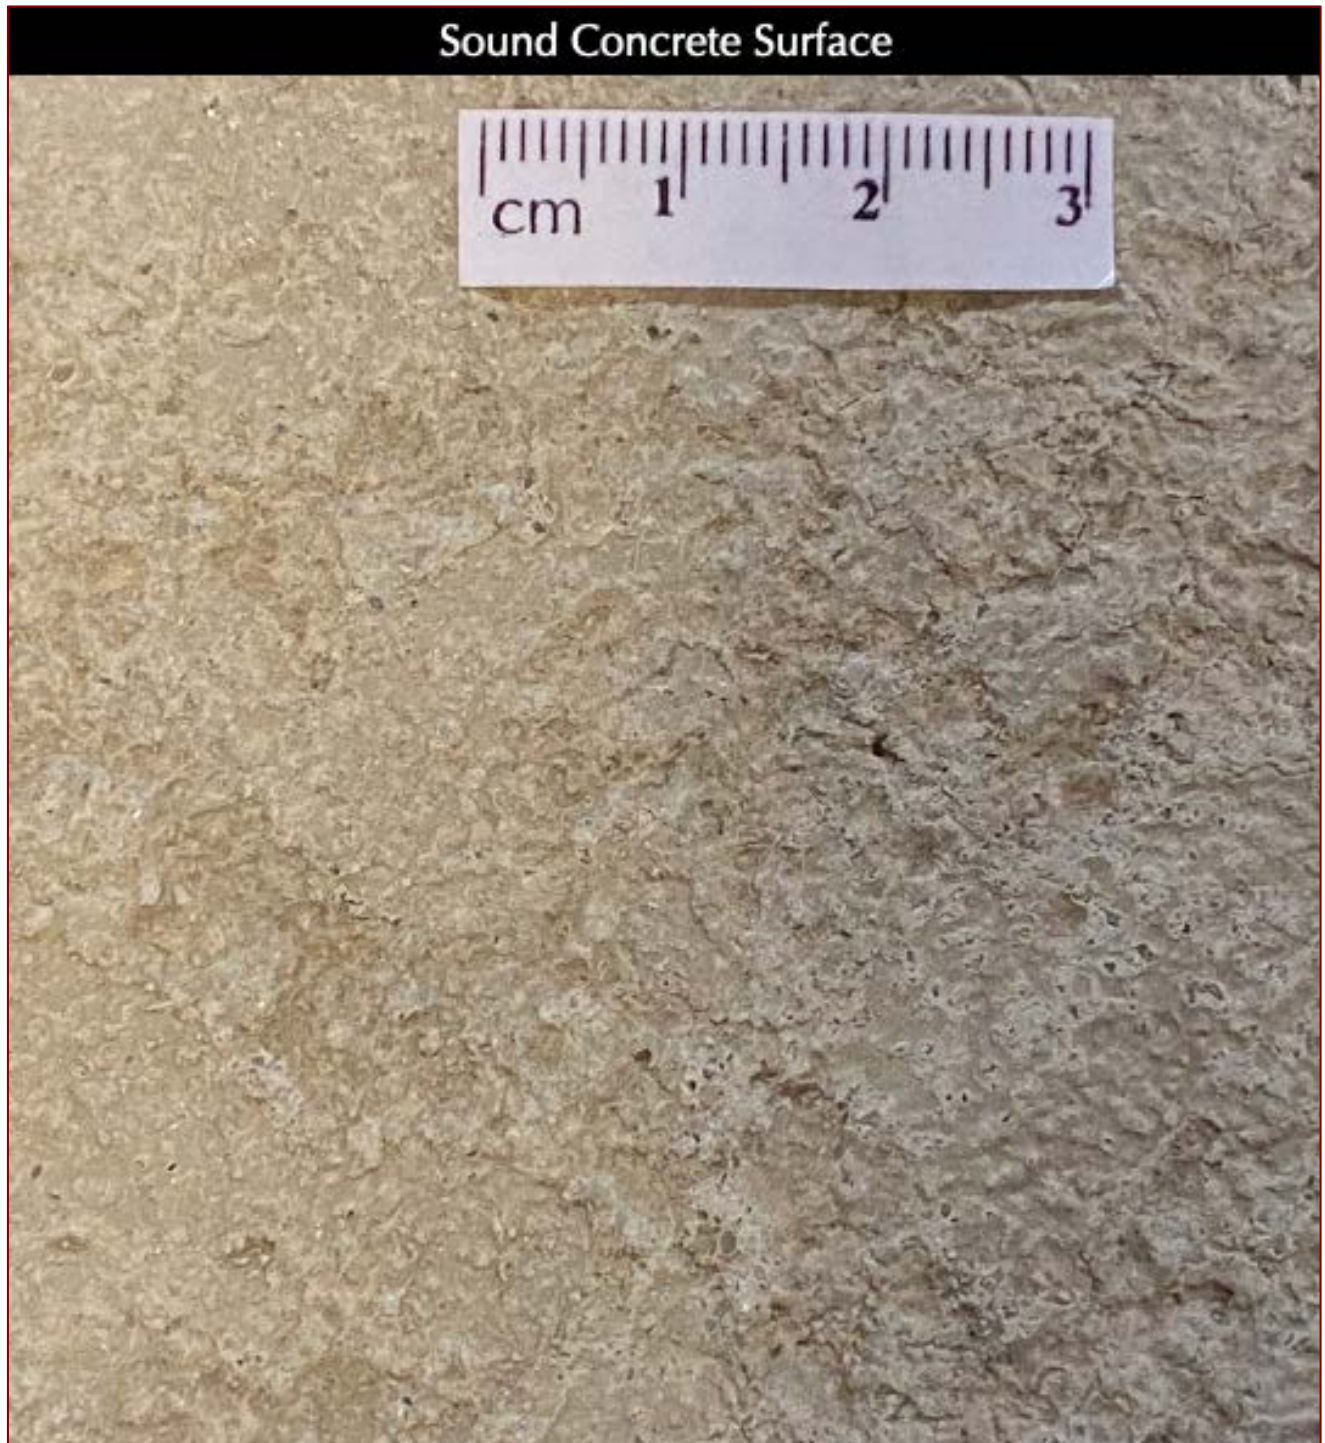
Figure 2: Enlarged view of the top exposed surface of the core collected from a sound location. The surface shows no loss of the original finished surface as seen in the core from the scaled area hence no exposure of near-surface coarse and fine aggregate particles. The original finished surface shows a light shiny appearance under reflected light indicating a possible application of a cure-seal compound after finishing.

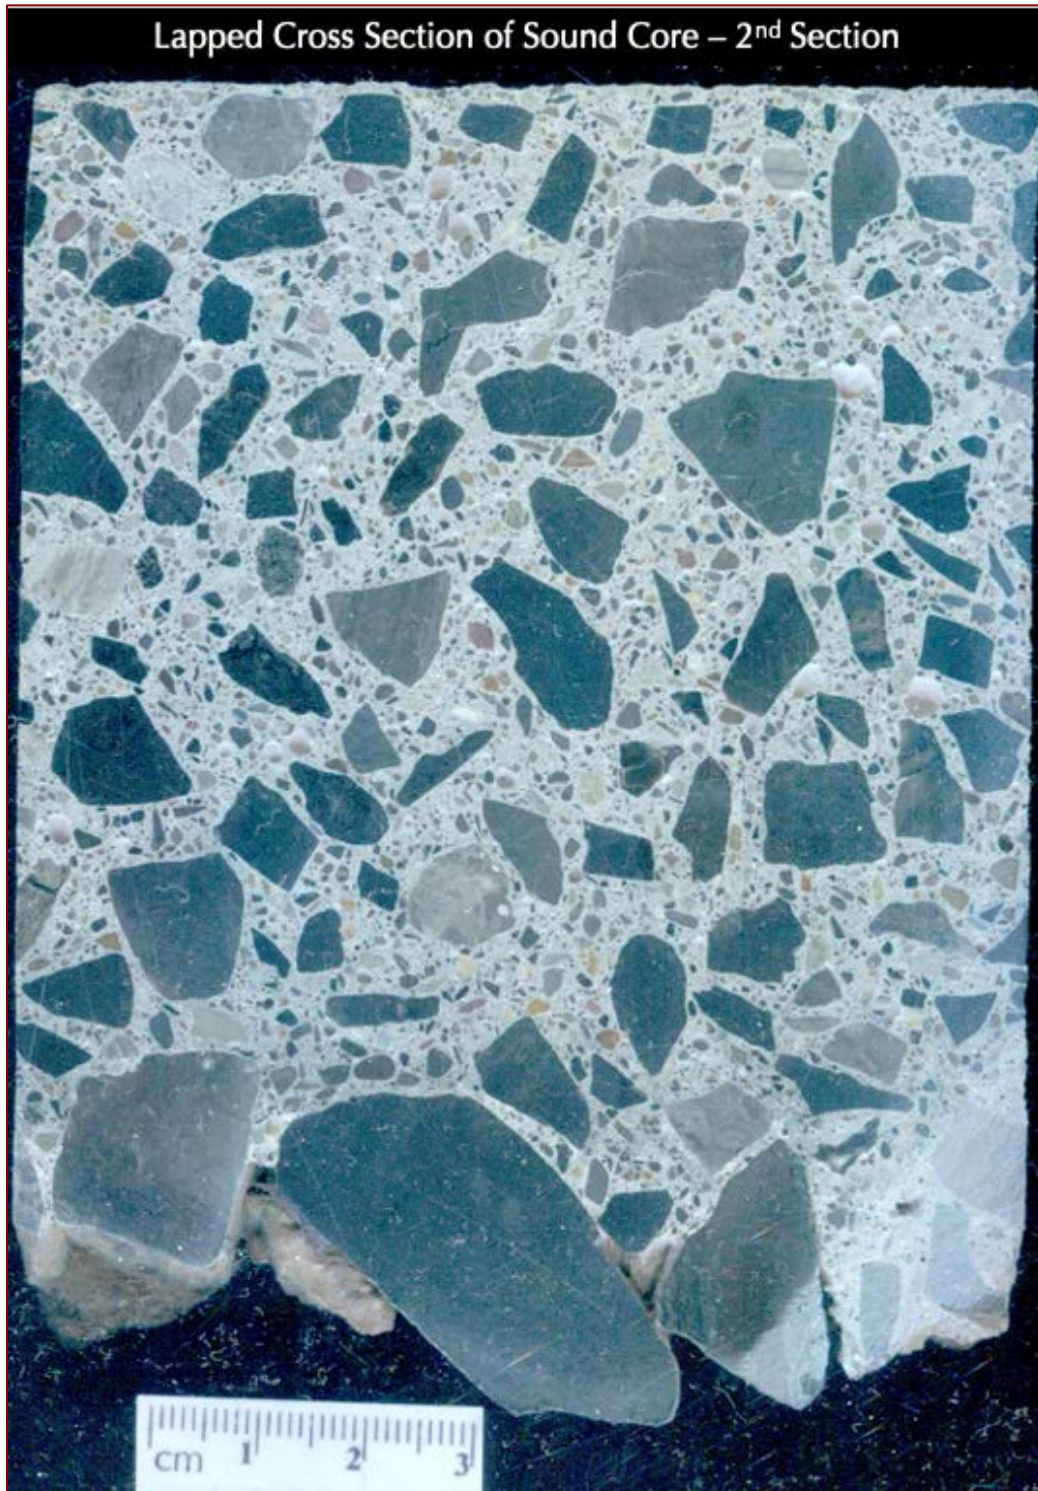
Figure 7: Lapped cross section of the core from sound area of driveway showing:

- (a) Medium beige to medium gray to dark gray, angular, dense, hard crushed stone coarse aggregate particles that are well-graded and well-distributed throughout the depth of the core;
- (b) Natural sand fine aggregate particles that are also well-graded and well-distributed;
- (c) Overall dense and well-consolidated nature of concrete without any coarse voids or visible cracks;
- (d) Uniform color tone of paste through depth;
- (e) Crushed stone of subbase adhered to the bottom end; and,
- (f) Lack of any wire mesh or steel reinforcement in the core.

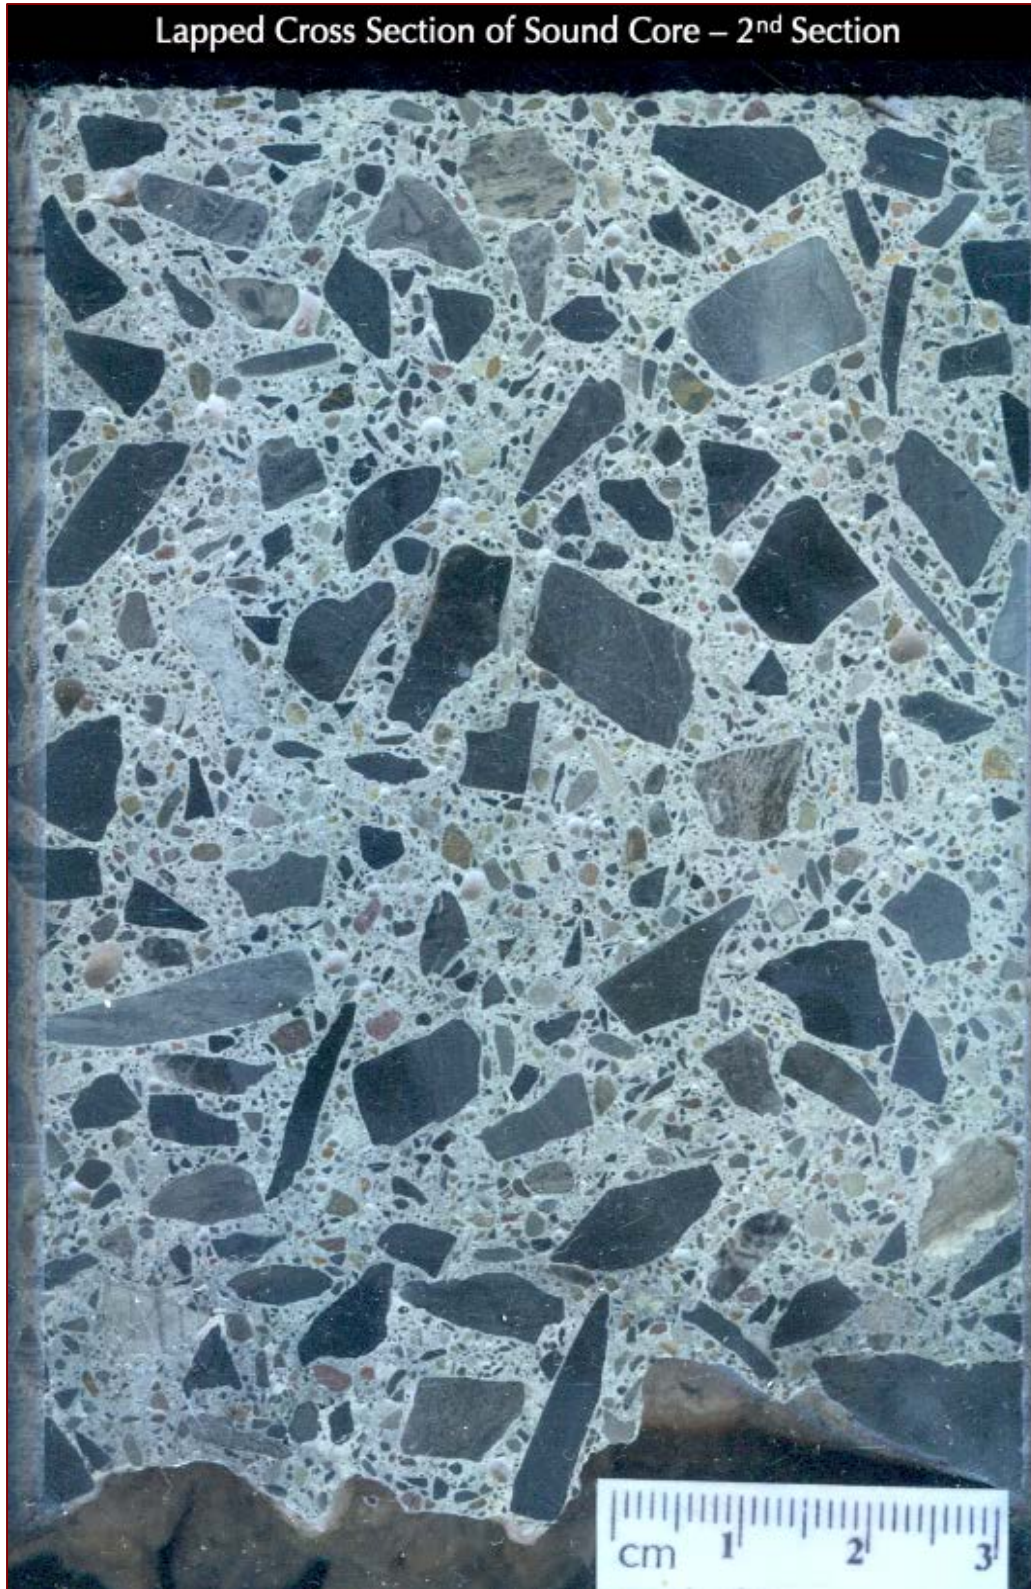
Figure 8: A second lapped cross section of the core from sound area of driveway showing:

- (a) Medium beige to medium gray to dark gray, angular, dense, hard crushed stone coarse aggregate particles that are well-graded and well-distributed throughout the depth of the core;
- (b) Natural sand fine aggregate particles that are also well-graded and well-distributed;
- (c) Overall dense and well-consolidated nature of concrete without any coarse voids or visible cracks;
- (d) Uniform color tone of paste through depth;
- (e) Crushed stone of subbase adhered to the bottom end; and,
- (f) Lack of any wire mesh or steel reinforcement in the core.

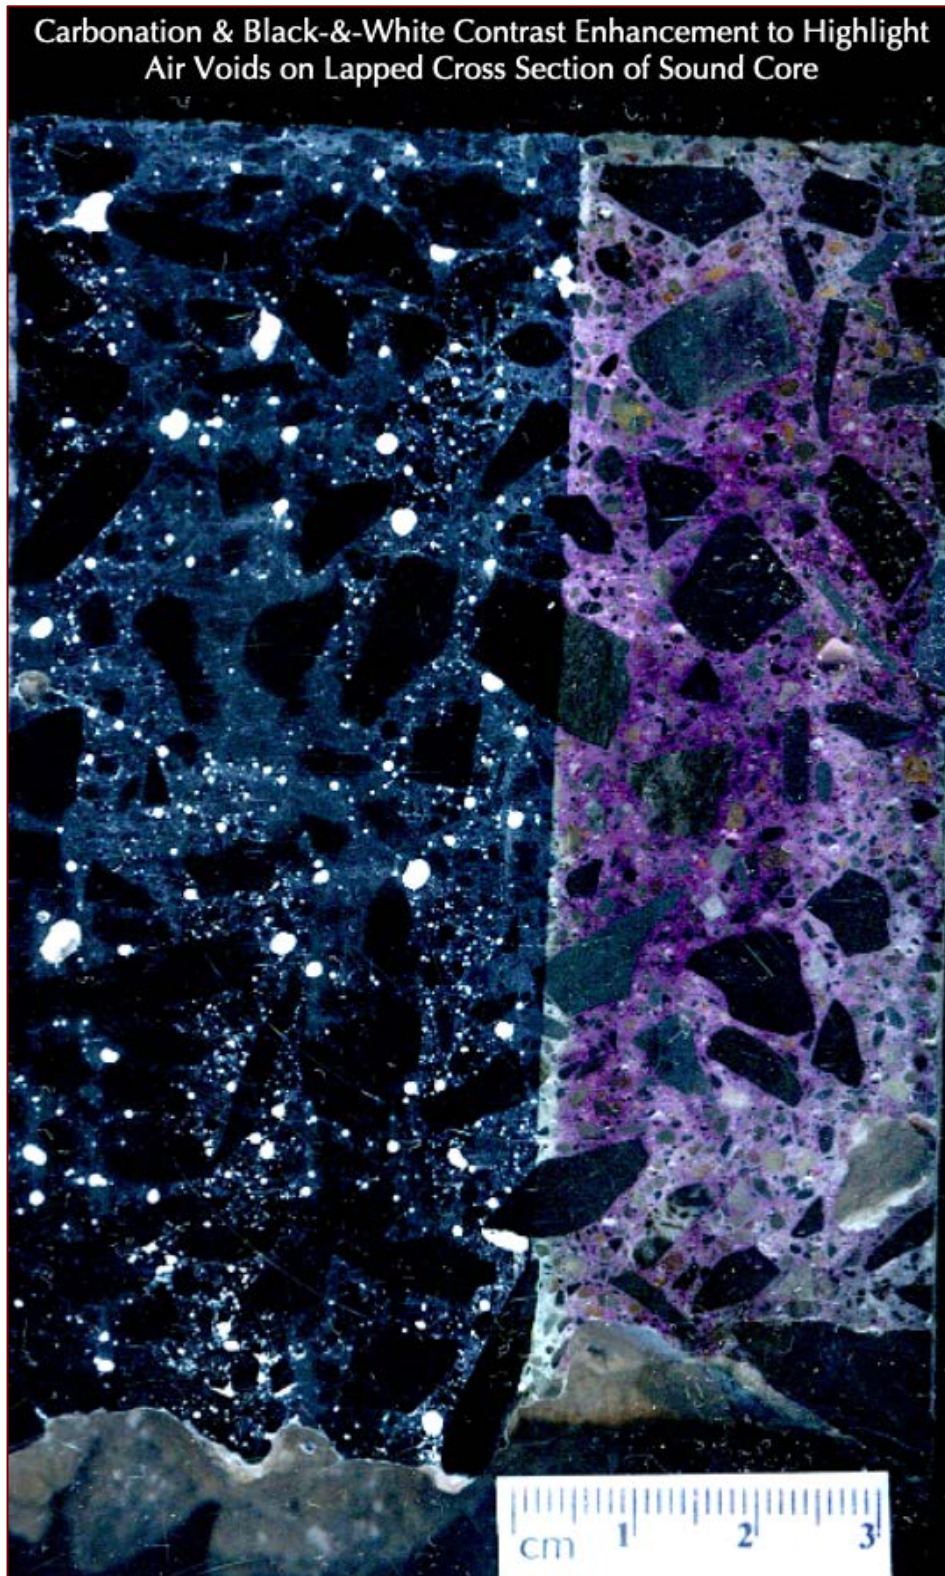
Figure 11: The lapped section of the sound core shown in Figure 8 but after:

(a) Highlighting air-entrainment in concrete by black and white contrast enhancement of one half of the section with a Sharpie marker pen followed by filling the air voids with a fine white zinc oxide power to highlight all voids in white against a black background of everything else, and,

(b) Highlighting shallow carbonation of concrete by treatment of the other half of lapped cross section with a phenolphthalein alcoholic solution to show the shallow depth of carbonation of concrete at the top few millimeters (< 5 mm) from the lack of pink discoloration in the shallow carbonated portion at the finished surface as opposed to pink discoloration of non-carbonated concrete in the interior.
