International Conference on Iron
Sulfide Reactions in Concrete

First International Conference on Iron
Sulfide Reactions in Concrete
May 2024

Cracking and crumbling of concrete blocks in County Donegal, Ireland: A holistic approach from case studies on deleterious effects of open microstructure of blocks, phyllite aggregate, pyrrhotite Oxidation, paste carbonation, lime leaching, and internal sulfate attacks

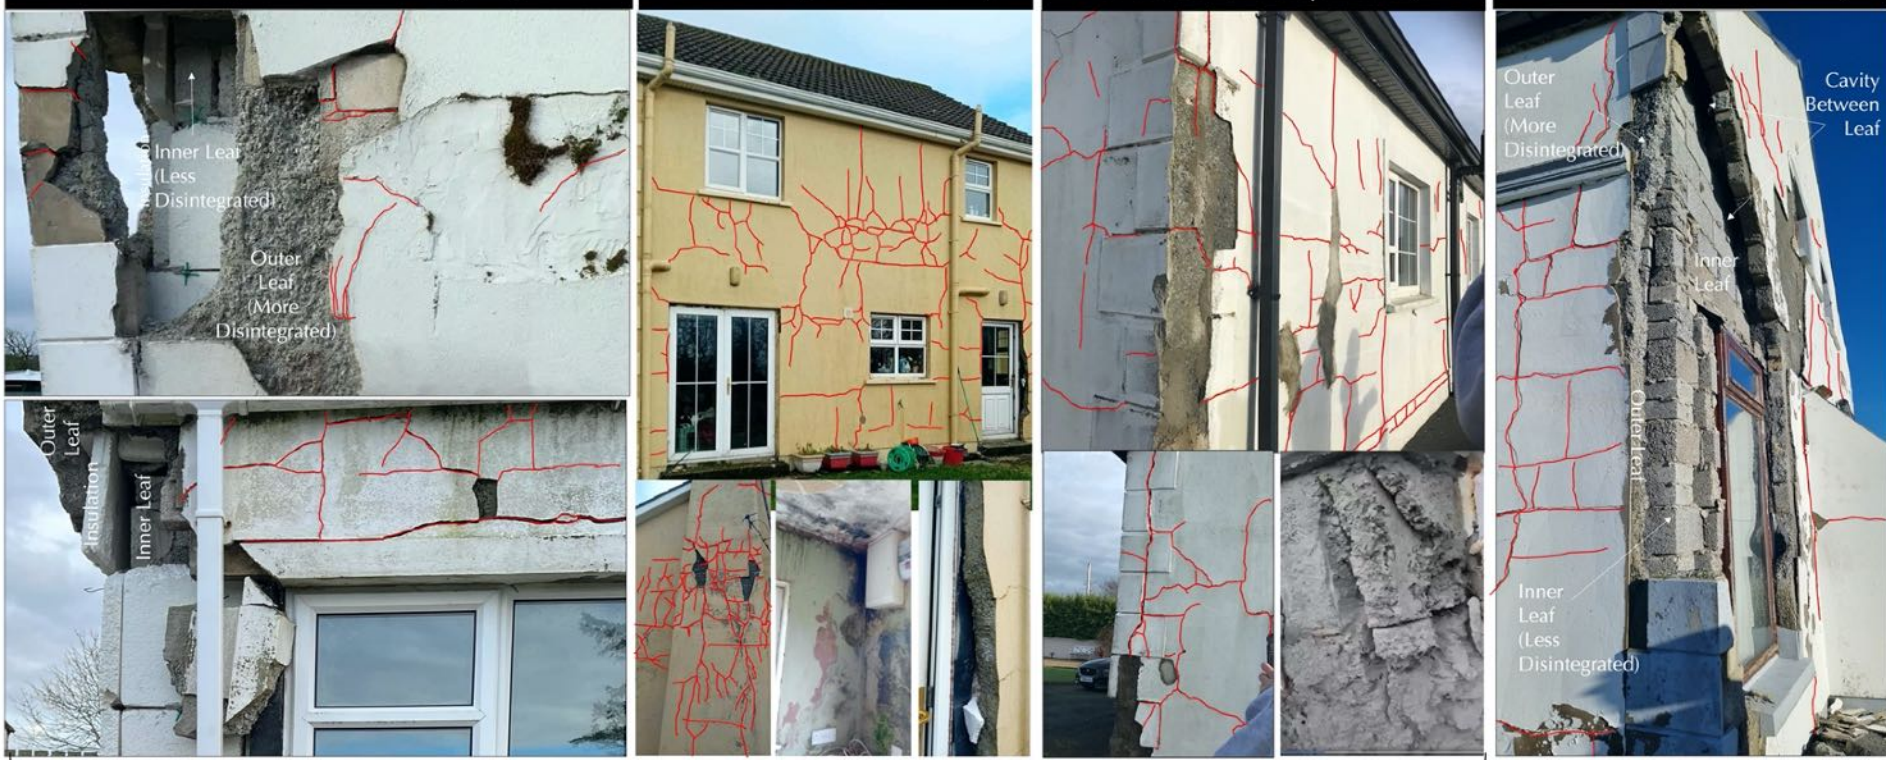
Crumbled block samples from Houses 1 to 3 and a sound foundation sample from House 3

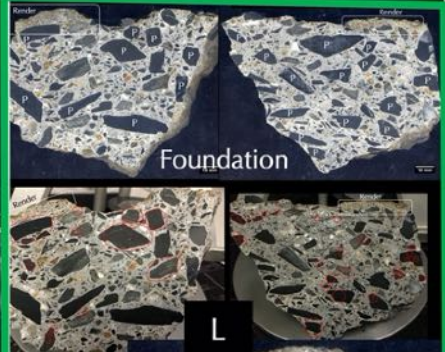
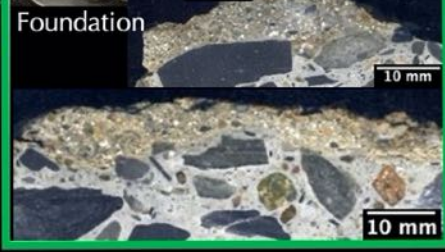
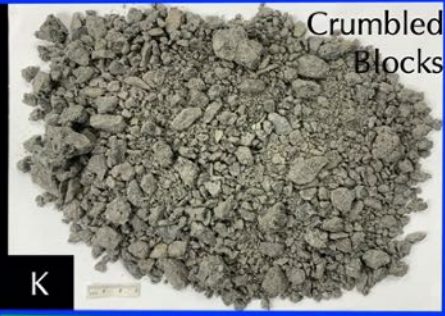
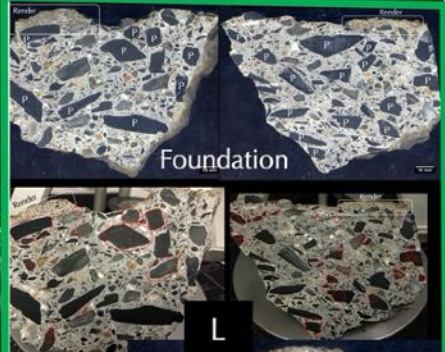
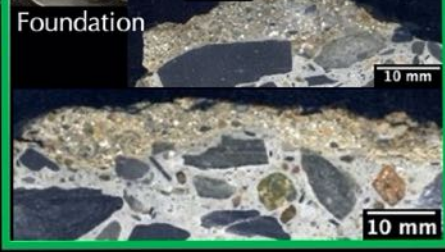
From Solid Fragments to Completely Disintegrated Samples of Blocks and A Sound Cast-in-Place Foundation Sample Received

House 1: Solid and Crumbled Block Fragments
House 2: Crumbled Block Fragments
House 3: Crumbled Block and Solid Foundation Samples

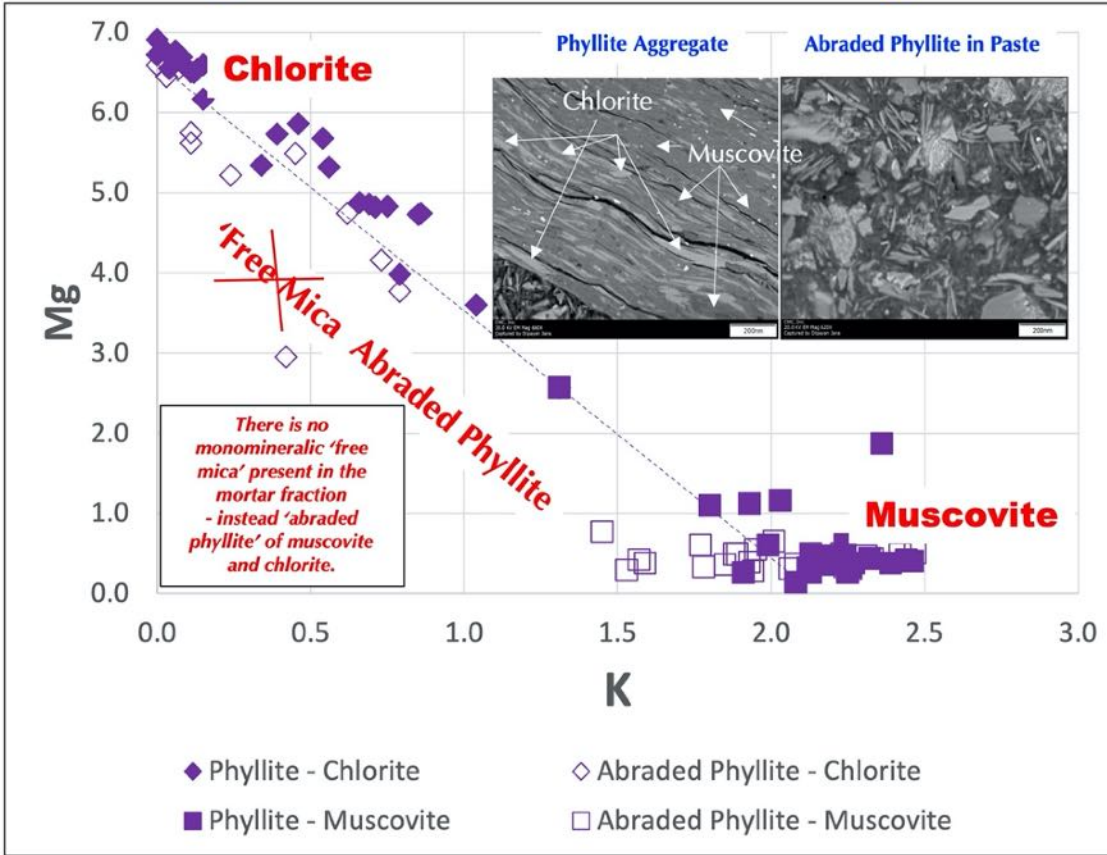
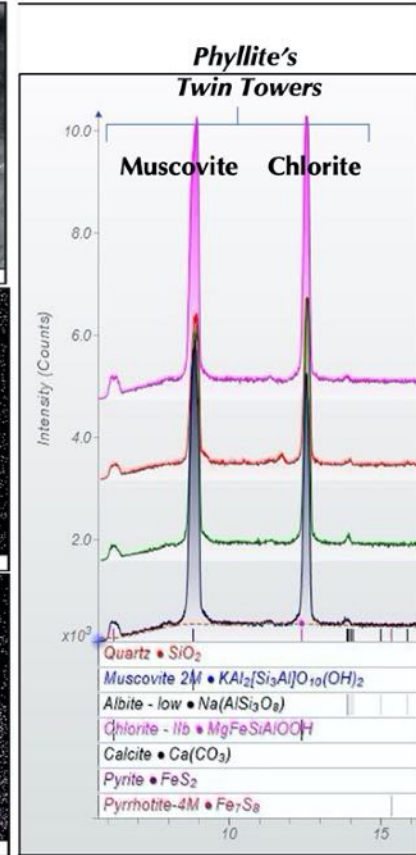
It is NOT Free Mica but Juxtaposed Layers of Intimately Mixed Mica and Chlorite

Mg-K Elemental Map

XRD

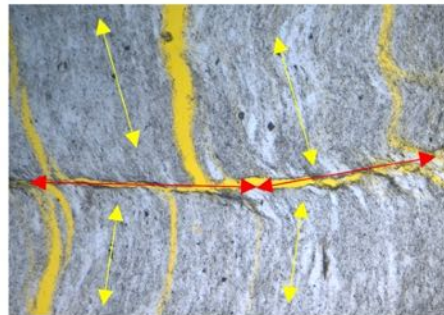
Textural Microcracks in Phyllite - Along Foliation Planes & Crenulation Cleavage Planes

**Excellent Pathways for
Penetration of
Moisture and O₂ to Pyrrhotite**

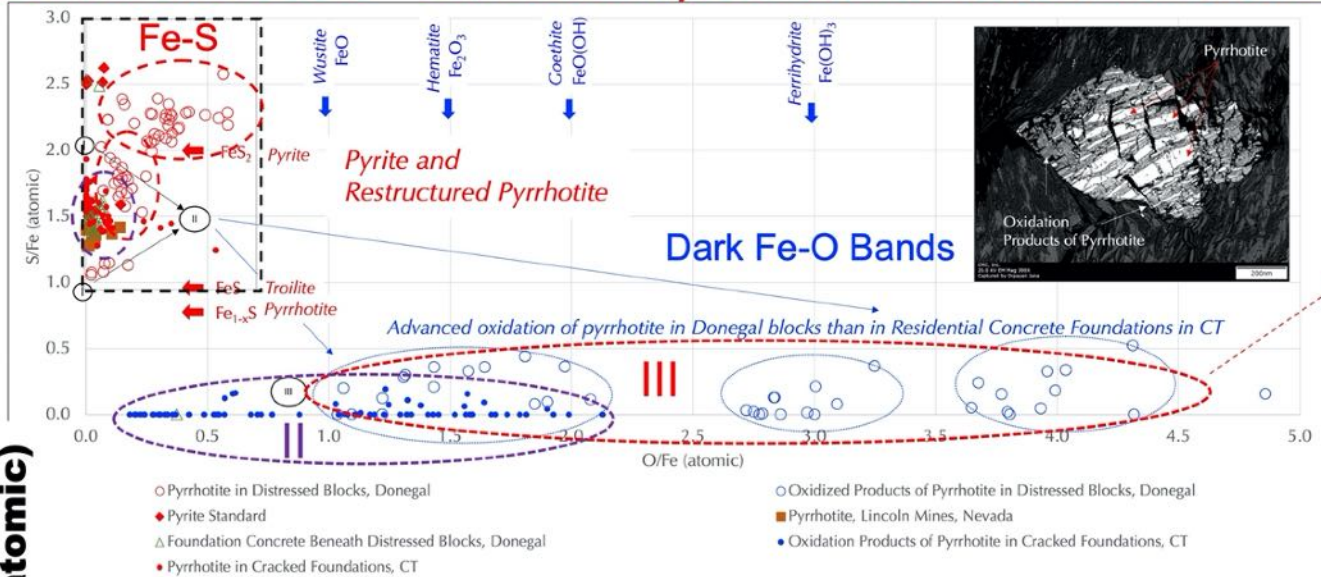
S/Fe vs. O/Fe Atomic Plots - Oxidized Pyrrhotite from Ireland and Connecticut

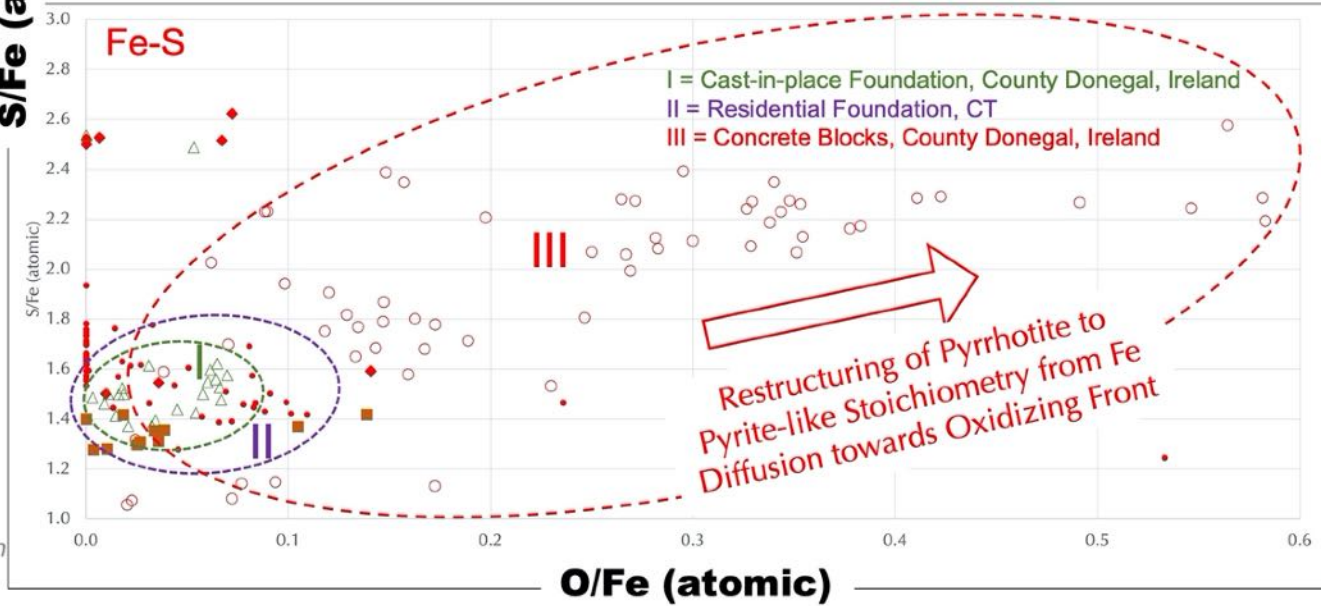
O/Fe atomic ratios in oxidation bands of oxidized pyrrhotite grains in Donegal blocks are noticeably higher than O/Fe ratios of oxidized pyrrhotite in Connecticut

Advanced Oxidation of Iron Sulfide in Ireland from:

1. Open microstructure of blocks
2. Phyllite host
3. Fine disseminated grain size of pyrrhotite

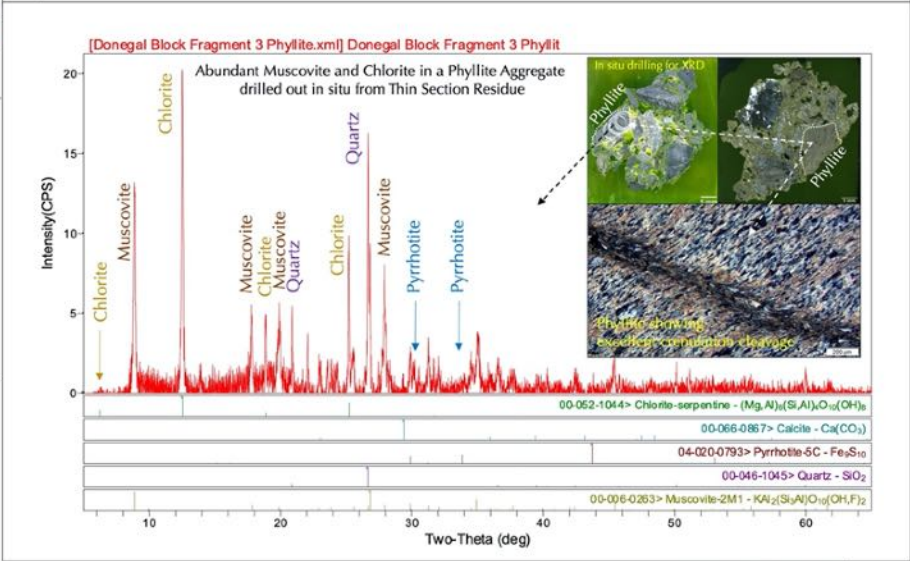
Bulk XRD of Blocks cannot find Pyrrhotite

In-Situ XRD of Phyllite can find Pyrrhotite

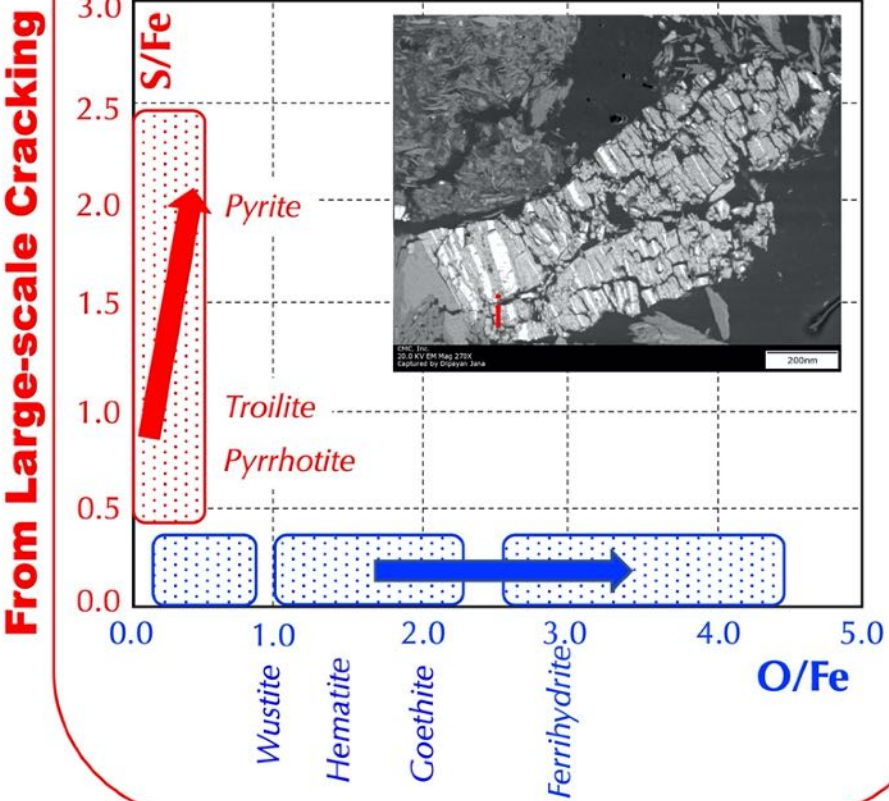
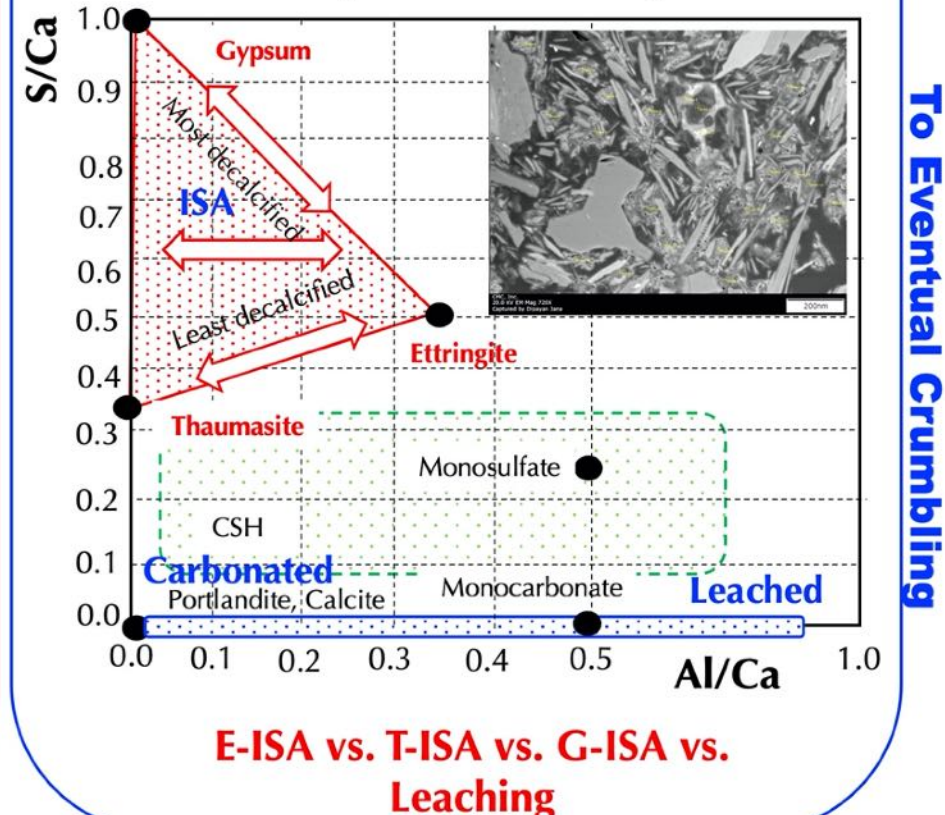
Pyrrhotite
Oxidation
(S/Fe vs. O/Fe)

Paste Deterioration from
ISA & Leaching/Decalcification
(S/Ca vs. Al/Ca)
