## Investigation of Extensive Cracking of a Swimming Pool from Petrographic Examinations of Four Composite Cores of Pool Plaster and Shotcrete

U-Center on Turner  
625 S 4th Street  
Columbia, MO 65203

September 12, 2023  
CMC 0823176

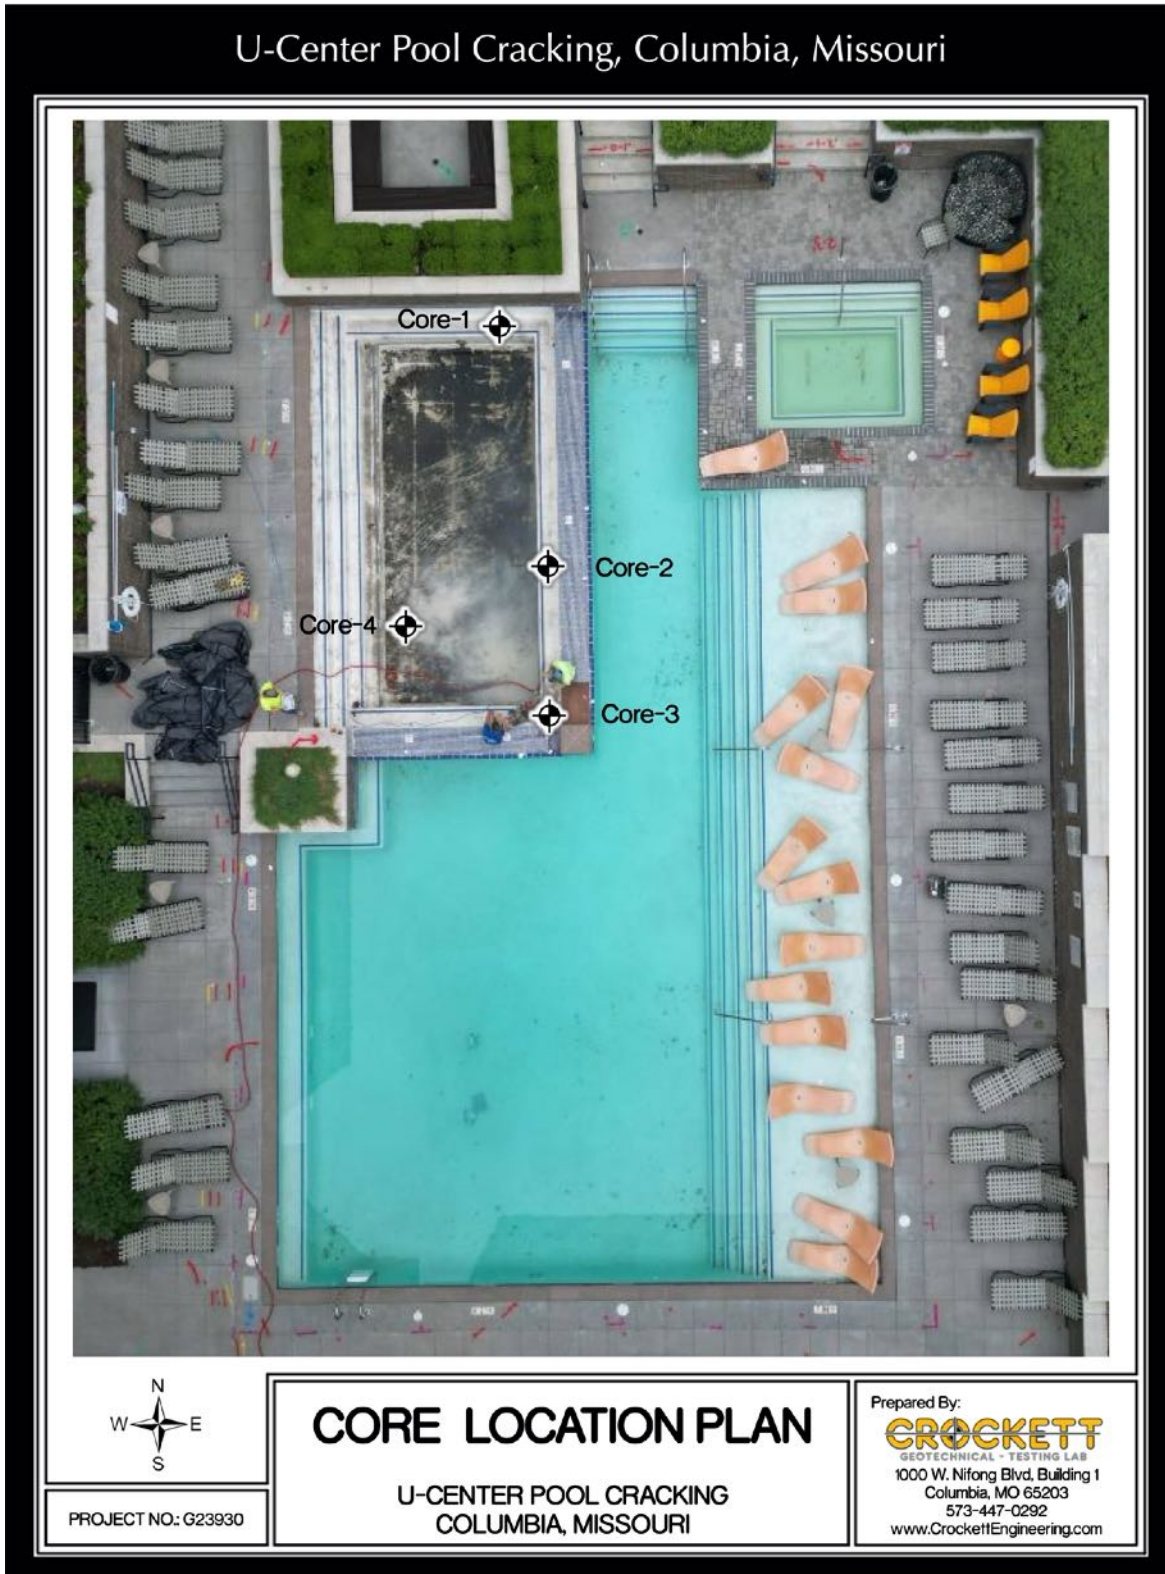
Figure 7: Locations of four cores Nos. 1 to 4 around various location of pool drilled through pool plaster to shotcrete and provided for detailed petrographic examinations.

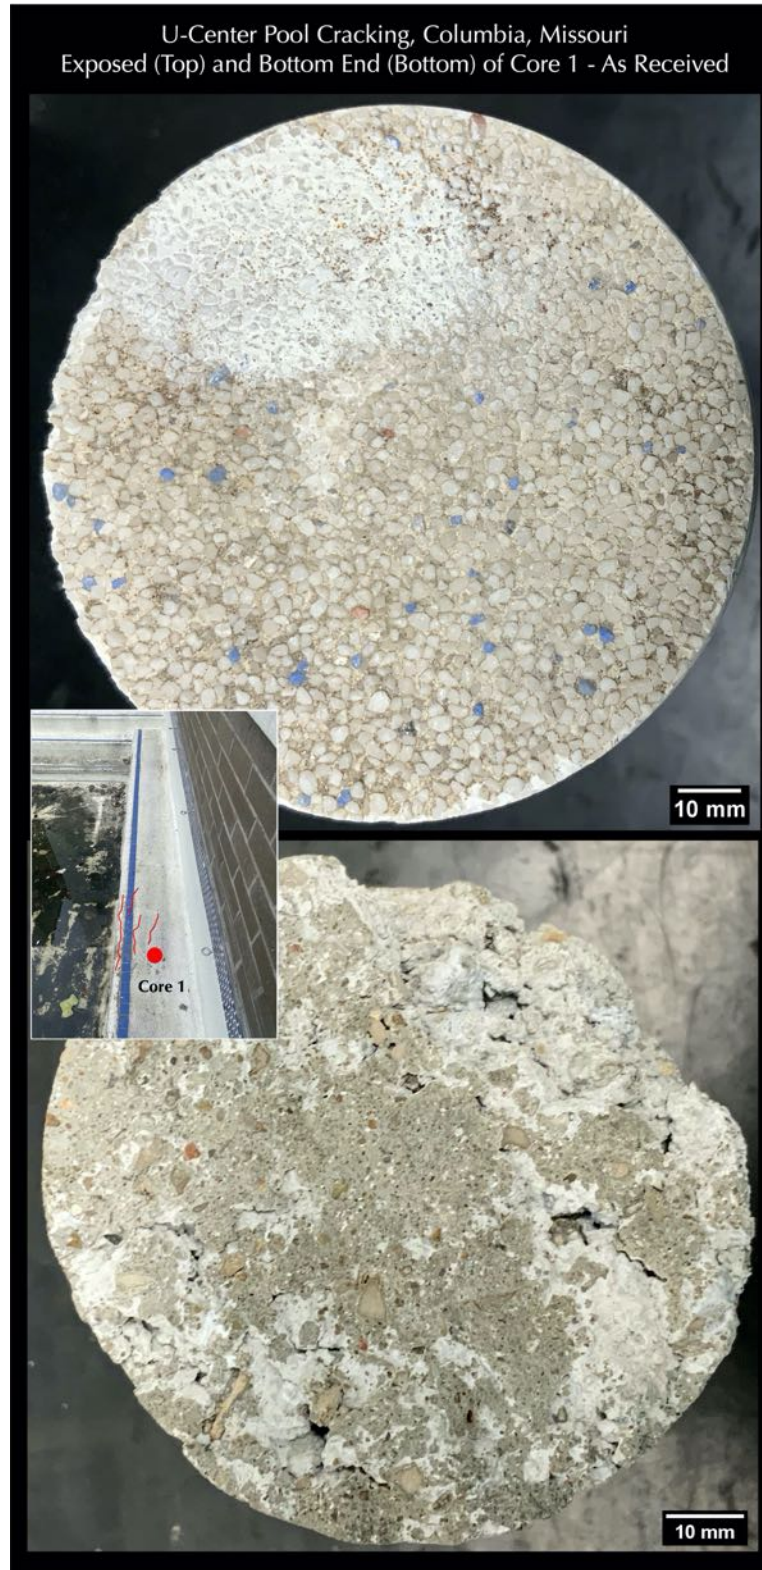
Figure 9: Shown are the top exposed surface of pool plaster without any visible cracks (top) and smooth flat formed base of shotcrete (bottom) in Core 1. Inset photo shows location of Core 1.

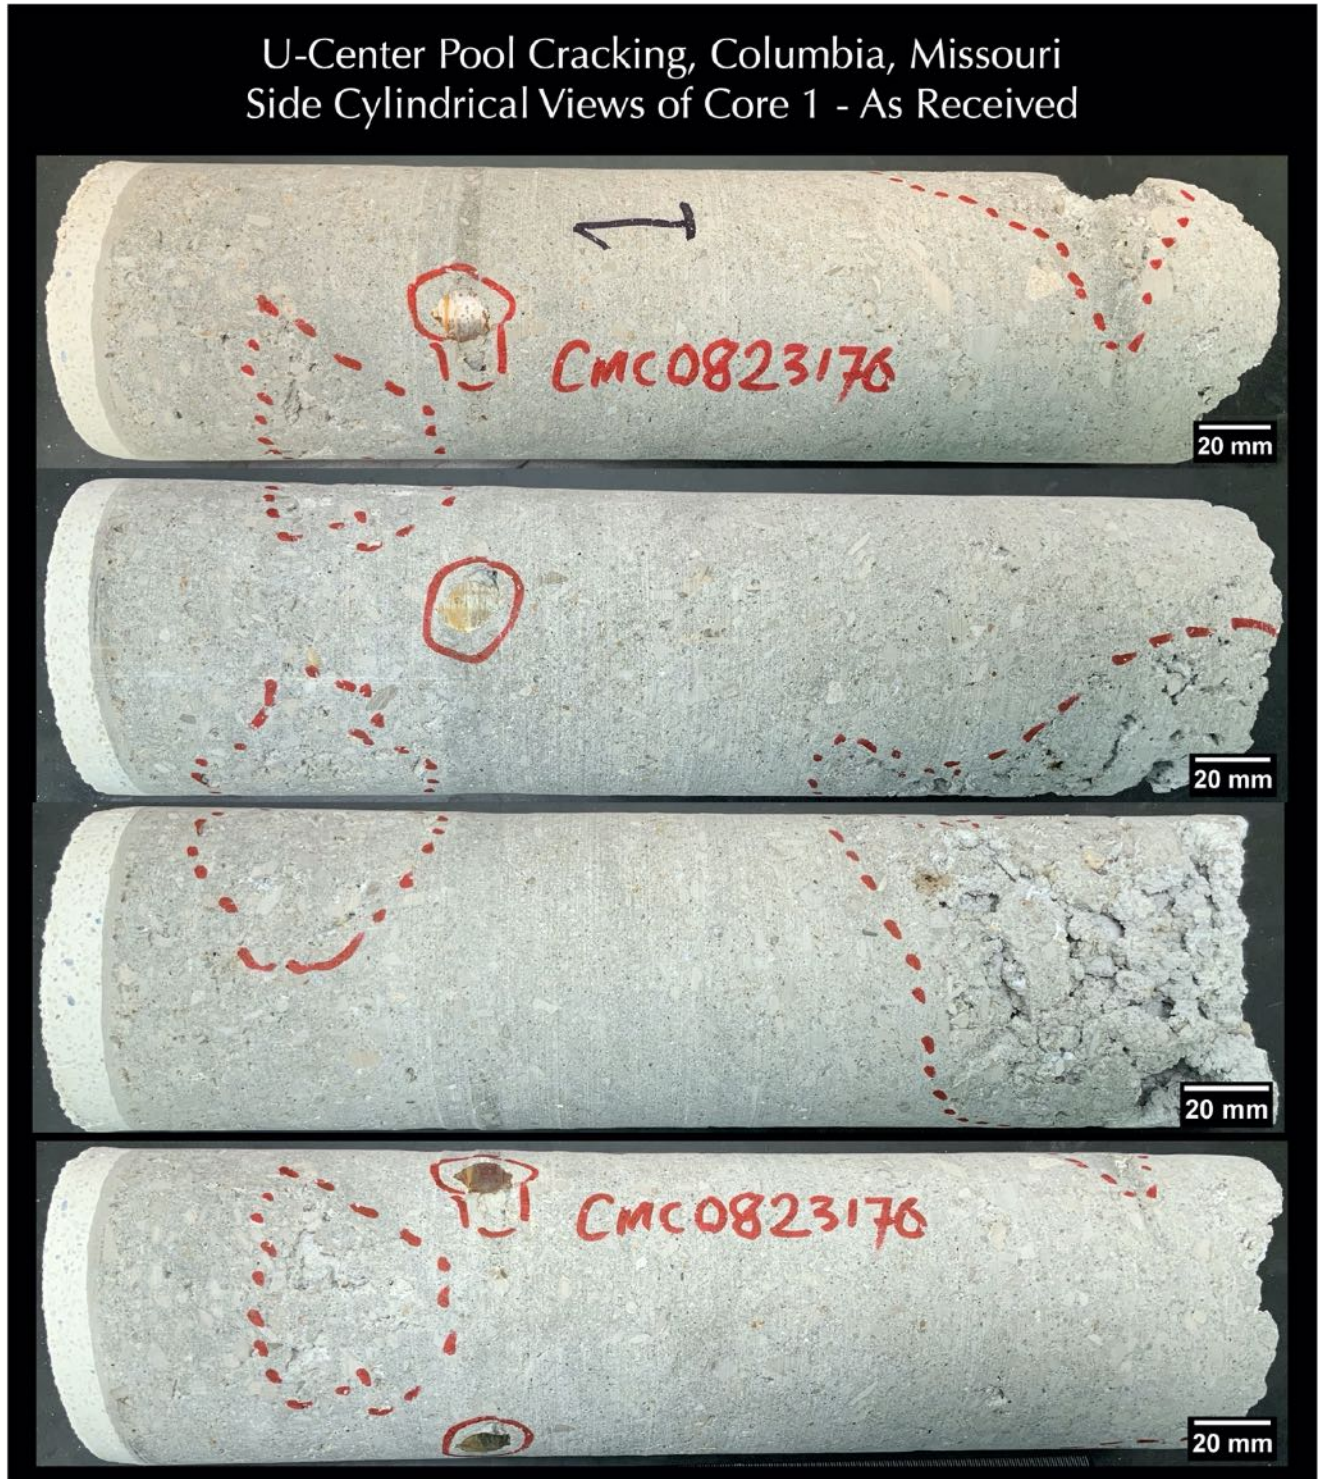
Figure 10: Shown are cylindrical surfaces of Core 1 where dotted lines enclose areas exhibiting coarse voids (honeycombing) and solid lines enclose steel reinforcement in shotcrete.

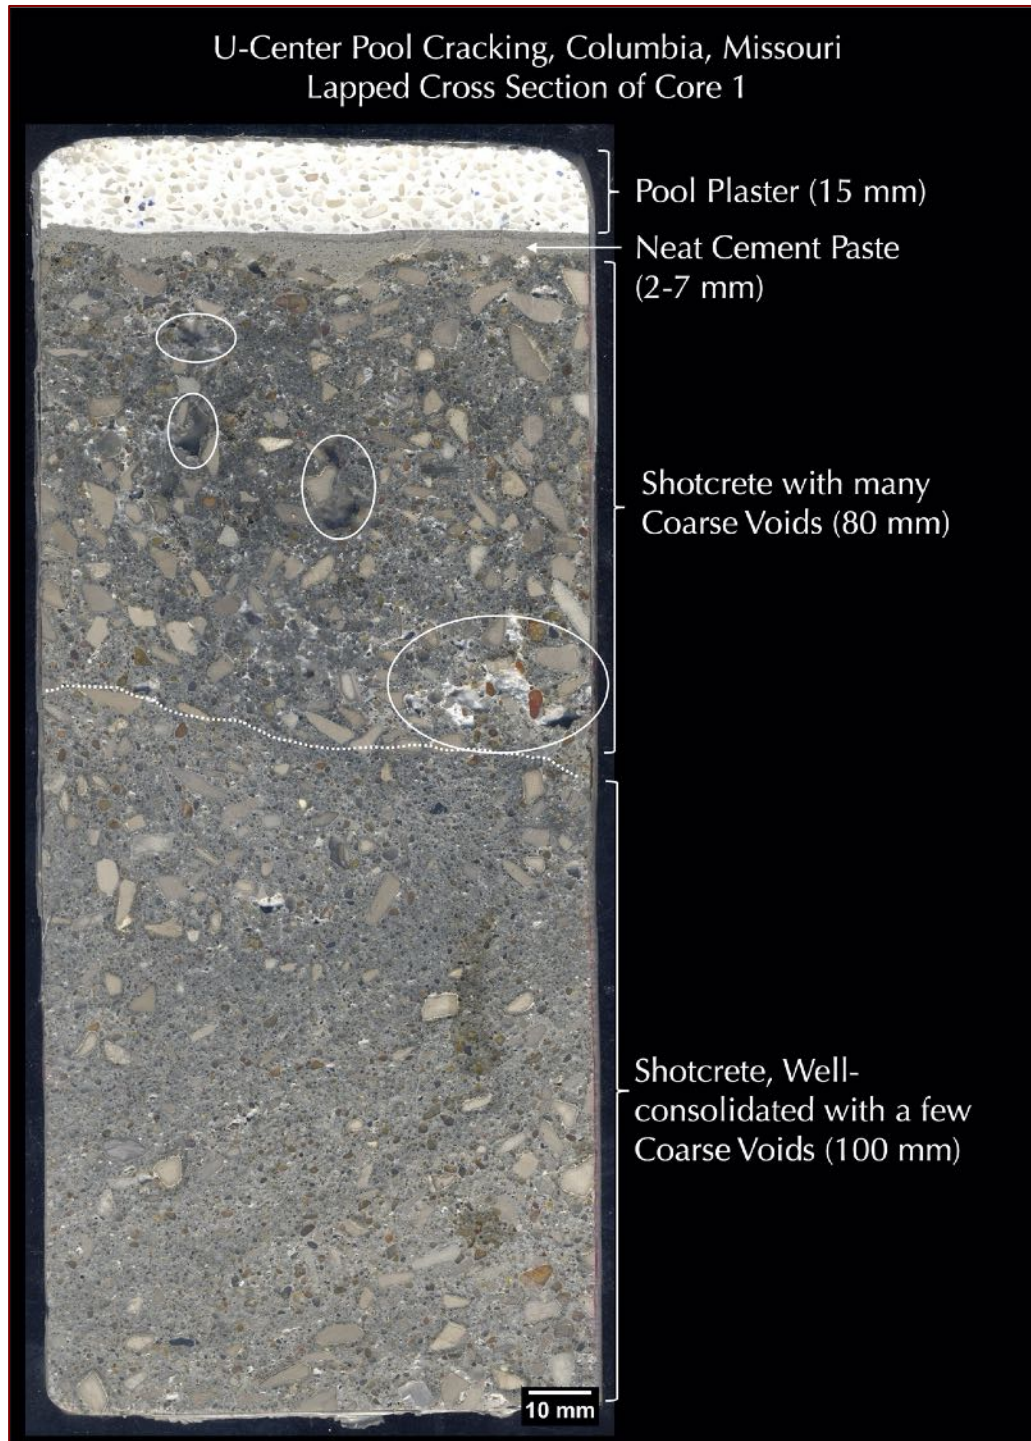
Figure 22: Lapped cross section of Core 1 showing: (a) 15 mm thick dense, white pool plaster, which is intimately bonded to (b) a medium to dark gray 2 to 7 mm thin paste-rich layer applied as a leveling coat on shotcrete prior to the installation of plaster, and (c) the main body of shotcrete consisting of areas rich in coarse voids as well as denser areas free of visible voids and have variable water-cementitious ratios due to the manner of pneumatic applications of shotcrete through a nozzle. Notice thin dark reaction rims around many crushed stone aggregate particles, which are described later.

Shotcrete is compositionally similar in terms of ingredients across all four cores consist of: (a) ¼ in. (6.25 mm) nominal maximum size crushed limestone and argillaceous dolomitic limestone aggregate (Figures 22, 24, 26, and 28), and (b) noticeably finer nominal 2-3 mm size crushed siliceous (quartz, quartzite) sand aggregates (Figures 39, 41, 43, and 45).

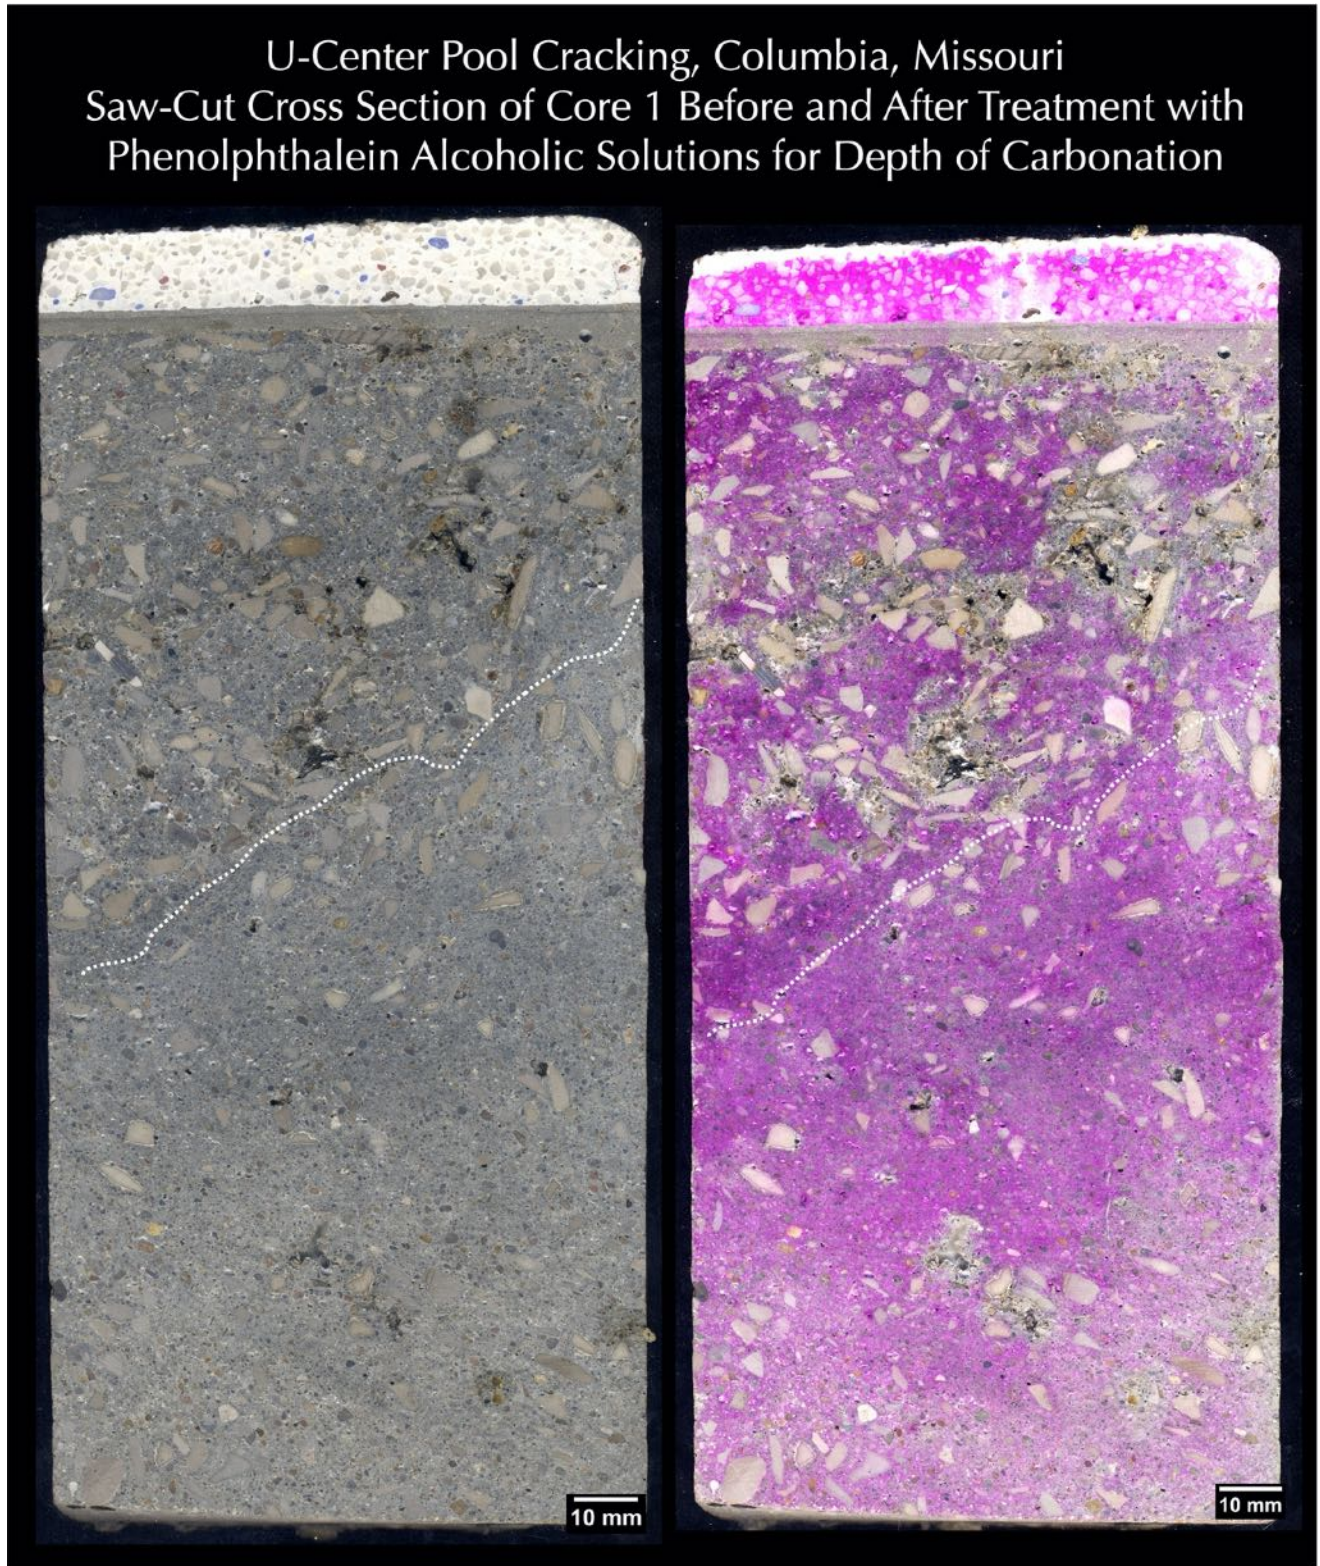
Figure 23: Sawcut cross section of Core 1 before (left) and after (right) treatment with phenolphthalein alcoholic solutions to show the depth and degree of carbonation of paste. Paste in both the pool plaster and most of the shotcrete (except in areas of coarse voids for ready penetration of atmospheric or dissolved CO<sub>2</sub>) show lack of carbonation hence turned pink after phenolphthalein treatment whereas paste in medium to dark gray thin leveling coat shows some carbonation to remain in its inherent gray color tone after treatment due to a short exposure to atmospheric CO<sub>2</sub> prior to the installation of plaster.

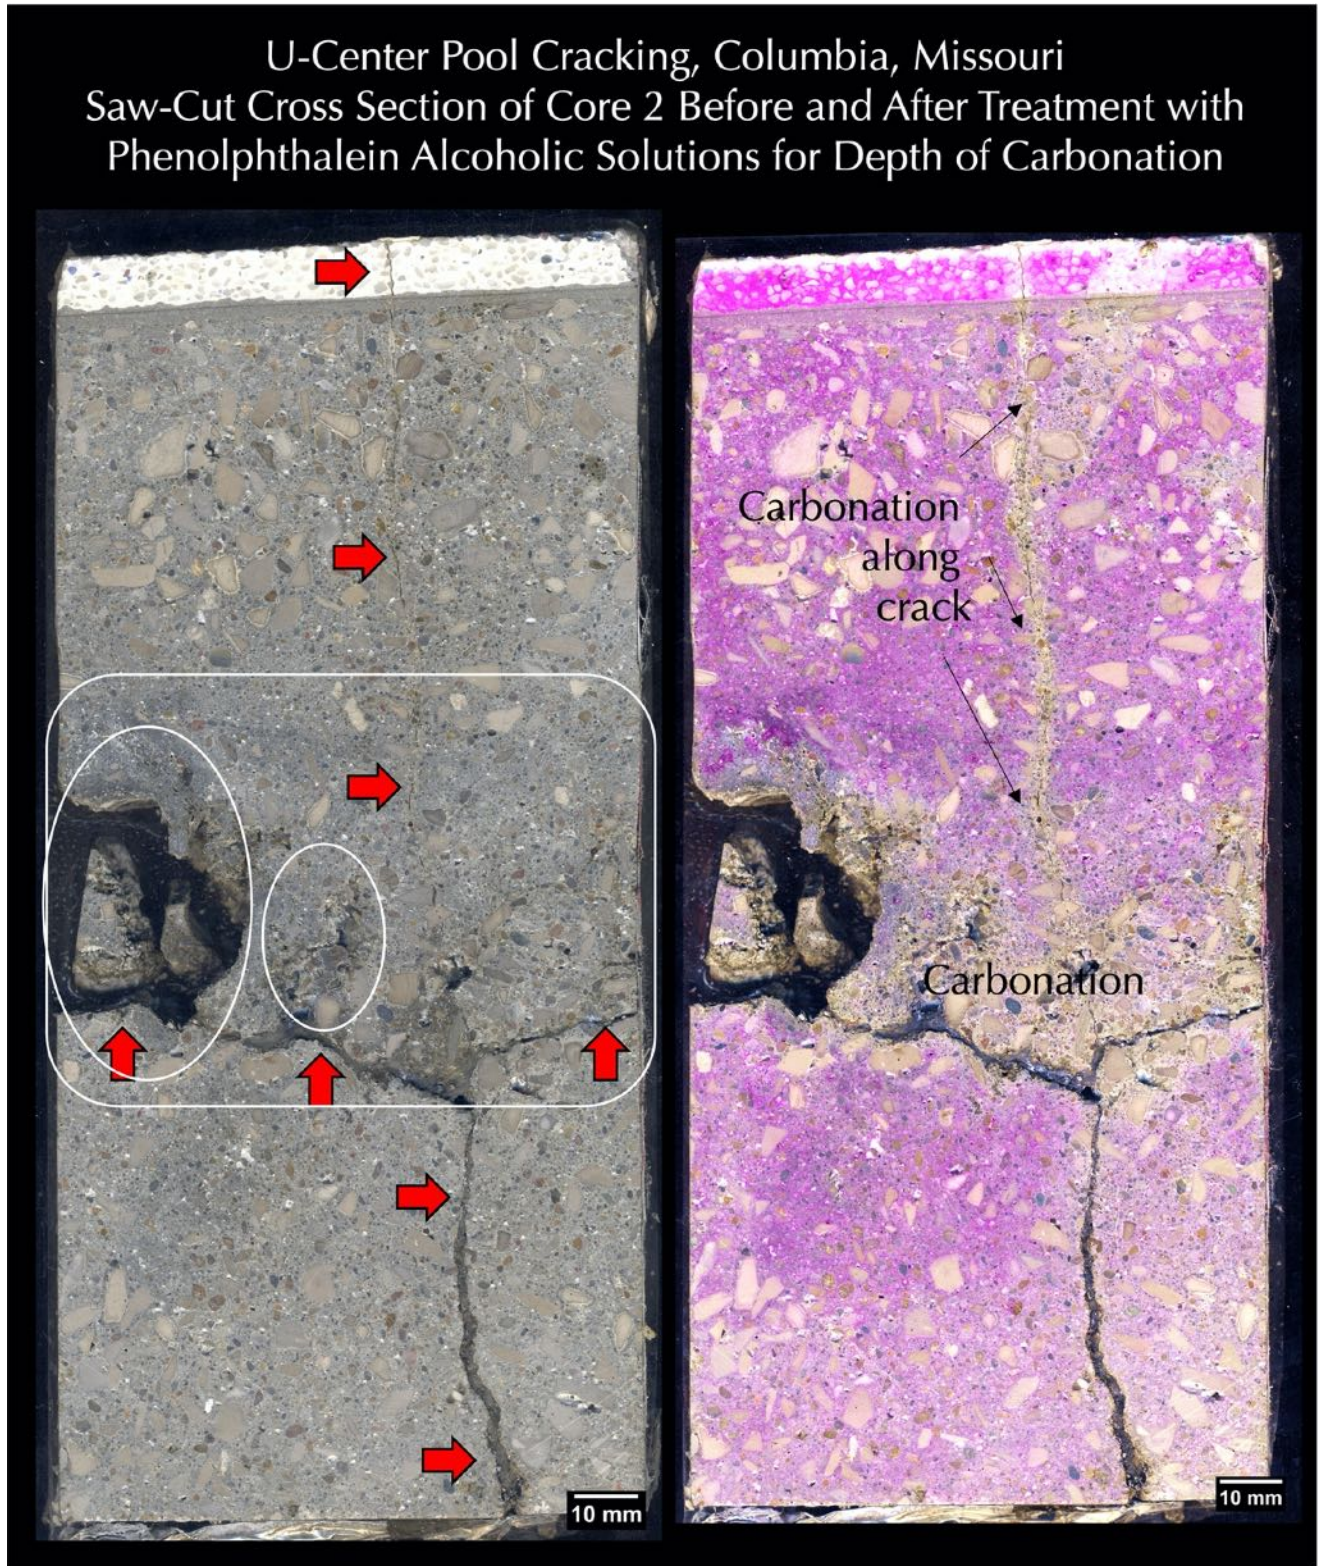
Figure 25: Sawcut cross section of Core 2 before (left) and after (right) treatment with phenolphthalein alcoholic solutions to show the depth and degree of carbonation of paste. Paste in both the pool plaster and most of the shotcrete (except along the major vertical crack and in areas of coarse voids for ready penetration of atmospheric or dissolved CO<sub>2</sub>) show lack of carbonation hence turned pink after phenolphthalein treatment whereas paste in medium to dark gray thin leveling coat shows some carbonation to remain in its inherent gray color tone after treatment due to a short exposure to atmospheric CO<sub>2</sub> prior to the installation of plaster.

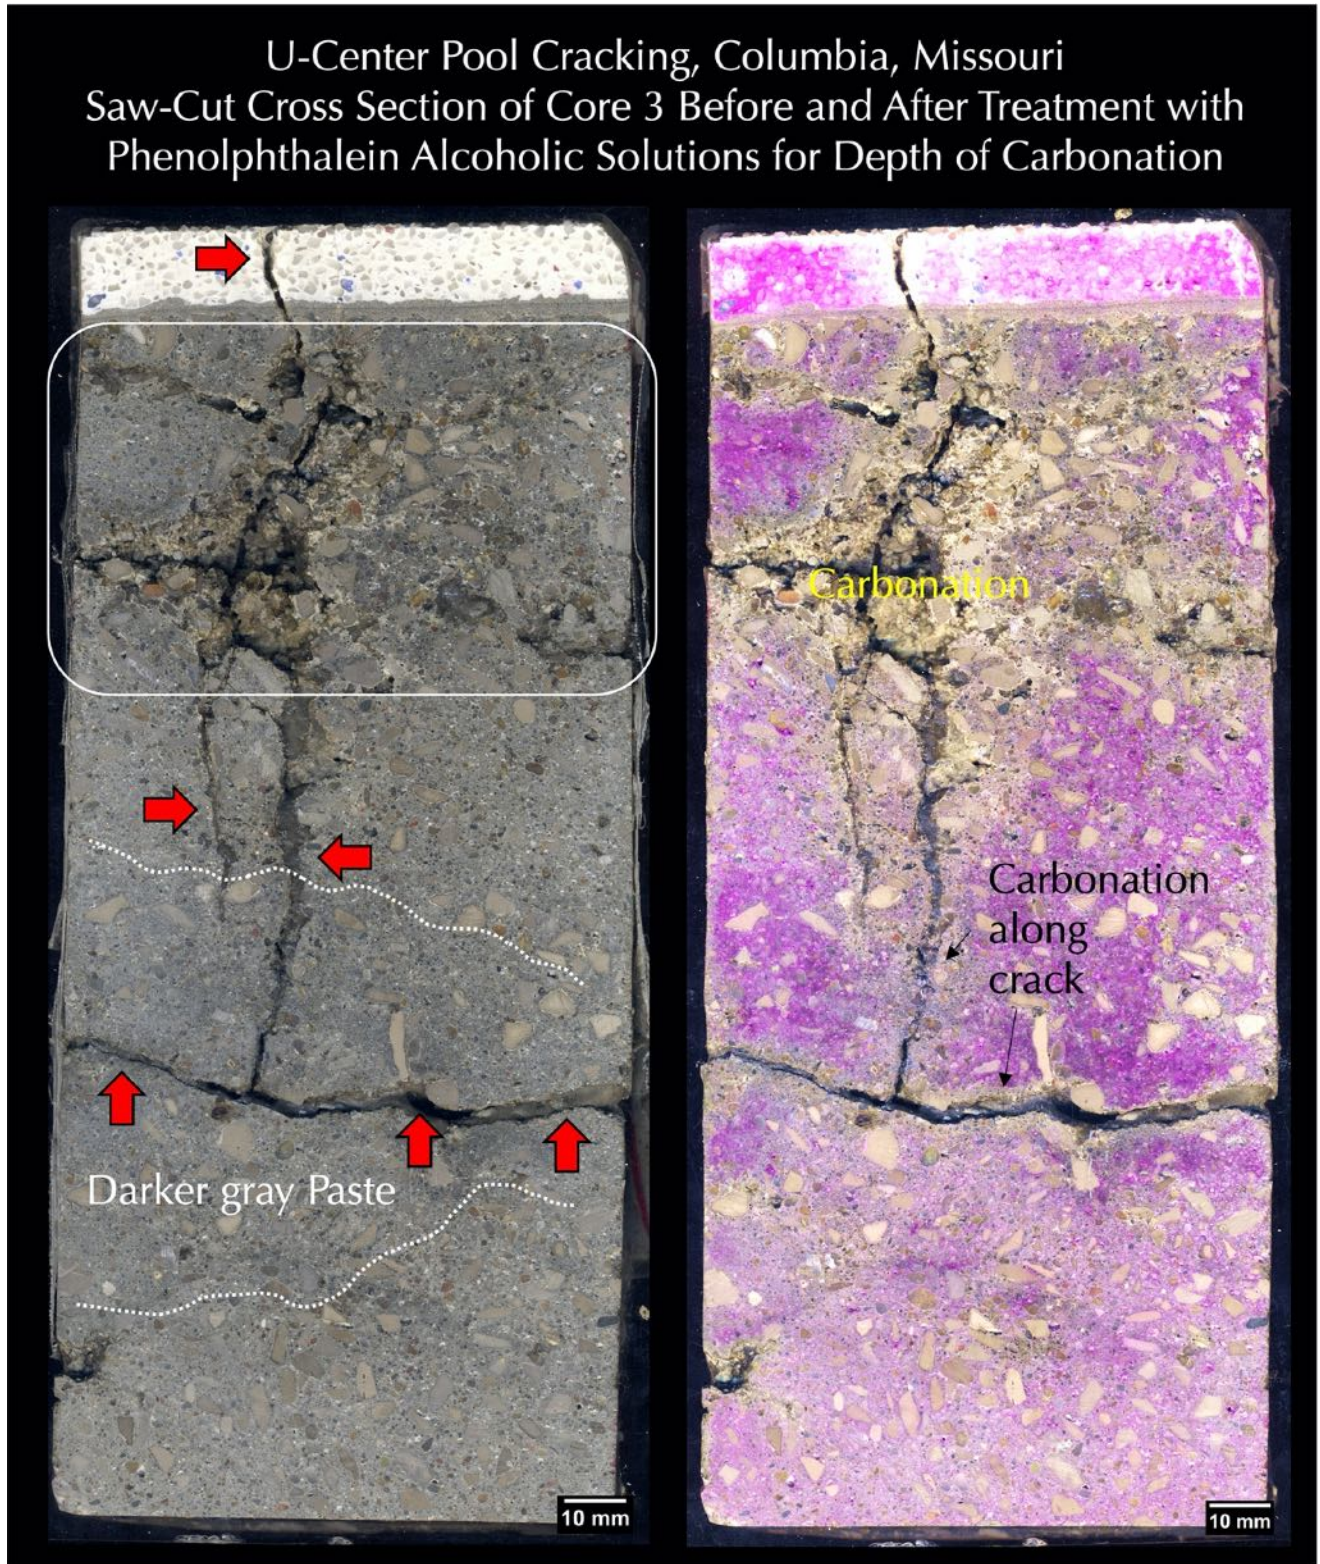
Figure 27: Sawcut cross section of Core 3 before (left) and after (right) treatment with phenolphthalein alcoholic solutions to show the depth and degree of carbonation of paste. Paste in both the pool plaster and most of the shotcrete (except along the major vertical crack and in areas of coarse voids for ready penetration of atmospheric or dissolved CO<sub>2</sub>) show lack of carbonation hence turned pink after phenolphthalein treatment whereas paste in medium to dark gray thin leveling coat shows some carbonation to remain in its inherent gray color tone after treatment due to a short exposure to atmospheric CO<sub>2</sub> prior to the installation of plaster.

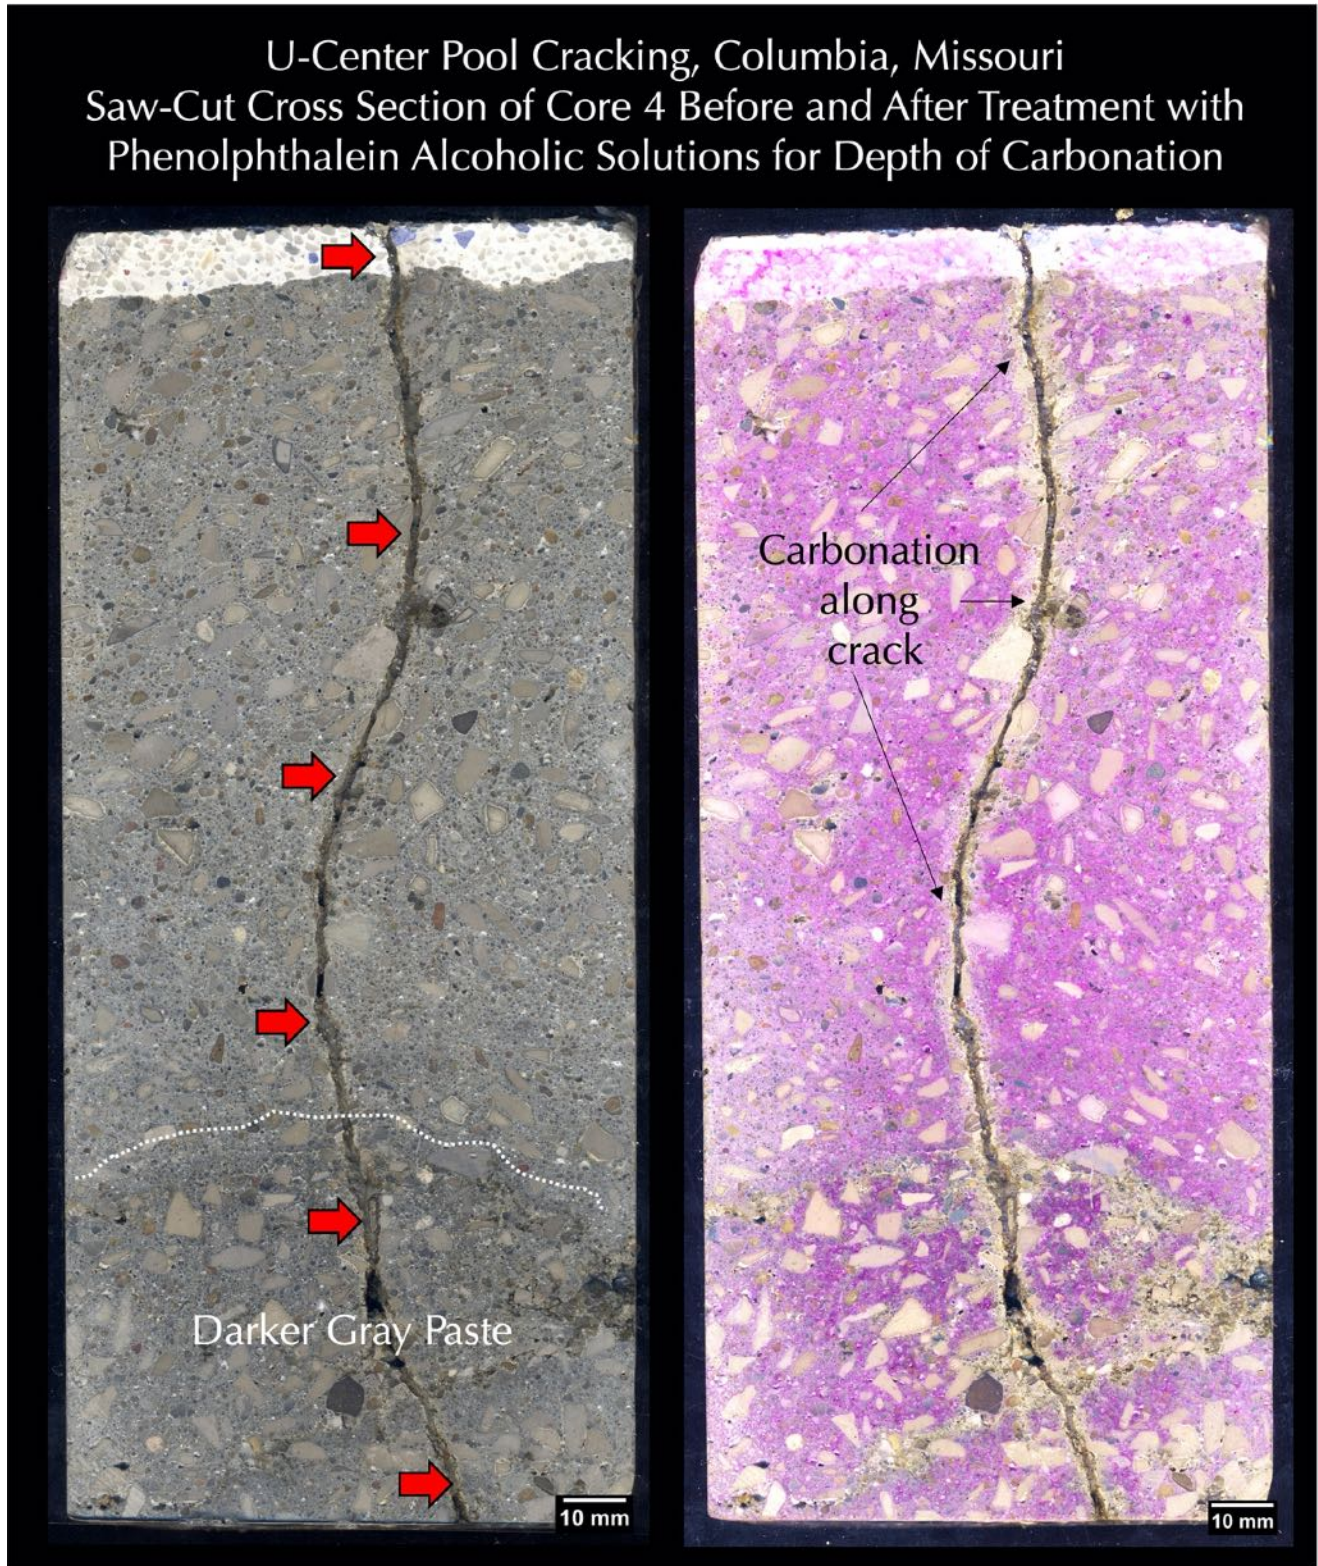
Figure 29: Sawcut cross section of Core 4 before (left) and after (right) treatment with phenolphthalein alcoholic solutions to show the depth and degree of carbonation of paste. Paste in both the pool plaster and most of the shotcrete (except along the major vertical crack and in areas of coarse voids for ready penetration of atmospheric or dissolved CO<sub>2</sub>) show lack of carbonation hence turned pink after phenolphthalein treatment whereas paste in medium to dark gray thin leveling coat shows some carbonation to remain in its inherent gray color tone after treatment due to a short exposure to atmospheric CO<sub>2</sub> prior to the installation of plaster.

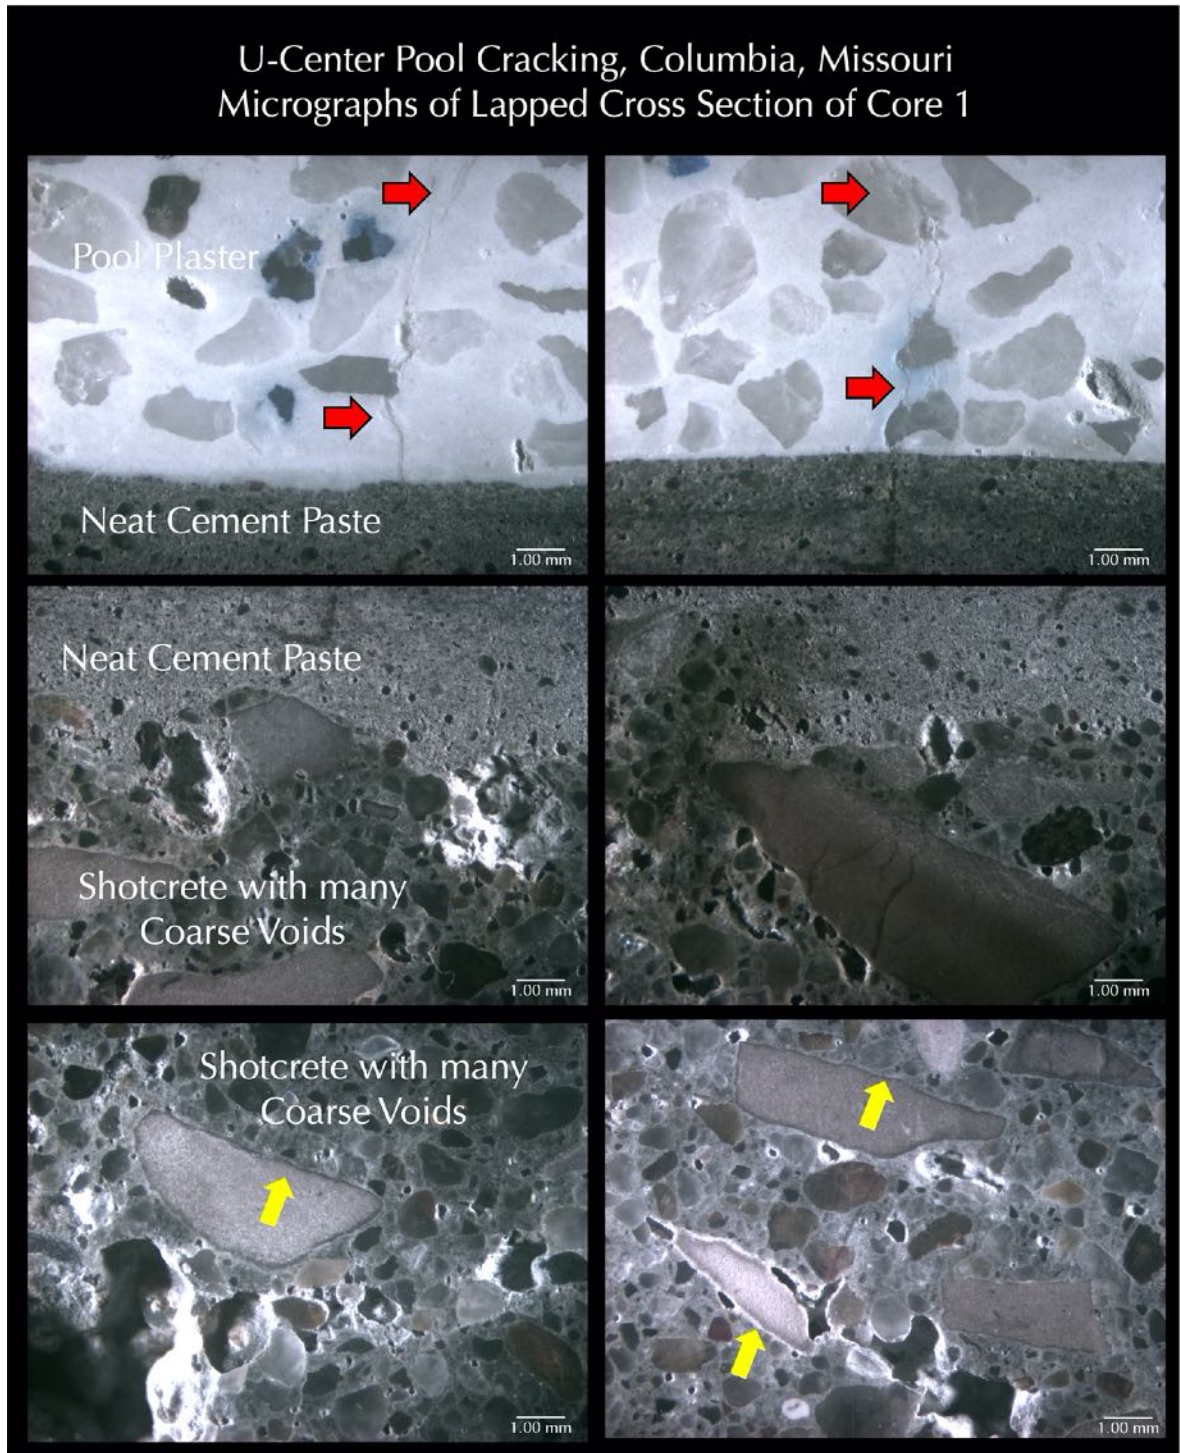
Figure 30: Micrographs of lapped cross section of Core 1 showing: (a) the dense, white, pool plaster with visible cracks extended into underlying leveling coat (top row, red arrows), (b) medium to dark gray thin neat cement paste leveling coat (middle row), (c) the shotcrete having crushed dolomitic limestone aggregate particles many with dark reaction rims followed by light cream-colored carbonated paste rims (yellow arrows), (d) overall non-air-entrained nature of shotcrete having many coarse voids, and (e) overall intimate bond between pool plaster, leveling coat, and shotcrete.

Pool plaster is compositionally similar cementitious plaster coat across all four cores and consist of: (a) white Portland cement, minor limestone fines, and 2 to 3 mm nominal size well-sorted, well-distributed lightly crushed siliceous (quartz, quartzite) filler (Figures 30, 32, 34, 36, 38 to 45). In all four cores, plaster showed extensive shrinkage cracking in the paste fractions (Figures 46, 54, 55, 63, 65, 761, 74, 75, and 77) due to high paste volume relative to silica fillers where cracks are confined within the plaster and did not extend into the underlying leveling coat or shotcrete. These extensive fine, hairline shrinkage cracks in plaster paste are invisible on the exposed surface of plaster relative to the major visible cracks that have transected through plaster into the shotcrete body and formed entirely due to shrinkage of a high paste-volume cementitious plaster.

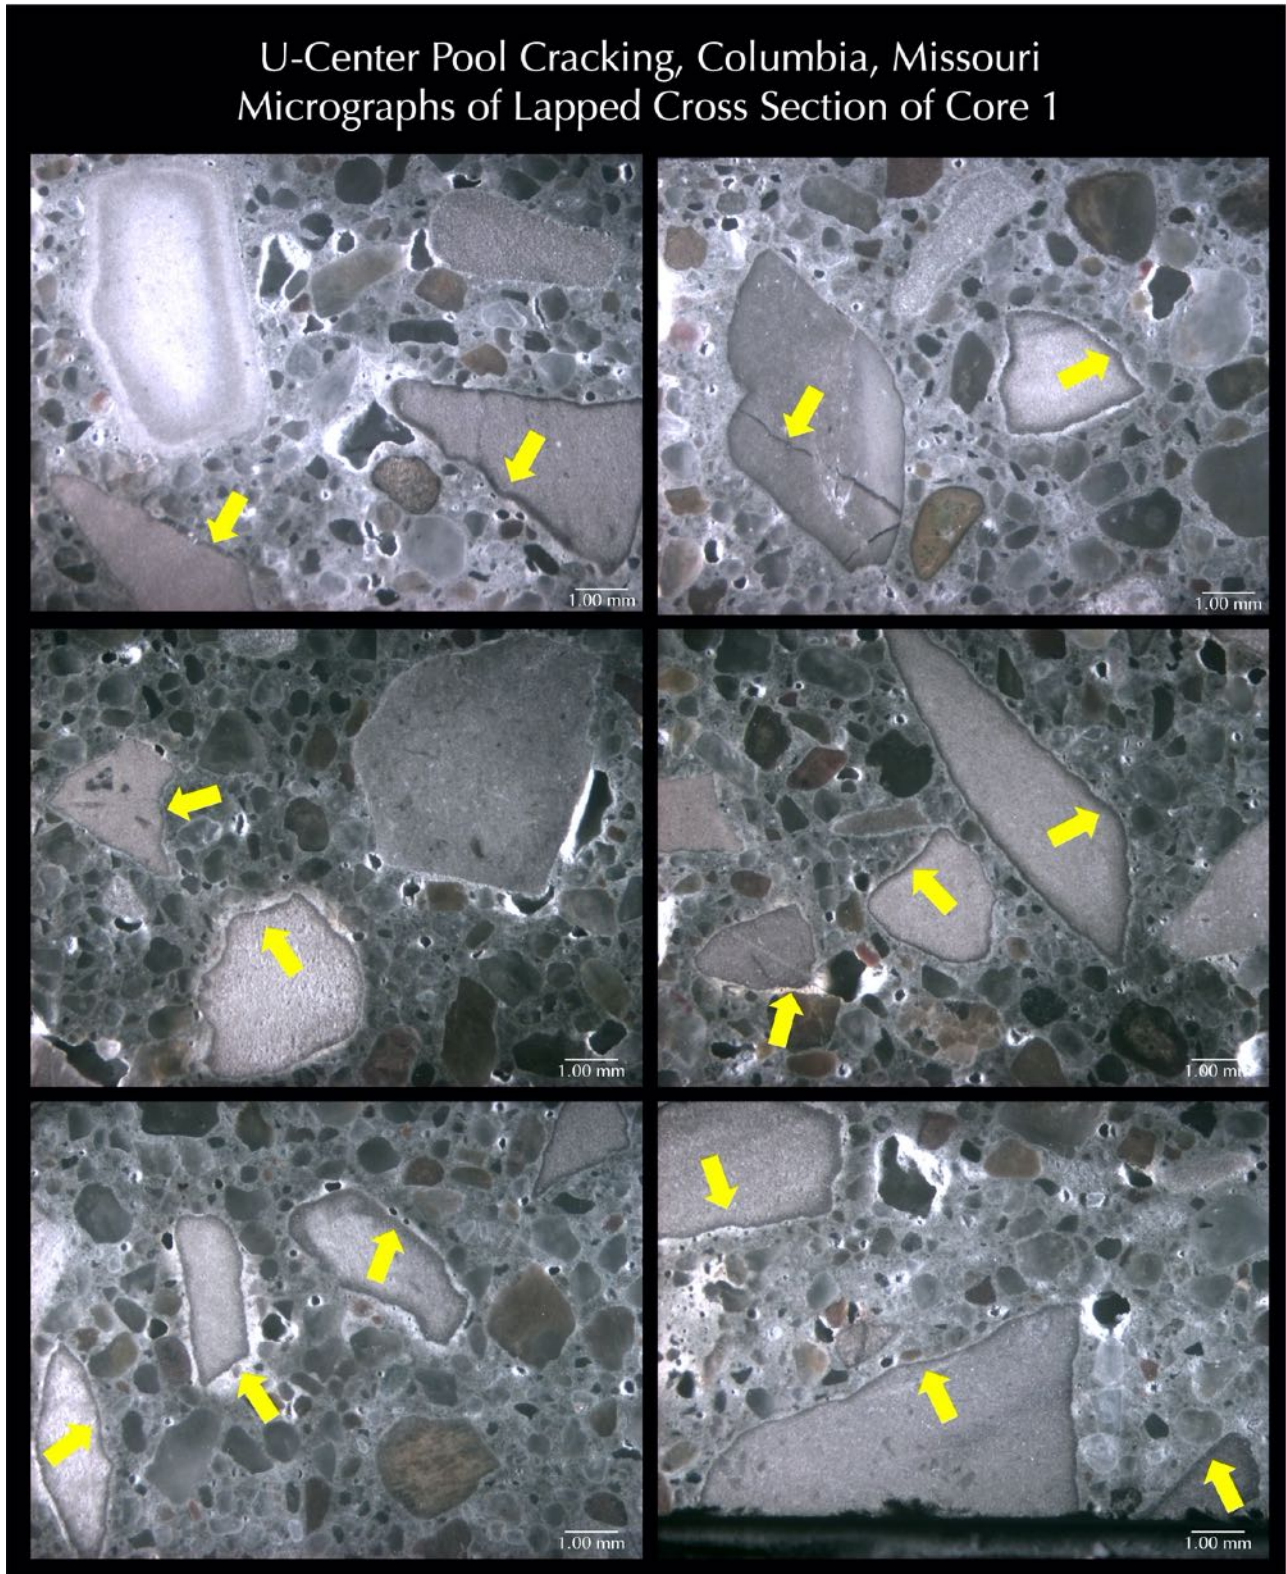
Figure 31: Micrographs of lapped cross section of Core 1 showing: (a) the shotcrete having crushed dolomitic limestone aggregate particles many with dark reaction rims followed by light cream-colored carbonated paste rims (yellow arrows), and (b) overall non-air-entrained nature of shotcrete having many coarse entrapped air voids.

Many argillaceous dolomitic limestone particles in aggregate showed dark reaction rims along the periphery of the aggregates (Figures 31, 33, 35, 37, 47-51, 59-62, 66, 67, 70, and 72) and many of those particles additionally showed lighter cream-colored carbonation rims in paste immediately adjacent to those particles. These particles show characteristic texture of many known alkali-carbonate reactive (ACR) rocks of Missouri in having rhombic crystals of dolomite floating in finer-grained matrix of calcite, quartz, and clay.

No cracking, however, was found in the interstitial paste fractions between those reactive particles or within the particles or in dark reaction rims (e.g., see Figures 31, 33, 35, and 37) to indicate distress from ACR.

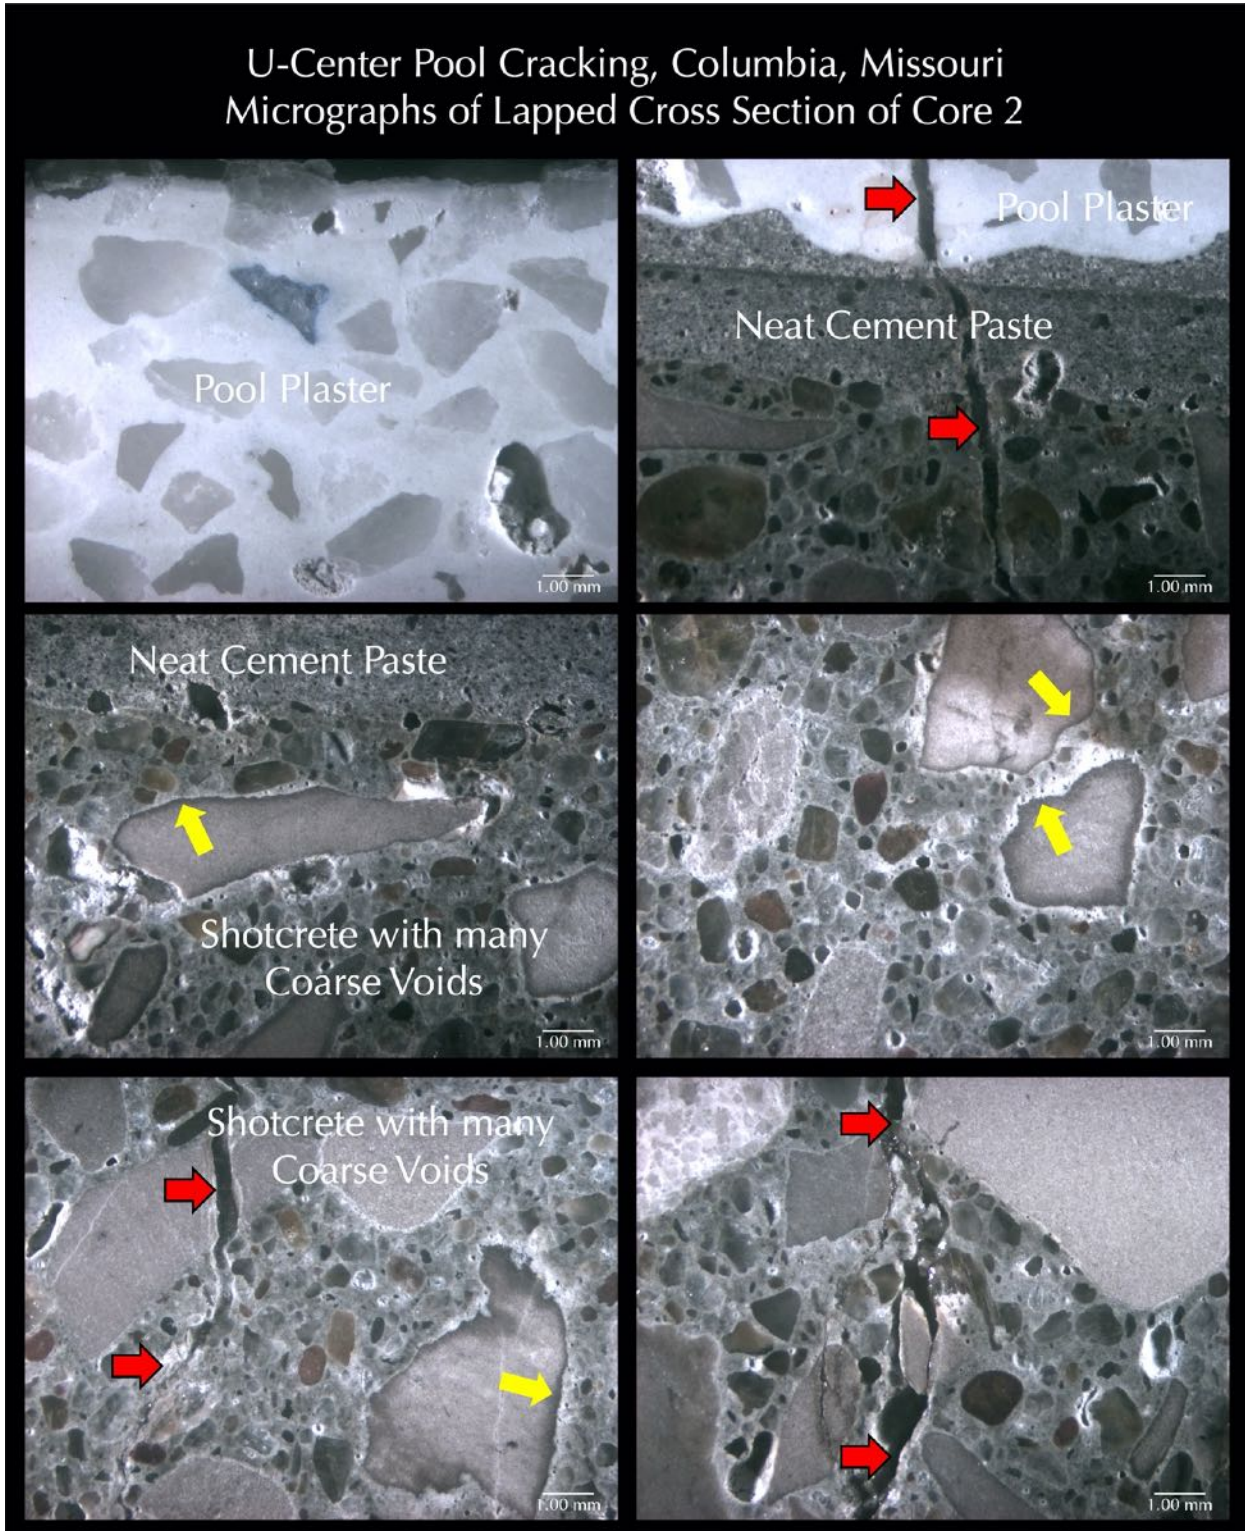
Figure 32: Micrographs of lapped cross section of Core 2 showing: (a) the dense, white, pool plaster with visible cracks extended into underlying leveling coat (top row right photo, red arrows), (b) medium to dark gray thin paste-rich layer of leveling coat (top right and middle row left photos), (c) the shotcrete having crushed dolomitic limestone aggregate particles many with dark reaction rims followed by light cream-colored carbonated paste rims (yellow arrows), (d) overall non-air-entrained nature of shotcrete having many coarse entrapped air voids, and (e) overall intimate bond between pool plaster, leveling coat, and shotcrete.
