## Investigation of Extensive Cracking of a Swimming Pool from Petrographic Examinations of Four Composite Cores of Pool Plaster and Shotcrete

U-Center on Turner  
625 S 4th Street  
Columbia, MO 65203

September 12, 2023  
CMC 0823176

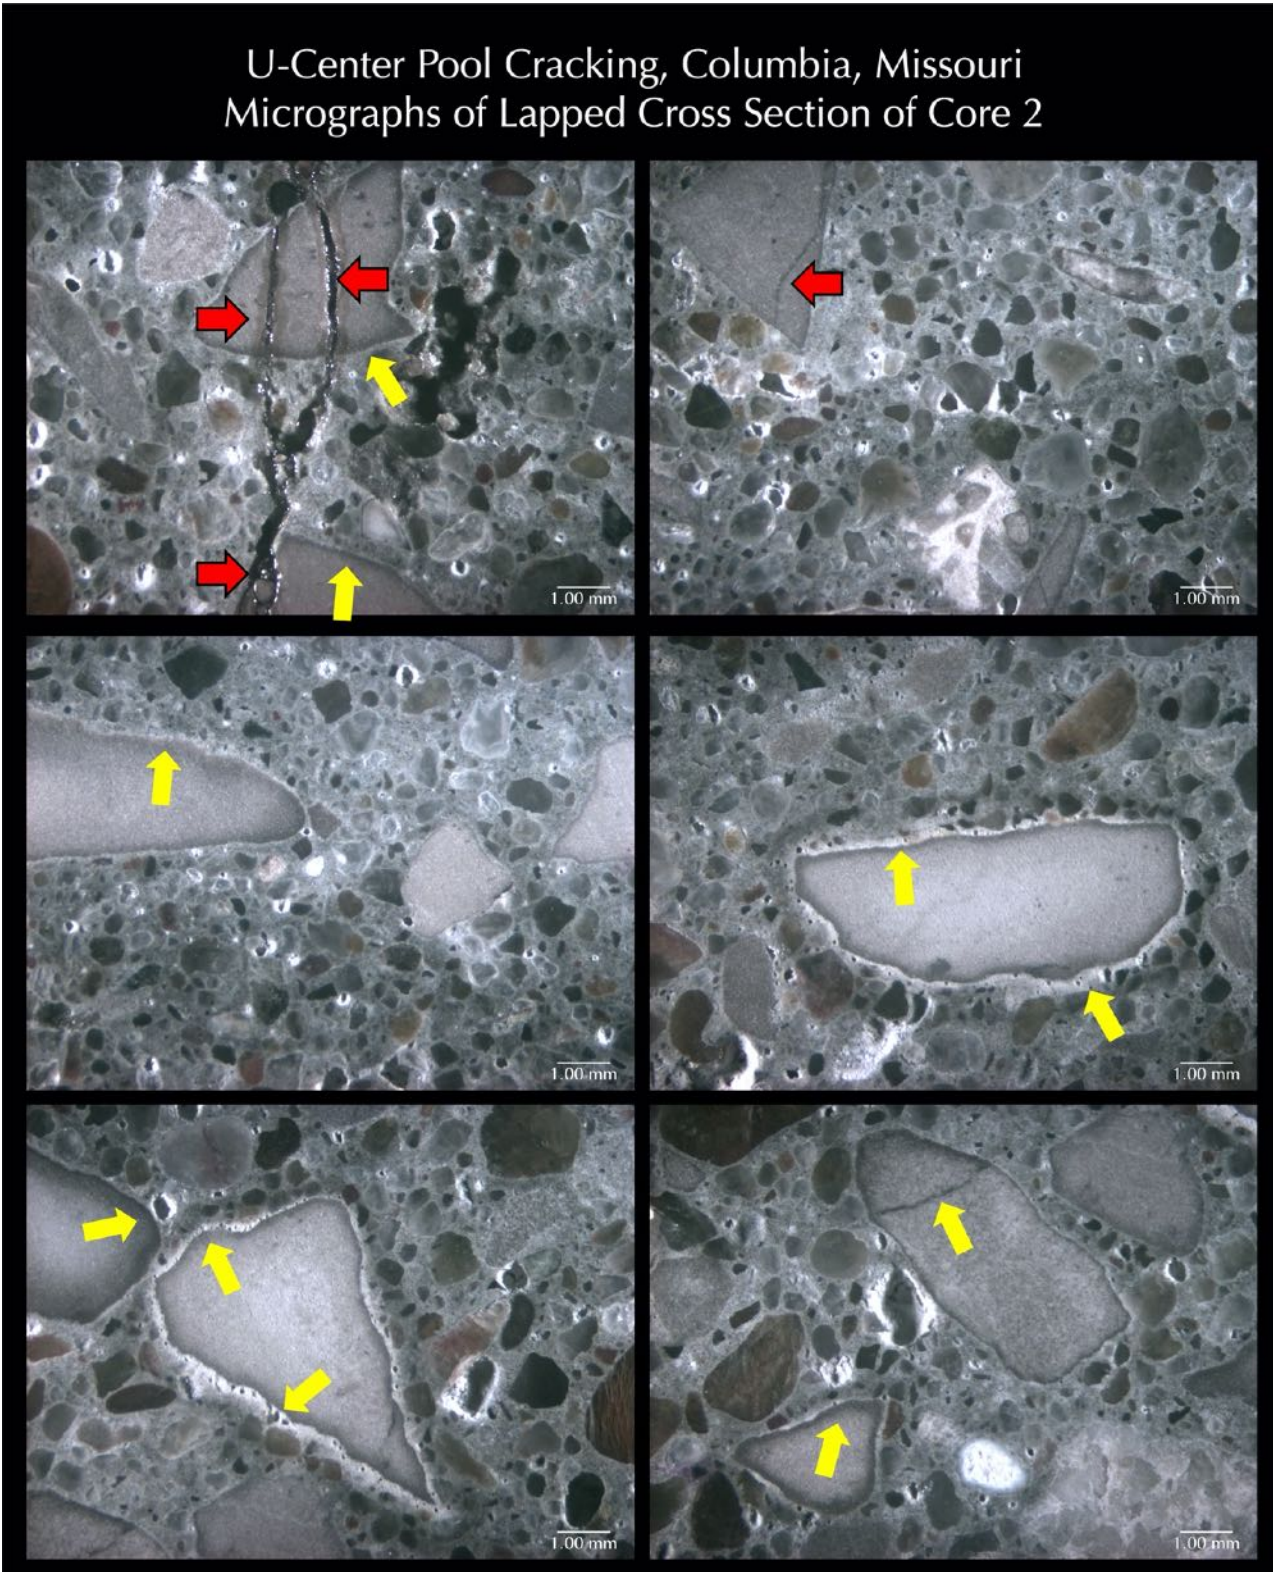
Figure 33: Micrographs of lapped cross section of Core 2 showing: (a) the shotcrete having crushed dolomitic limestone coarse aggregate particles many with dark reaction rims followed by light cream-colored carbonated paste rims (yellow arrows), and (b) overall non-air-entrained nature of shotcrete having many coarse entrapped air voids. The top row left photo shows a visible crack that has transected a crushed dolomitic limestone aggregate particle.

Many argillaceous dolomitic limestone particles in aggregate showed dark reaction rims along the periphery of the aggregates (Figures 31, 33, 35, 37, 47-51, 59-62, 66, 67, 70, and 72) and many of those particles additionally showed lighter cream-colored carbonation rims in paste immediately adjacent to those particles. These particles show characteristic texture of many known alkali-carbonate reactive (ACR) rocks of Missouri in having rhombic crystals of dolomite floating in finer-grained matrix of calcite, quartz, and clay.

No cracking, however, was found in the interstitial paste fractions between those reactive particles or within the particles or in dark reaction rims (e.g., see Figures 31, 33, 35, and 37) to indicate distress from ACR.

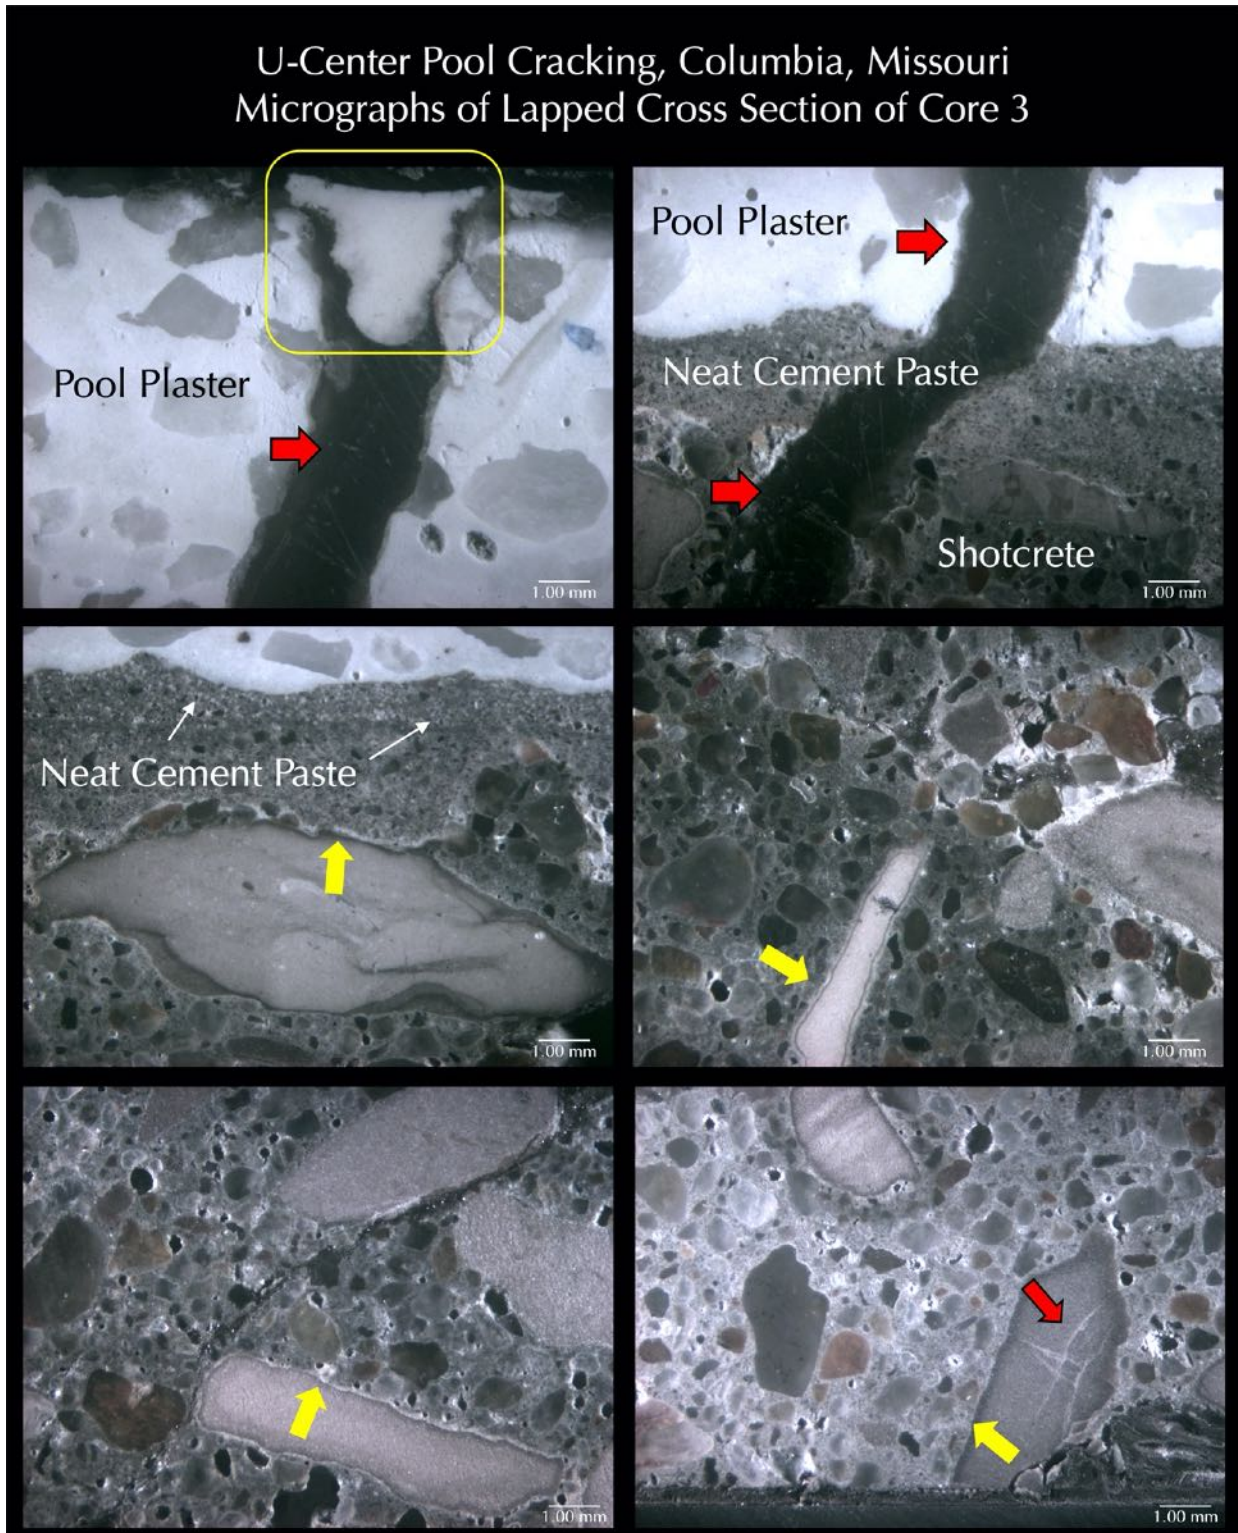
Figure 34: Micrographs of lapped cross section of Core 3 showing: (a) the dense, white, pool plaster with visible cracks extended into underlying leveling coat (top row, red arrows) and a crack seal caulk in the top left photo (boxed), (b) medium to dark gray thin paste-rich layer of leveling coat (top right and middle row left photos, thin white arrows), (c) the shotcrete having crushed dolomitic limestone aggregate particles many with dark reaction rims followed by light carbonated paste rims (yellow arrows), (d) overall non-air-entrained nature of shotcrete having many coarse entrapped air voids, and (e) overall intimate bond between pool plaster, leveling coat, and shotcrete.

Pool plaster is compositionally similar cementitious plaster coat across all four cores and consist of: (a) white Portland cement, minor limestone fines, and 2 to 3 mm nominal size well-sorted, well-distributed lightly crushed siliceous (quartz, quartzite) filler (Figures 30, 32, 34, 36, 38 to 45). In all four cores, plaster showed extensive shrinkage cracking in the paste fractions (Figures 46, 54, 55, 63, 65, 761, 74, 75, and 77) due to high paste volume relative to silica fillers where cracks are confined within the plaster and did not extend into the underlying leveling coat or shotcrete. These extensive fine, hairline shrinkage cracks in plaster paste are invisible on the exposed surface of plaster relative to the major visible cracks that have transected through plaster into the shotcrete body and formed entirely due to shrinkage of a high paste-volume cementitious plaster.

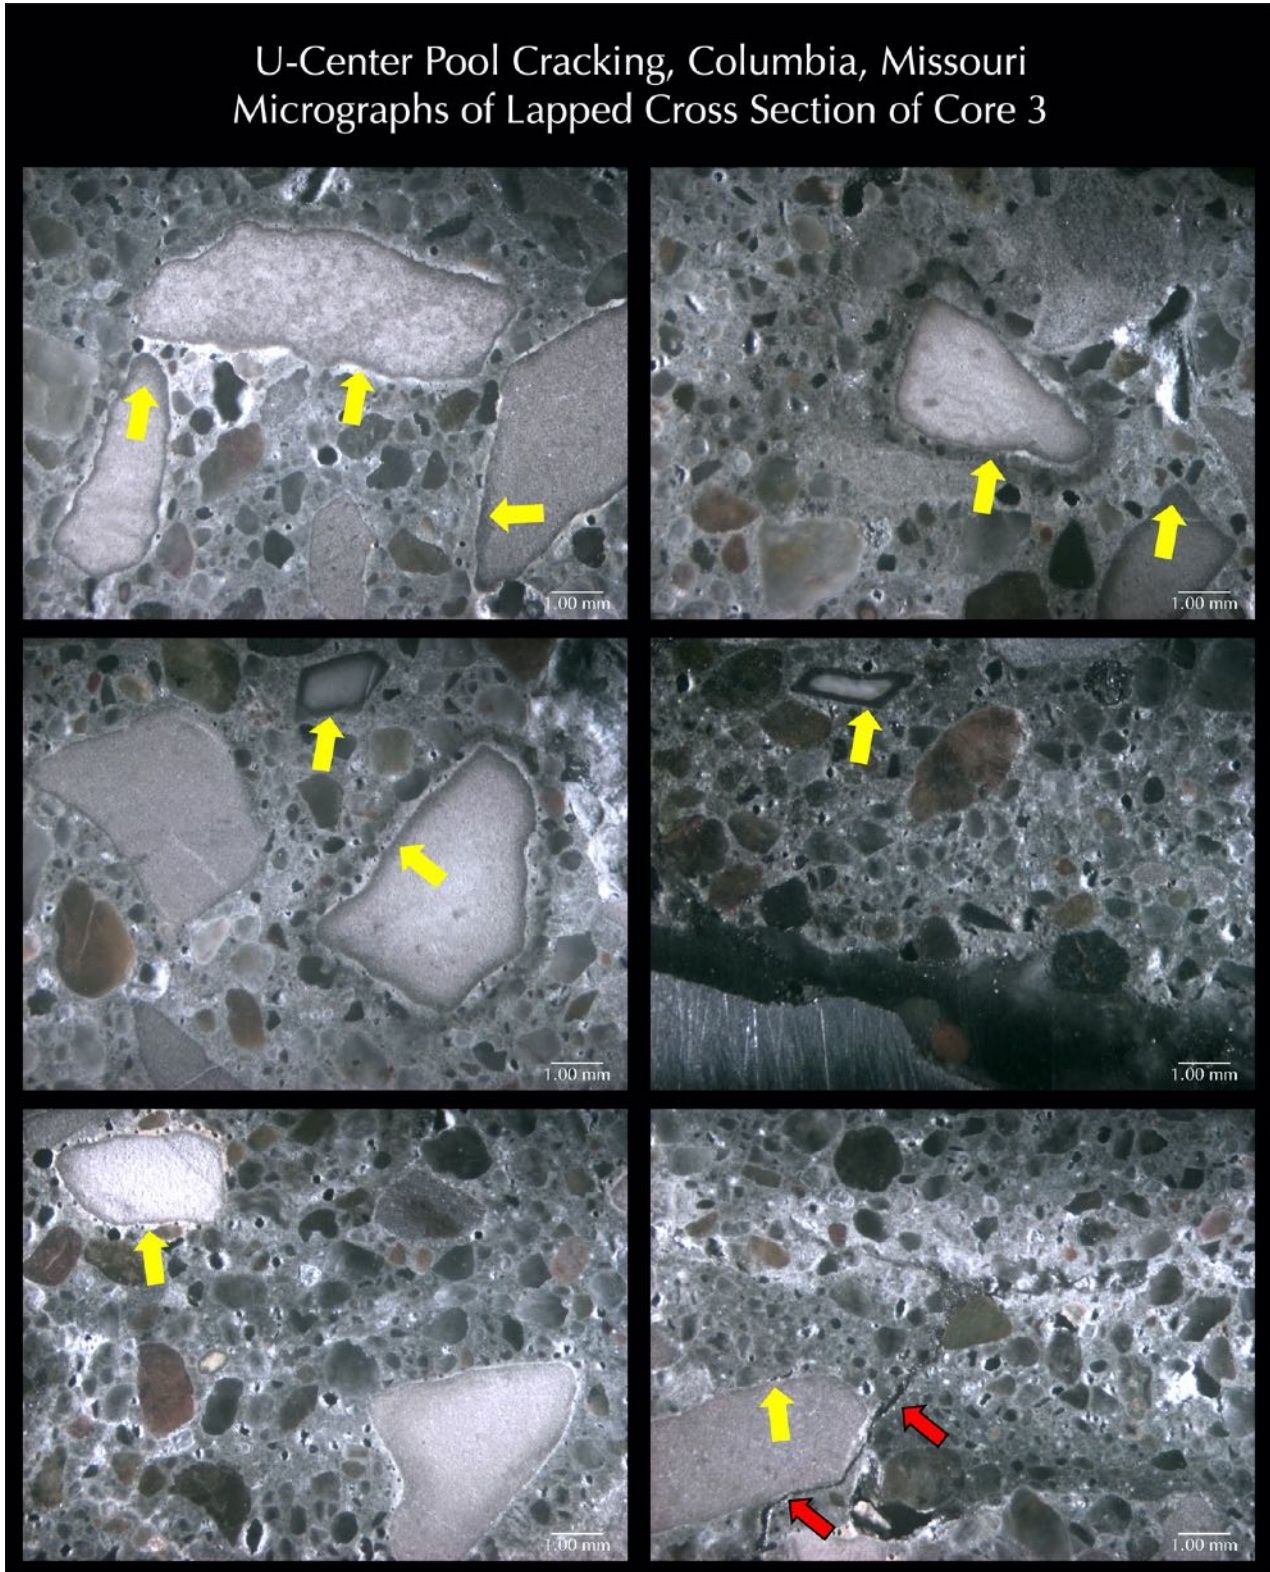
Figure 35: Micrographs of lapped cross section of Core 3 showing: (a) the shotcrete having crushed dolomitic limestone aggregate particles many with dark reaction rims followed by light cream-colored carbonated paste rims (yellow arrows), and (b) overall non-air-entrained nature of shotcrete having many coarse entrapped air voids.

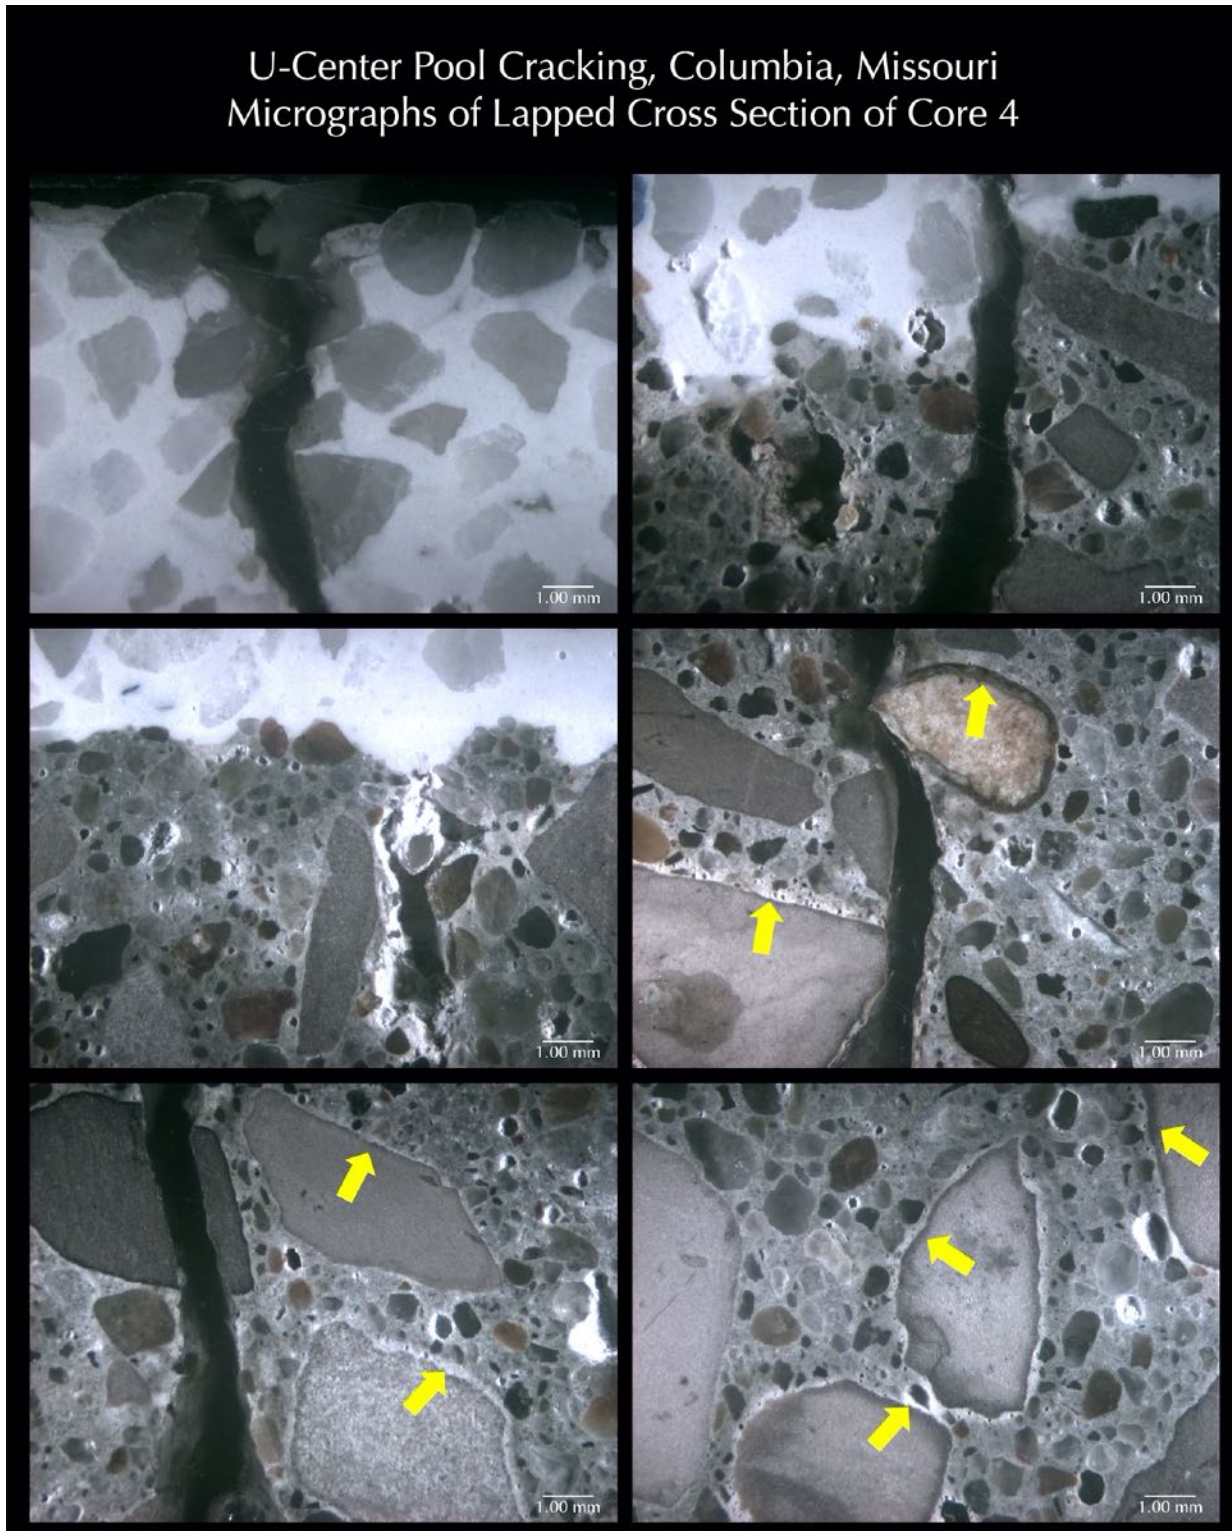
Figure 36: Micrographs of lapped cross section of Core 4 showing: (a) the dense, white, pool plaster with visible cracks extended into underlying leveling coat (top row), (b) no medium to dark gray leveling coat found in other 3 cores but not applied in the floor, (c) the shotcrete having crushed dolomitic limestone aggregate particles many with dark reaction rims followed by light cream-colored carbonated paste rims (yellow arrows), (d) overall non-air-entrained nature of shotcrete having many coarse entrapped air voids, and (e) overall intimate bond between pool plaster, leveling coat, and shotcrete. Major vertical crack through pool plaster and shotcrete are seen in four photos.

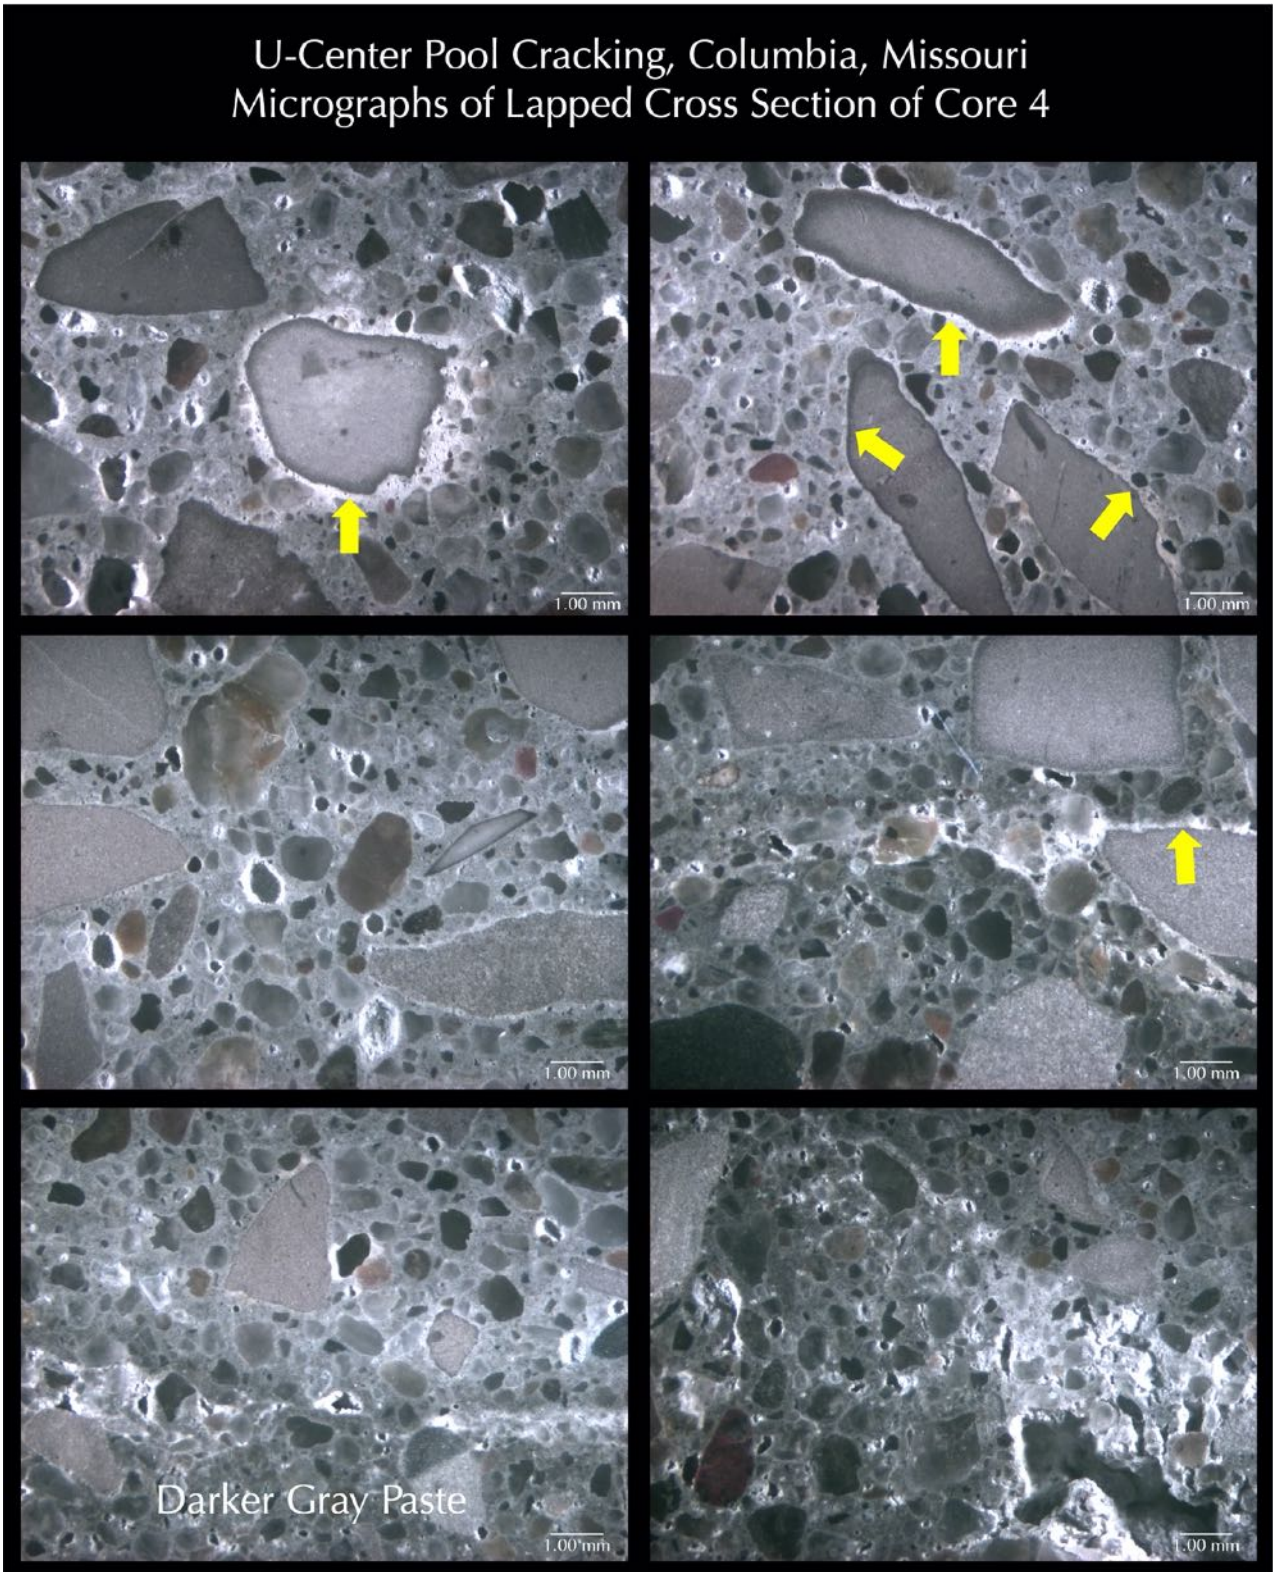
Figure 37: Micrographs of lapped cross section of Core 4 showing: (a) the shotcrete having crushed dolomitic limestone aggregate particles many with dark reaction rims followed by light cream-colored carbonated paste rims (yellow arrows), and (b) overall non-air-entrained nature of shotcrete having many coarse entrapped air voids.

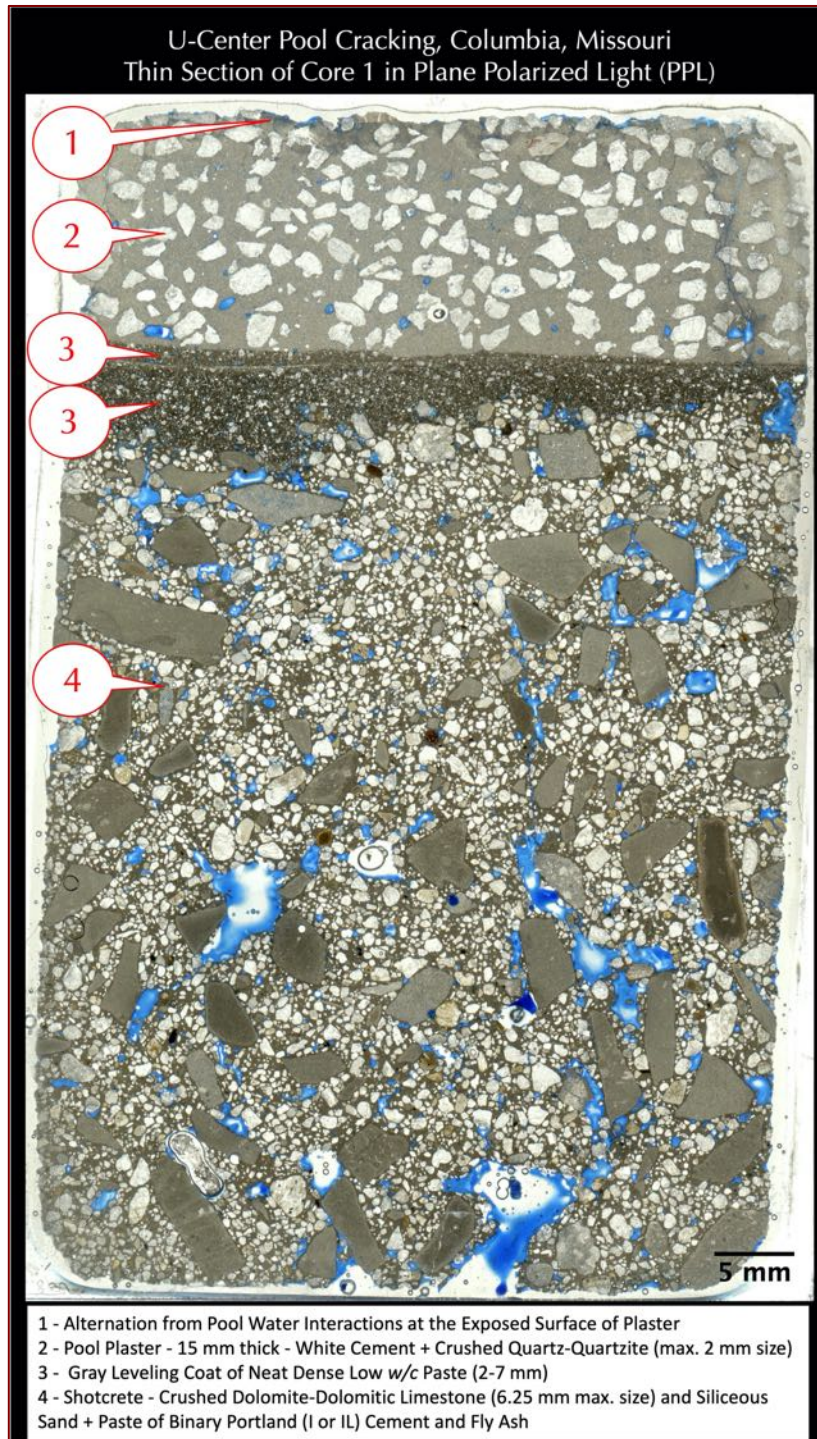
Figure 38: Blue dye-mixed epoxy-impregnated thin section of Core 1 showing: (a) a thin altered zone (Callout '1') from pool water interaction on the dense pool plaster (Callout '2') having many well-graded, well-distributed sub-rounded to angular (crushed) siliceous sand filler (2-3 mm size), (b) thin dark gray-toned paste of leveling coat (Callout '3'), and (c) the main shotcrete body (Callout '4') having crushed limestone and dolomitic limestone aggregate particles, natural siliceous sand aggregate, and interstitial paste with many coarse entrapped air voids highlighted by blue epoxy. The image was taken on a flatbed film scanner with a polarizing filter placed on the thin section to obtain plane polarized light view of polarizing microscope.

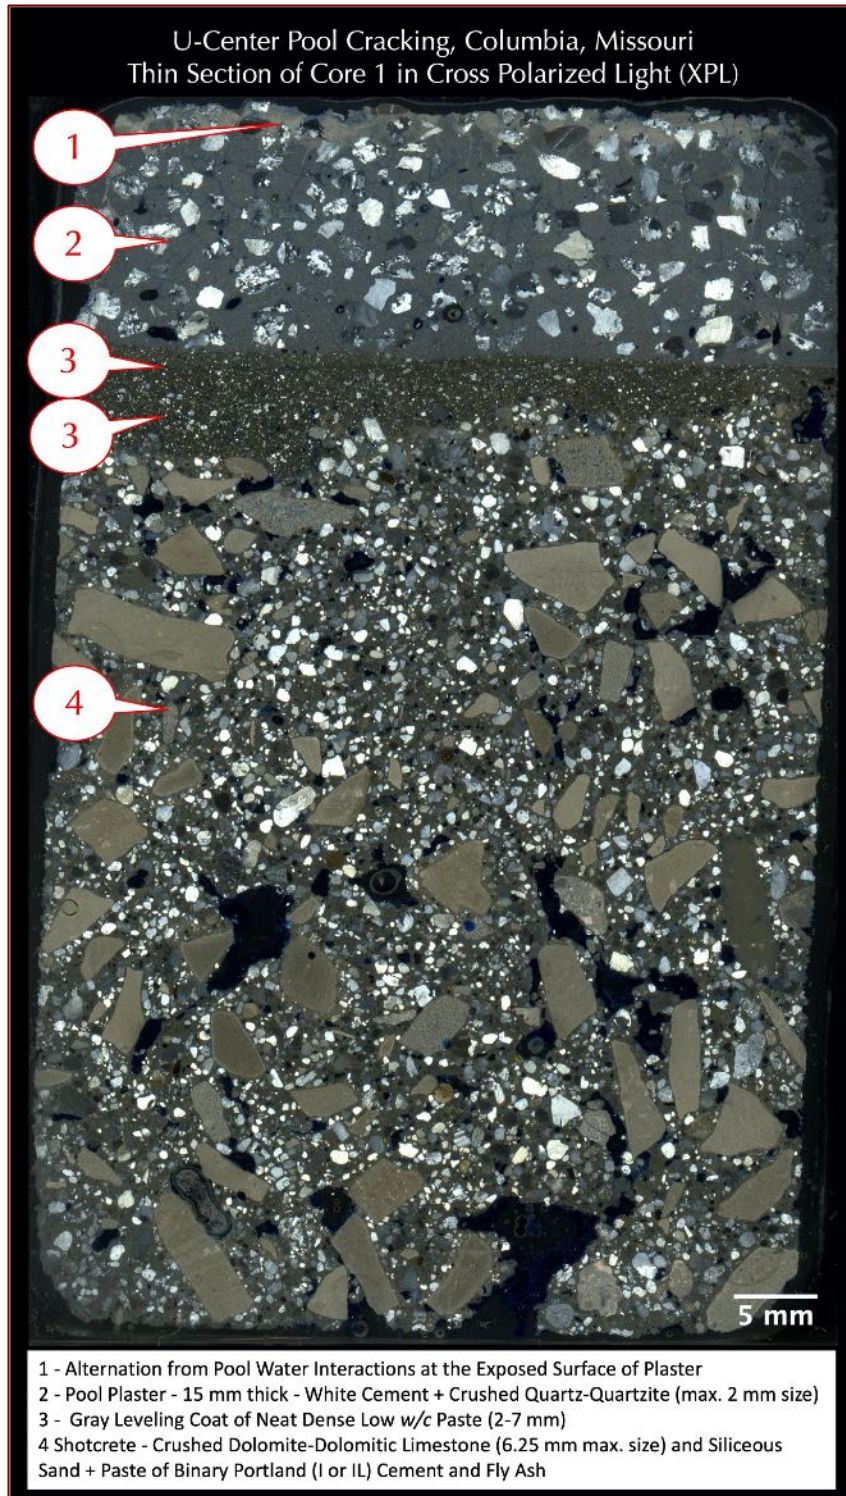
Figure 39: Blue dye-mixed epoxy-impregnated thin section of Core 1 showing: (a) a thin altered zone (Callout '1') from pool water interaction on the dense pool plaster (Callout '2') having many well-graded, well-distributed sub-rounded to angular (crushed) siliceous sand filler (2-3 mm size), (b) thin dark-toned paste of leveling coat (Callout '3'), and (c) the main shotcrete body (Callout '4') having crushed limestone and dolomitic limestone aggregate particles, natural siliceous sand aggregate, and interstitial paste with many coarse voids. The image was taken on a flatbed film scanner with two perpendicular polarizing filters placed on both sides of thin section to obtain cross polarized light view of polarizing microscope.

Shotcrete is compositionally similar in terms of ingredients across all four cores consist of: (a) ¼ in. (6.25 mm) nominal maximum size crushed limestone and argillaceous dolomitic limestone aggregate (Figures 22, 24, 26, and 28), and (b) noticeably finer nominal 2-3 mm size crushed siliceous (quartz, quartzite) sand aggregates (Figures 39, 41, 43, and 45).

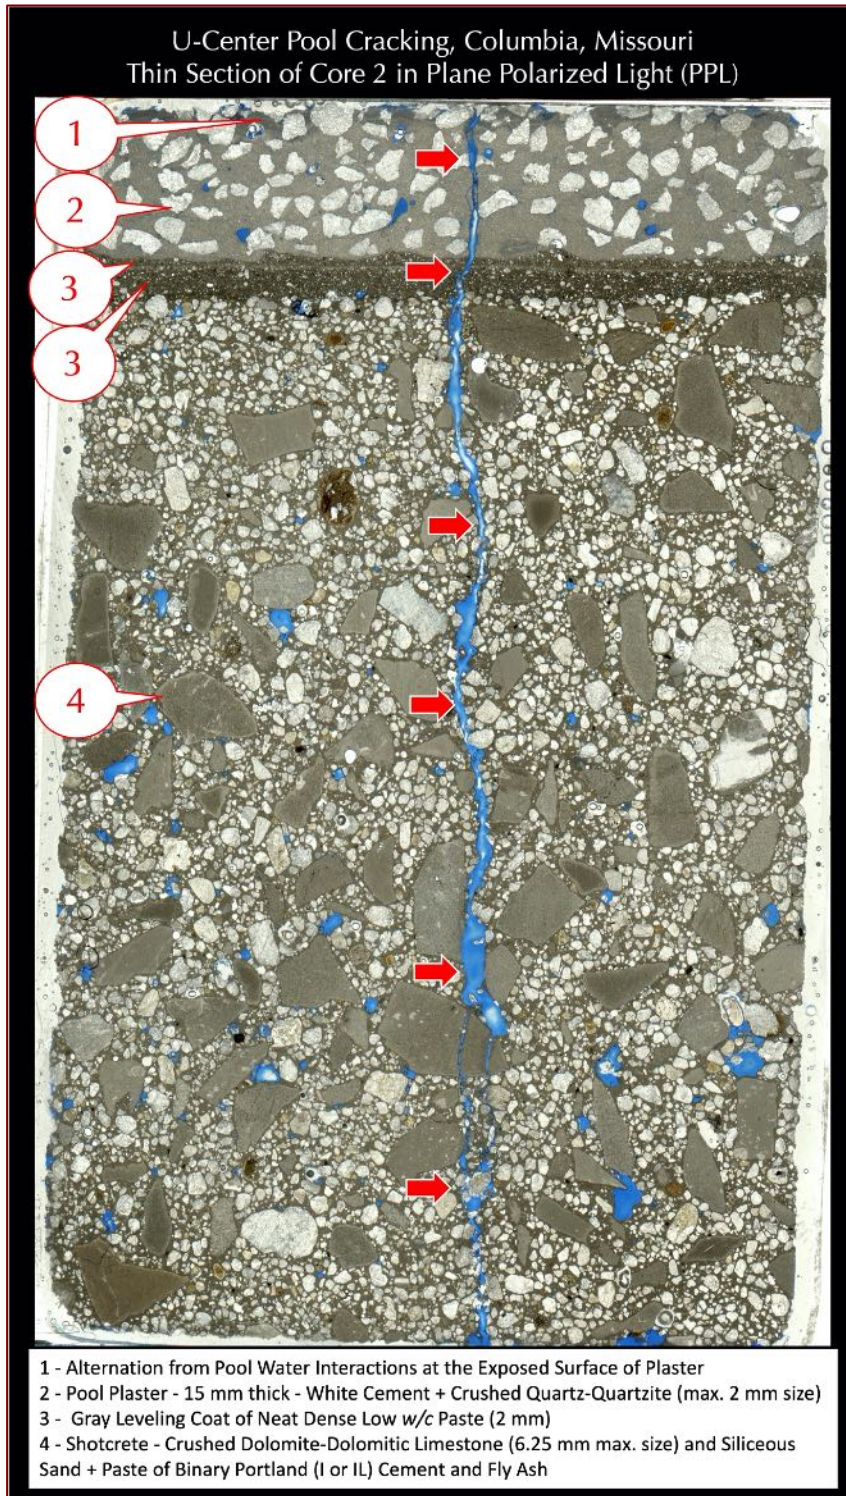
Figure 40: Blue dye-mixed epoxy-impregnated thin section of Core 2 showing: (a) a thin altered zone (Callout '1') from pool water interaction on the dense pool plaster (Callout '2') having many well-graded, well-distributed sub-rounded to angular (crushed) siliceous sand filler (2-3 mm size), (b) thin dark gray-toned paste of leveling coat (Callout '3'), and (c) the main shotcrete body (Callout '4') having crushed limestone and dolomitic limestone aggregate particles, natural siliceous sand aggregate, and interstitial paste with many coarse entrapped air voids highlighted by blue epoxy. The image was taken on a flatbed film scanner with a polarizing filter placed on the thin section to obtain plane polarized light view of polarizing microscope. The major vertical crack through pool plaster, leveling coat, and main shotcrete body is highlighted by blue epoxy and marked with red arrows.

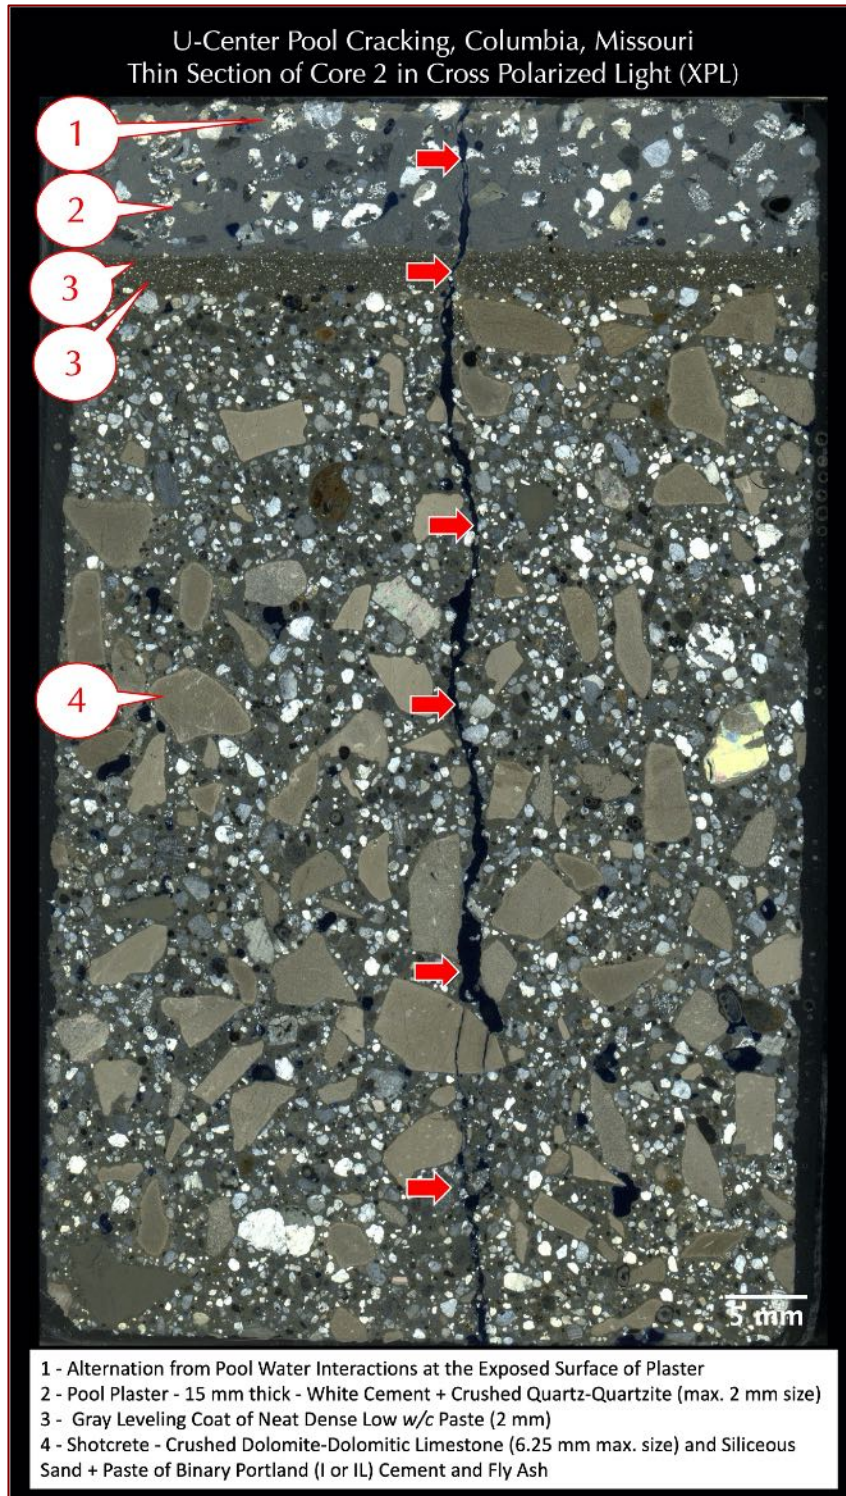
Figure 41: Blue dye-mixed epoxy-impregnated thin section of Core 2 showing: (a) a thin altered zone (Callout '1') from pool water interaction on the dense pool plaster (Callout '2') having many well-graded, well-distributed sub-rounded to angular (crushed) siliceous sand filler, (b) thin dark-toned paste of leveling coat (Callout '3'), and (c) the main shotcrete body (Callout '4') having crushed limestone and dolomitic limestone aggregate particles, natural siliceous sand aggregate, and interstitial paste with many coarse entrapped air voids. The image was taken on a flatbed film scanner with two perpendicular polarizing filters placed on both sides of thin section to obtain cross polarized light view of polarizing microscope. The major vertical crack through pool plaster, leveling coat, and main shotcrete body is highlighted with red arrows.

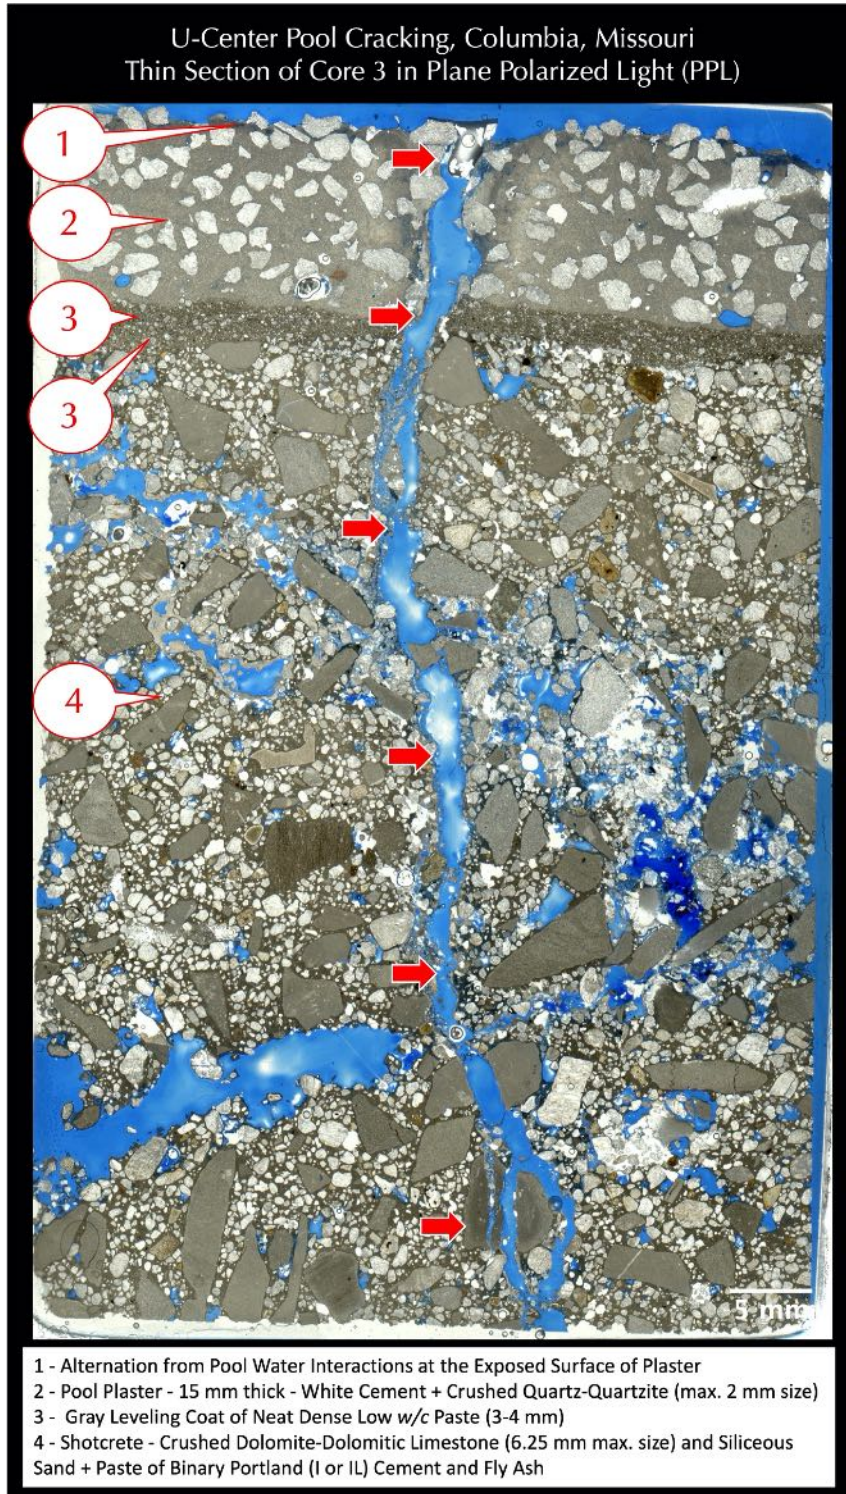
Figure 42: Blue dye-mixed epoxy-impregnated thin section of Core 3 showing: (a) a thin altered zone (Callout '1') from pool water interaction on the dense pool plaster (Callout '2') having many well-graded, well-distributed sub-rounded to angular (crushed) siliceous sand filler (2-3 mm size), (b) thin dark gray-toned paste of leveling coat (Callout '3'), and (c) the main shotcrete body (Callout '4') having crushed limestone and dolomitic limestone aggregate particles, natural siliceous sand aggregate, and interstitial paste with many coarse voids highlighted by blue epoxy. The image was taken on a flatbed film scanner with a polarizing filter placed on the thin section to obtain plane polarized light view of polarizing microscope. The major vertical crack through pool plaster, leveling coat, and main shotcrete body is highlighted by blue epoxy and marked with red arrows.

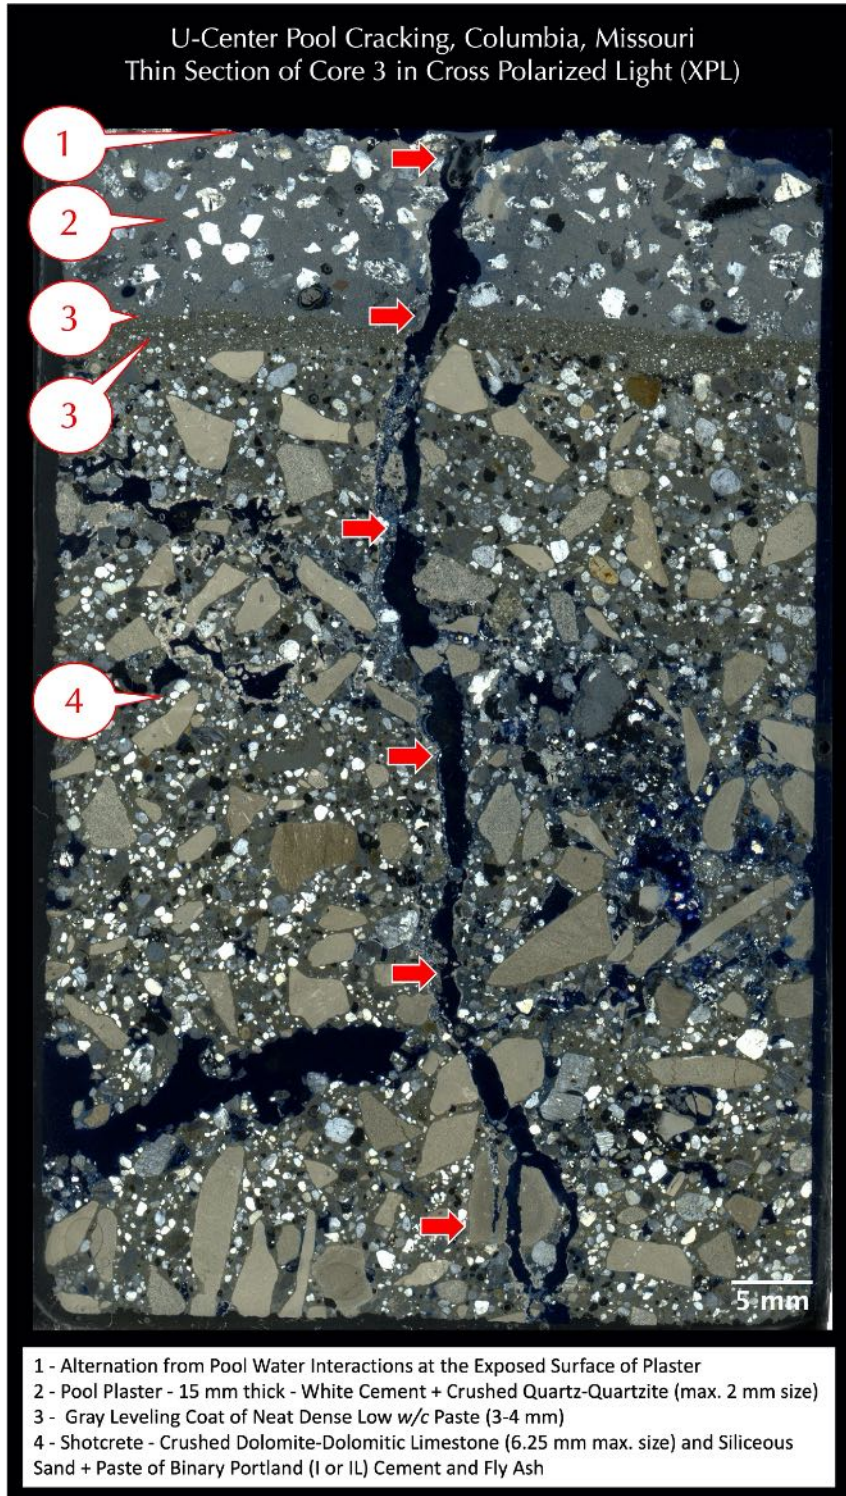
Figure 43: Blue dye-mixed epoxy-impregnated thin section of Core 3 showing: (a) a thin altered zone (Callout '1') from pool water interaction on the dense pool plaster (Callout '2') having many well-graded, well-distributed sub-rounded to angular (crushed) siliceous sand filler (2-3 mm size), (b) thin dark-toned paste of leveling coat (Callout '3'), and (c) the main shotcrete body (Callout '4') having crushed limestone and dolomitic limestone aggregate particles, natural siliceous sand aggregate, and interstitial paste with many coarse voids. The image was taken on a flatbed film scanner with two perpendicular polarizing filters placed on both sides of thin section to obtain cross polarized light view of polarizing microscope. The major vertical crack through pool plaster, leveling coat, and main shotcrete body is highlighted with red arrows.

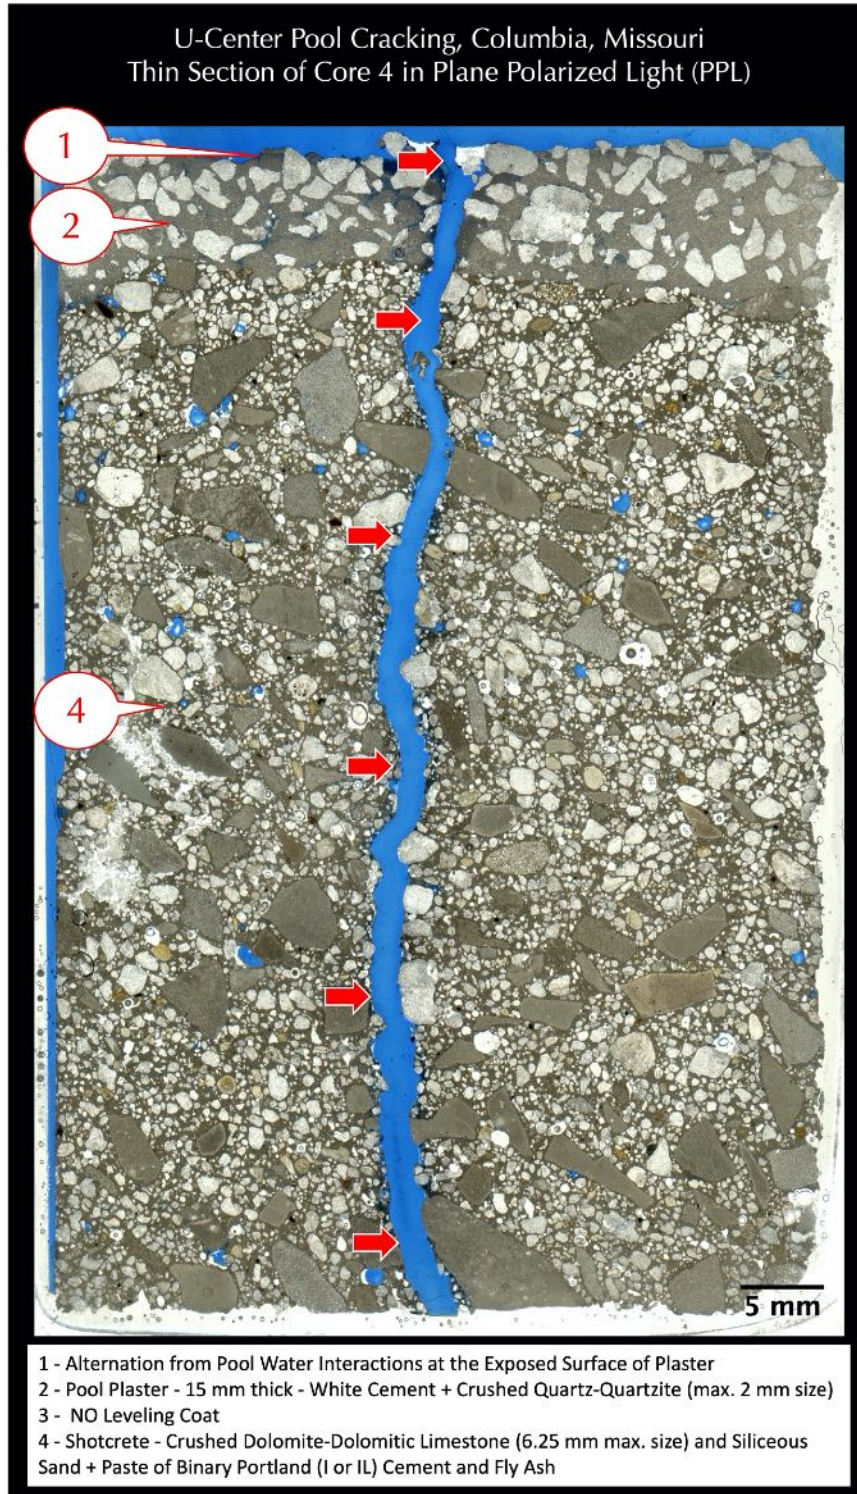
Figure 44: Blue dye-mixed epoxy-impregnated thin section of Core 4 showing: (a) a thin altered zone (Callout '1') from pool water interaction on the dense pool plaster (Callout '2') having many well-graded, well-distributed sub-rounded to angular (crushed) siliceous sand filler (2-3 mm size), (b) absence of the thin dark-toned paste of leveling coat found in other three cores, and (c) the main shotcrete body (Callout '4') having crushed limestone and dolomitic limestone aggregate particles, natural siliceous sand aggregate, and interstitial paste with many coarse voids. The image was taken on a flatbed film scanner with two perpendicular polarizing filters placed on both sides of thin section to obtain cross polarized light view of polarizing microscope. The major vertical crack through pool plaster, leveling coat, and main shotcrete body is highlighted with red arrows.

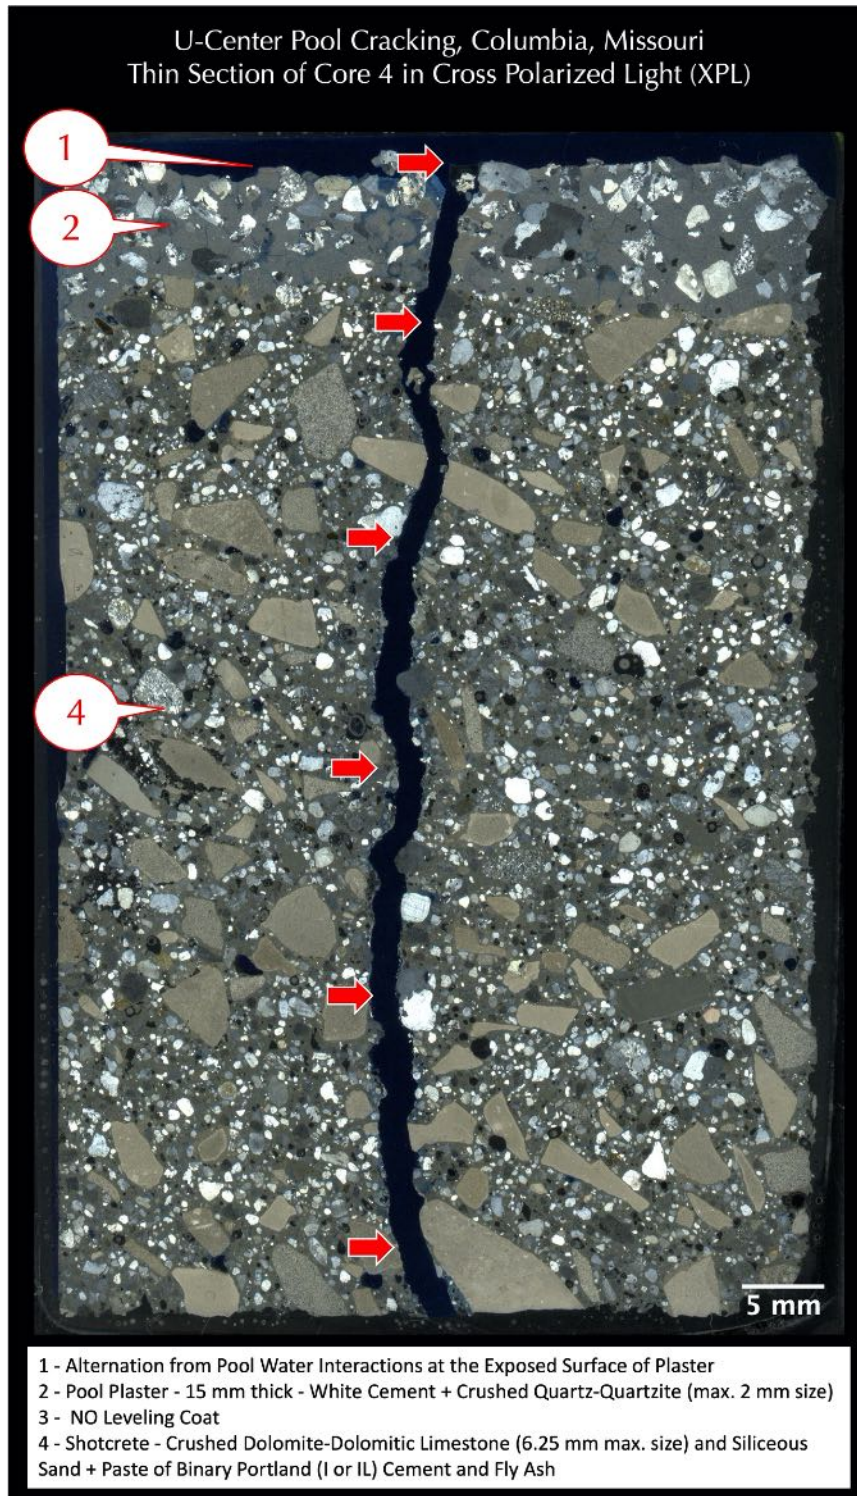
Figure 45: Blue dye-mixed epoxy-impregnated thin section of Core 4 showing: (a) a thin altered zone (Callout '1') from pool water interaction on the dense pool plaster (Callout '2') having many well-graded, well-distributed sub-rounded to angular (crushed) siliceous sand filler (2-3 mm size), (b) absence of thin dark-toned paste of leveling coat found in three other cores, and (c) the main shotcrete body (Callout '4') having crushed limestone and dolomitic limestone aggregate particles, natural siliceous sand aggregate, and interstitial paste with many coarse voids. The image was taken on a flatbed film scanner with two perpendicular polarizing filters placed on both sides of thin section to obtain cross polarized light view of polarizing microscope. The major vertical crack through pool plaster, leveling coat, and main shotcrete body is highlighted with red arrows.
