## Investigation of Extensive Cracking of a Swimming Pool from Petrographic Examinations of Four Composite Cores of Pool Plaster and Shotcrete

U-Center on Turner  
625 S 4th Street  
Columbia, MO 65203

September 12, 2023  
CMC 0823176

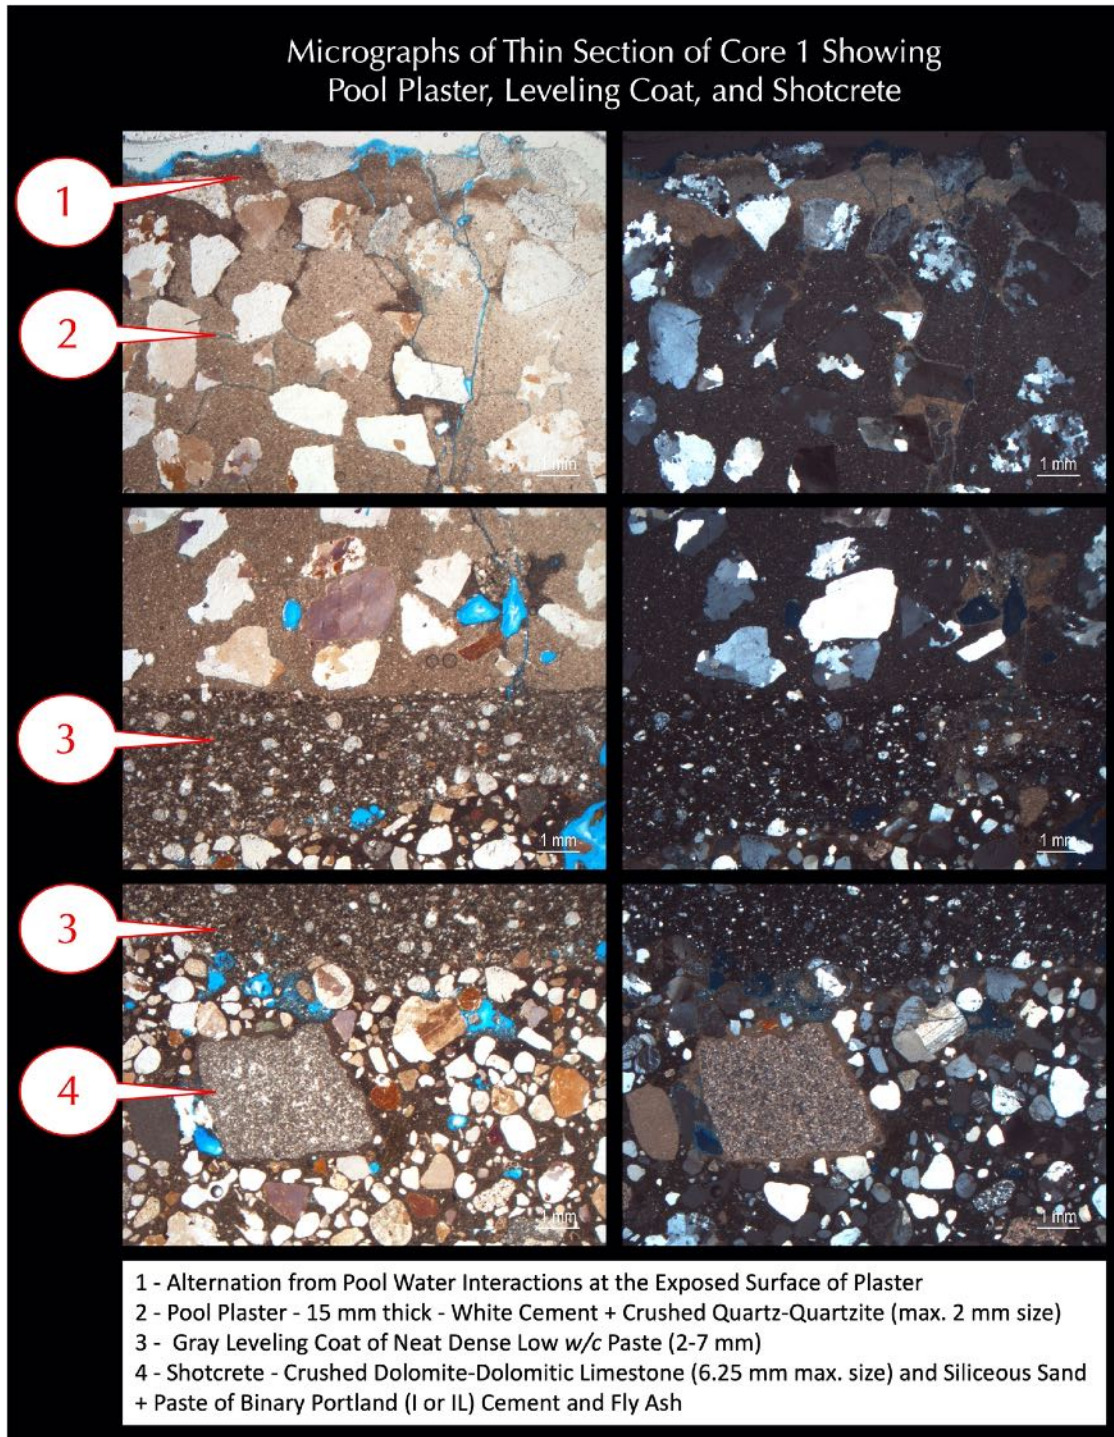
Figure 46: Micrographs of thin section of Core 1 showing: (a) a thin altered zone (Callout '1') from pool water interaction on the dense pool plaster (Callout '2') having many well-graded, well-distributed sub-rounded to angular (crushed) siliceous sand filler (2-3 mm size), (b) absence of thin dark-toned paste of leveling coat found in three other cores, and (c) the main shotcrete body (Callout '4') having crushed dolomitic limestone aggregate particles, natural siliceous sand aggregate, and interstitial paste with many coarse voids. Images were taken in plane (PPL, left) and corresponding cross (XPL, right) polarized light modes respectively, in a stereozoom microscope.

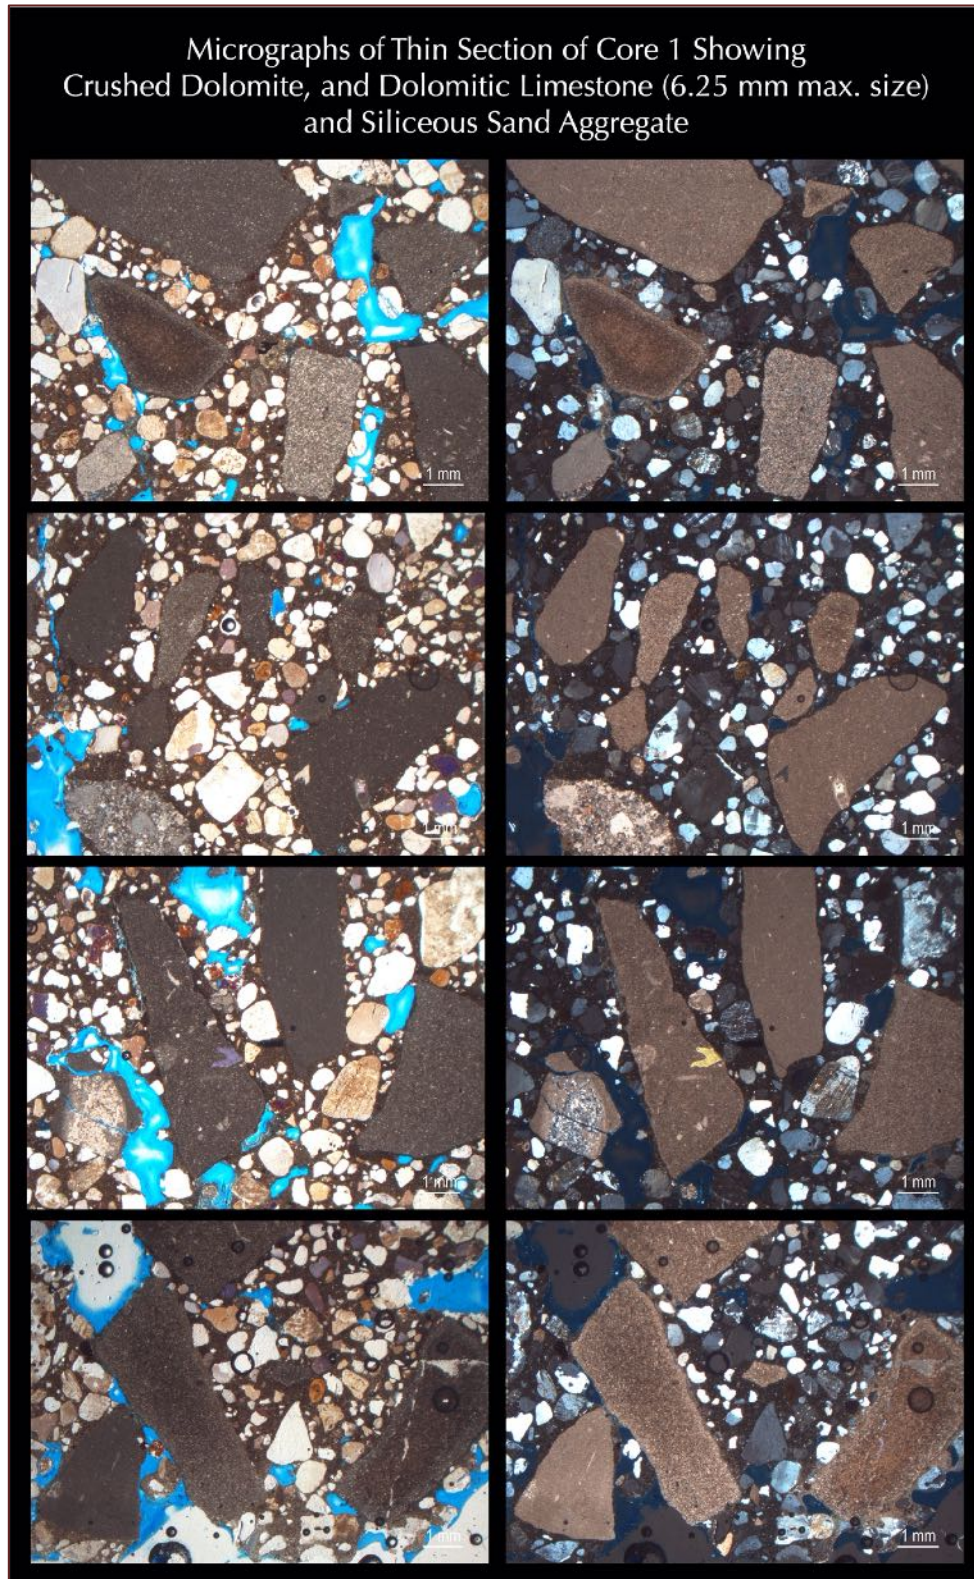
Figure 47: Micrographs of thin section of Core 1 showing: (a) the main shotcrete body having crushed limestone and dolomitic limestone aggregate particles, natural siliceous sand aggregate, and interstitial paste with many coarse voids. Images were taken in plane (PPL, left) and corresponding cross (XPL, right) polarized light modes respectively, in a stereozoom microscope.

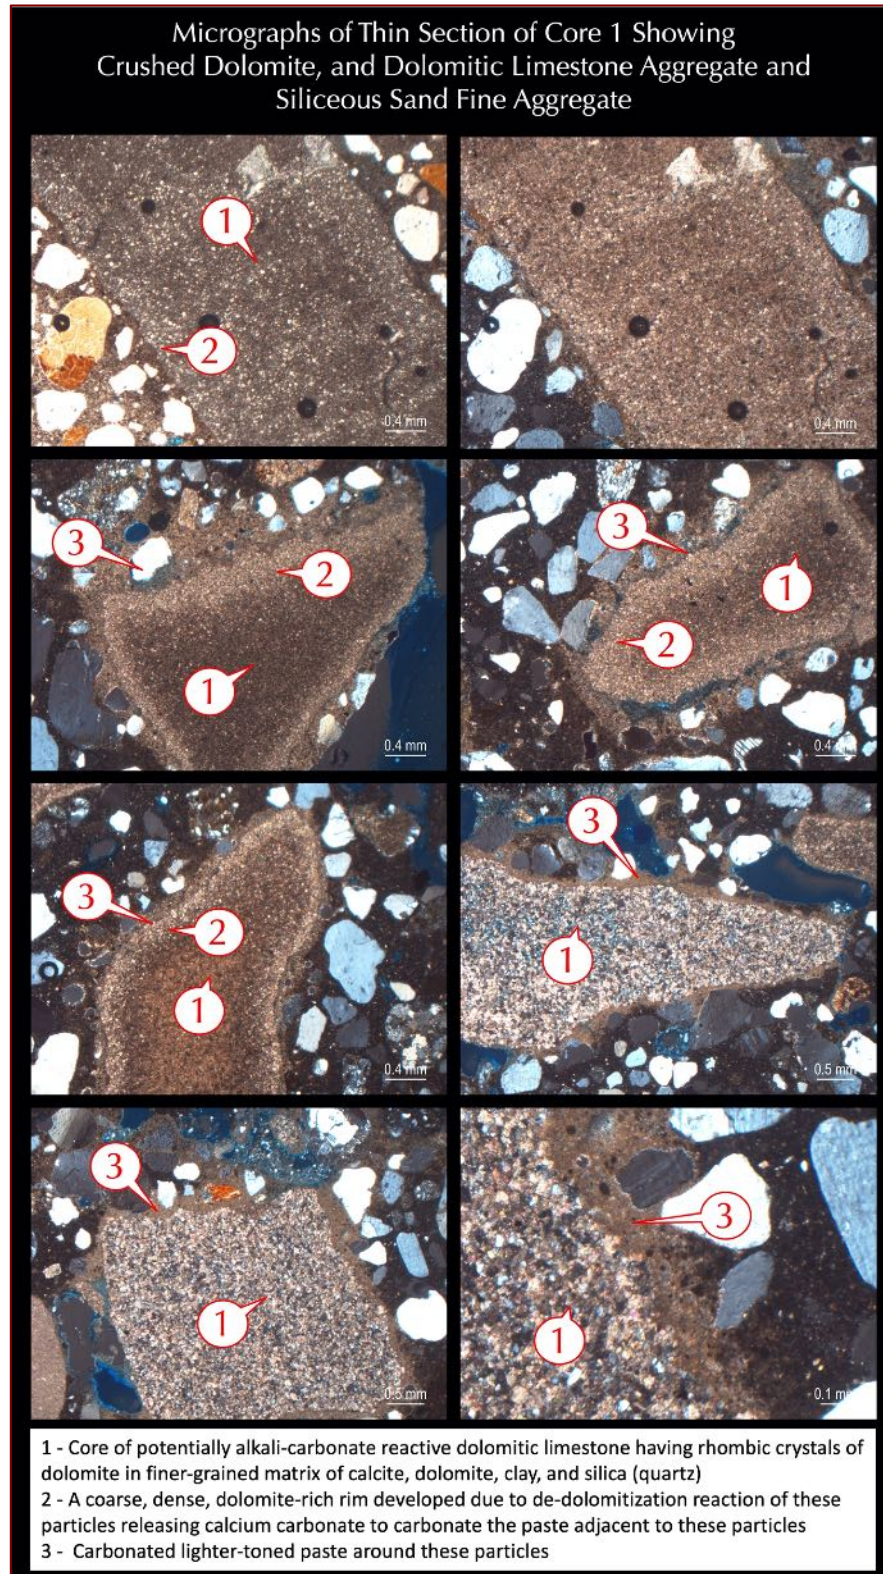
Figure 48: Micrographs of thin section of Core 1 showing many crushed dolomitic limestone aggregate particles having a core of rhombic crystals of dolomite in finer grains matrix of calcite, dolomite, clay, and quartz (Callout '1'), within a dense rim of coarse dolomite rhombs (Callout '2') and an outer lighter-toned carbonated paste rim (Callout '3'), which are potentially unsound alkali-carbonate reactive dolomitic limestone particles in aggregate. Images were taken in plane (PPL) or cross (XPL) polarized light modes in a stereozoom microscope.

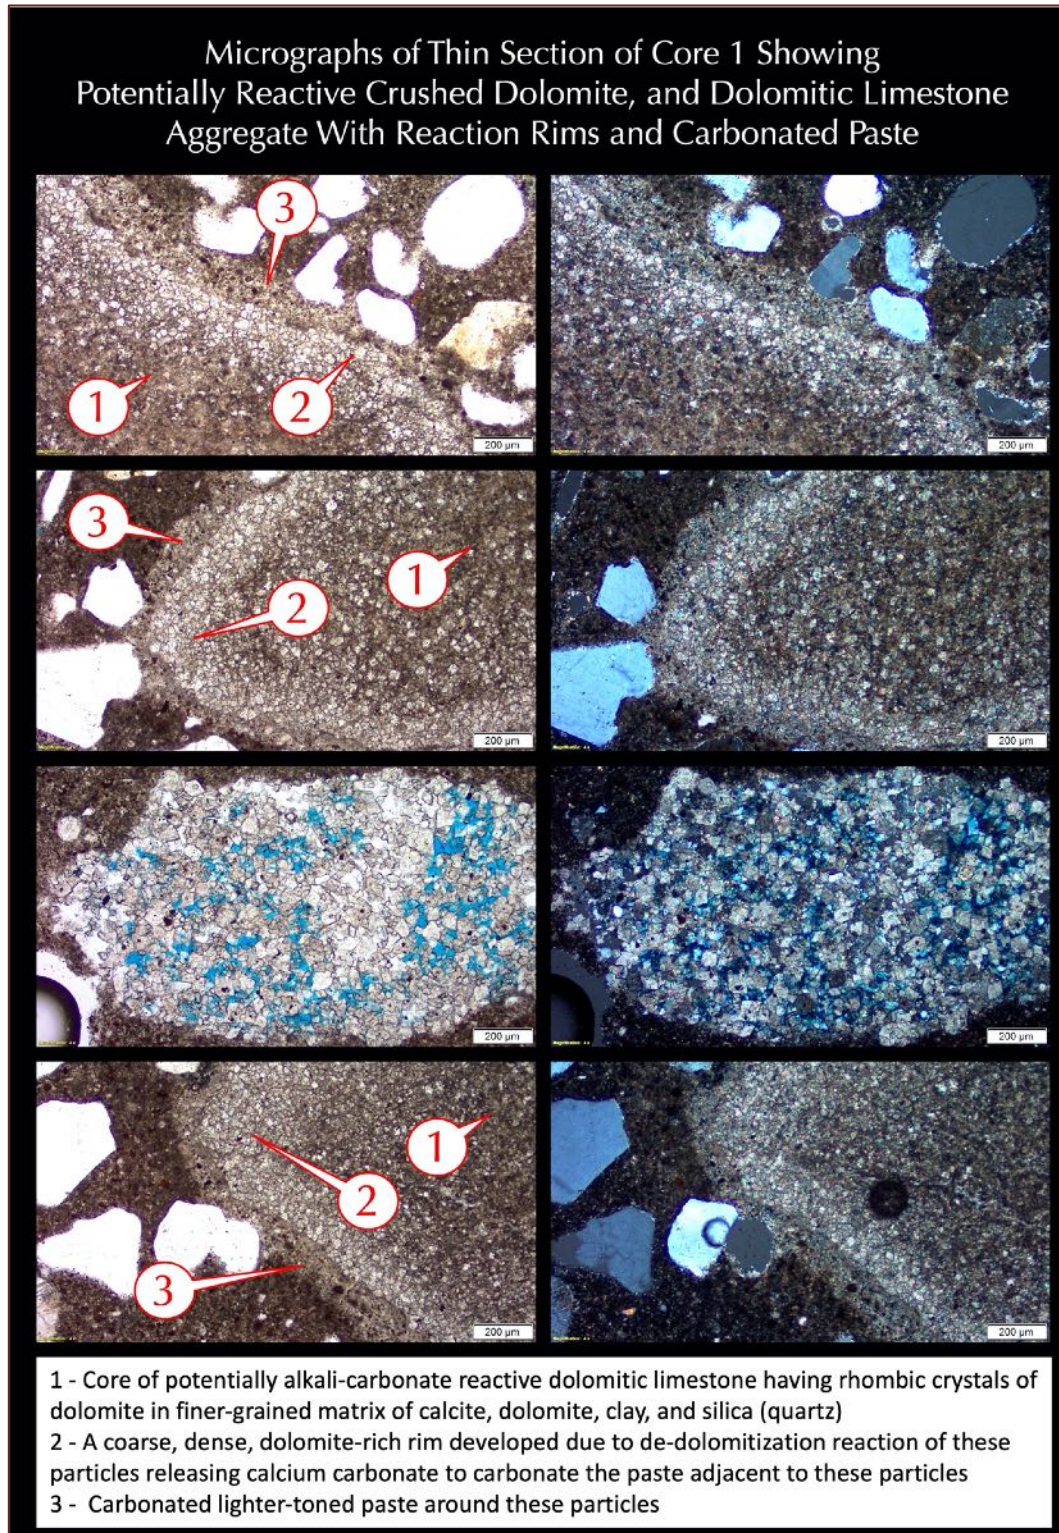
Figure 49: Micrographs of thin section of Core 1 showing many crushed dolomitic limestone aggregate particles having a core of rhombic crystals of dolomite in finer grains matrix of calcite, dolomite, clay, and quartz (Callout '1'), within a dense rim of coarse dolomite rhombs (Callout '2') and an outer lighter-toned carbonated paste rim (Callout '3'), which are potentially unsound alkali-carbonate reactive dolomitic limestone particles in aggregate. Images were taken in plane (PPL) or cross (XPL) polarized light modes in a petrographic microscope.

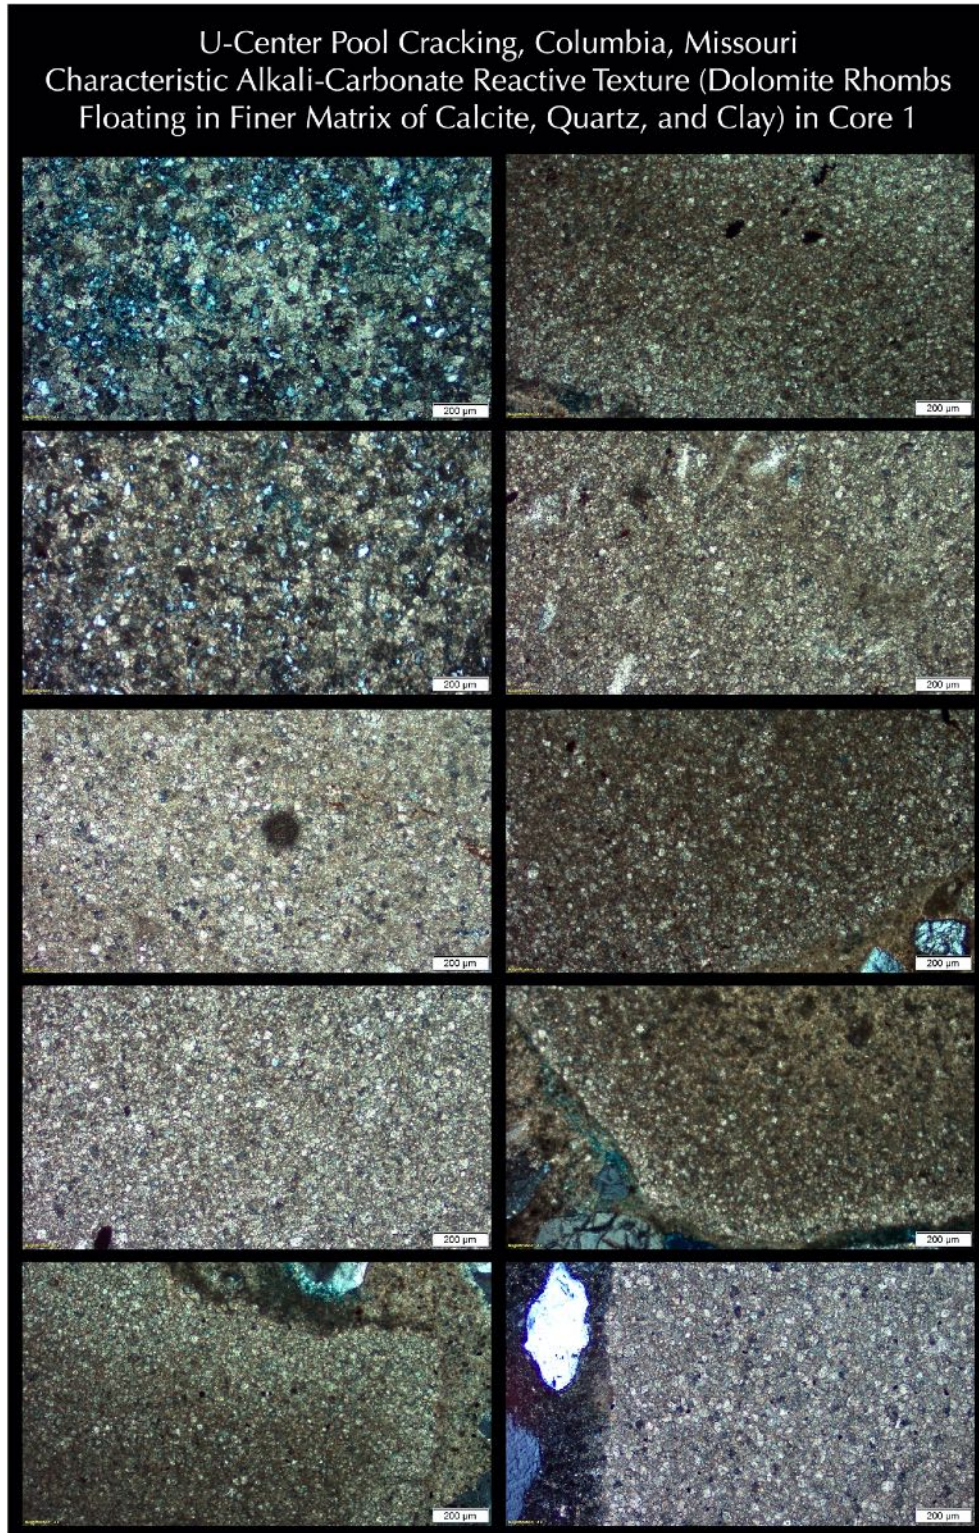
Figure 50: Micrographs of thin section of Core 1 showing characteristic texture of alkali-carbonate reactive (ACR) rocks in shotcrete in having dolomite rhombs floating in finer-grained matrix of calcite, quartz, and clay.

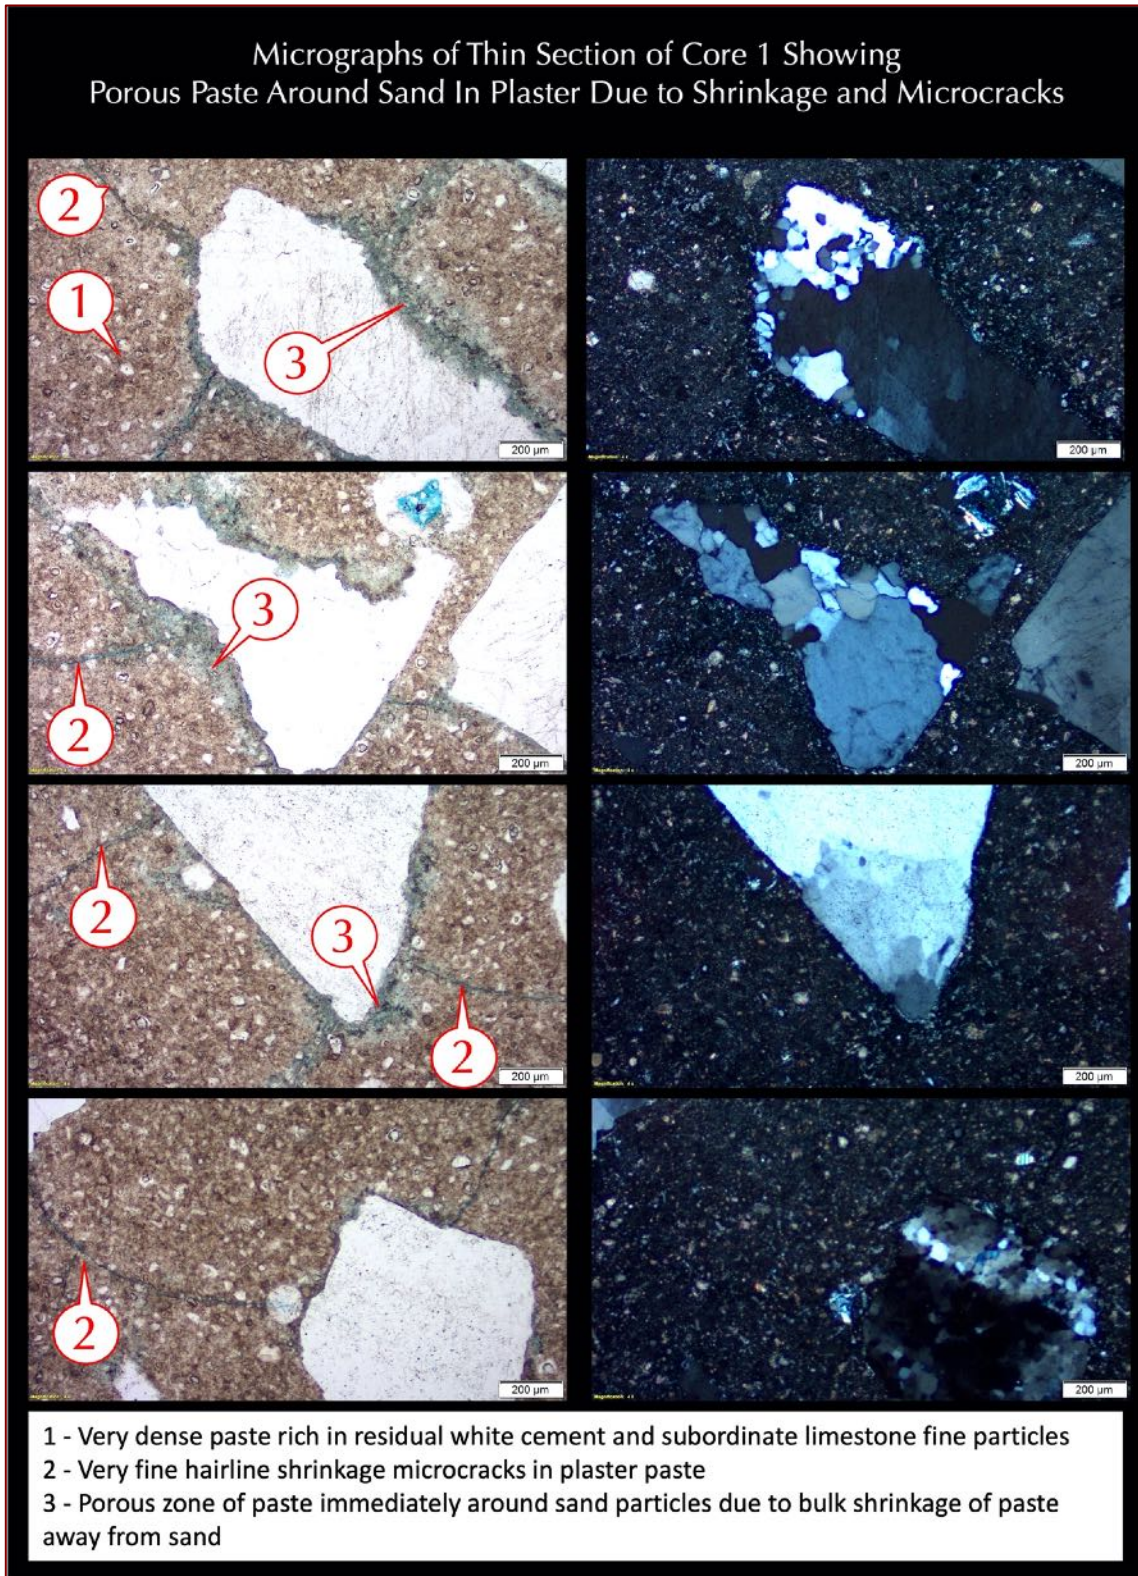
Figure 55: Micrographs of thin section of Core 1 showing: (a) dense white cement paste in pool plaster consisting of a dense matrix of cement hydration products and many very fine residual cement particles (Callout '1'), (b) extensive fine microcracks within the white pool plaster (Callout '2'), and (c) gaps or porous higher w/c zone of paste and associated microcracks around siliceous sand (quartz, quartzite) fillers in pool plaster (Callout '3'). Images were taken in plane (PPL) and cross (XPL) polarized light modes in a petrographic microscope.

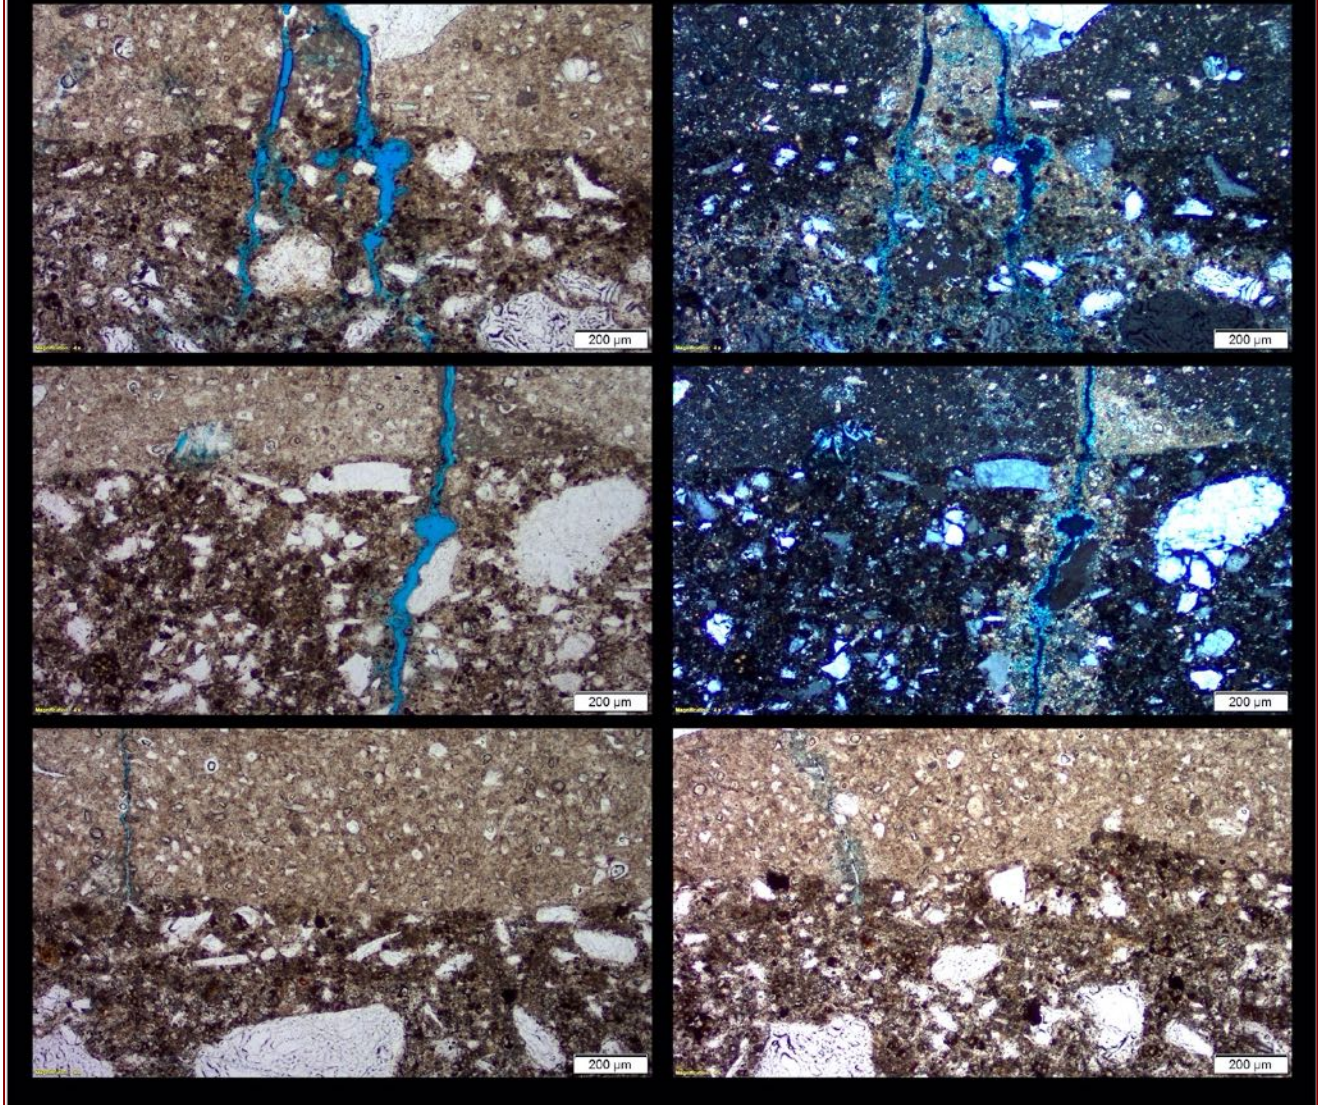
Figure 56: Micrographs of thin section of Core 1 showing microcracks extending from pool plaster through thin dark-toned intermediate leveling coat and carbonation of paste along the walls of microcracks indicating penetration of atmospheric and/or dissolved carbon dioxide from pool to shotcrete. Notice very different composition and microstructure of pool plaster and relatively darker brown thin calcium aluminate cement paste-rich layer of leveling coat where leveling coat have finely ground crushed quartz, quartzite particles and calcium aluminate-based cement (responsible for imparting the overall darker gray color tone). Images were taken in plane (PPL) and cross (XPL) polarized light modes in a petrographic microscope.

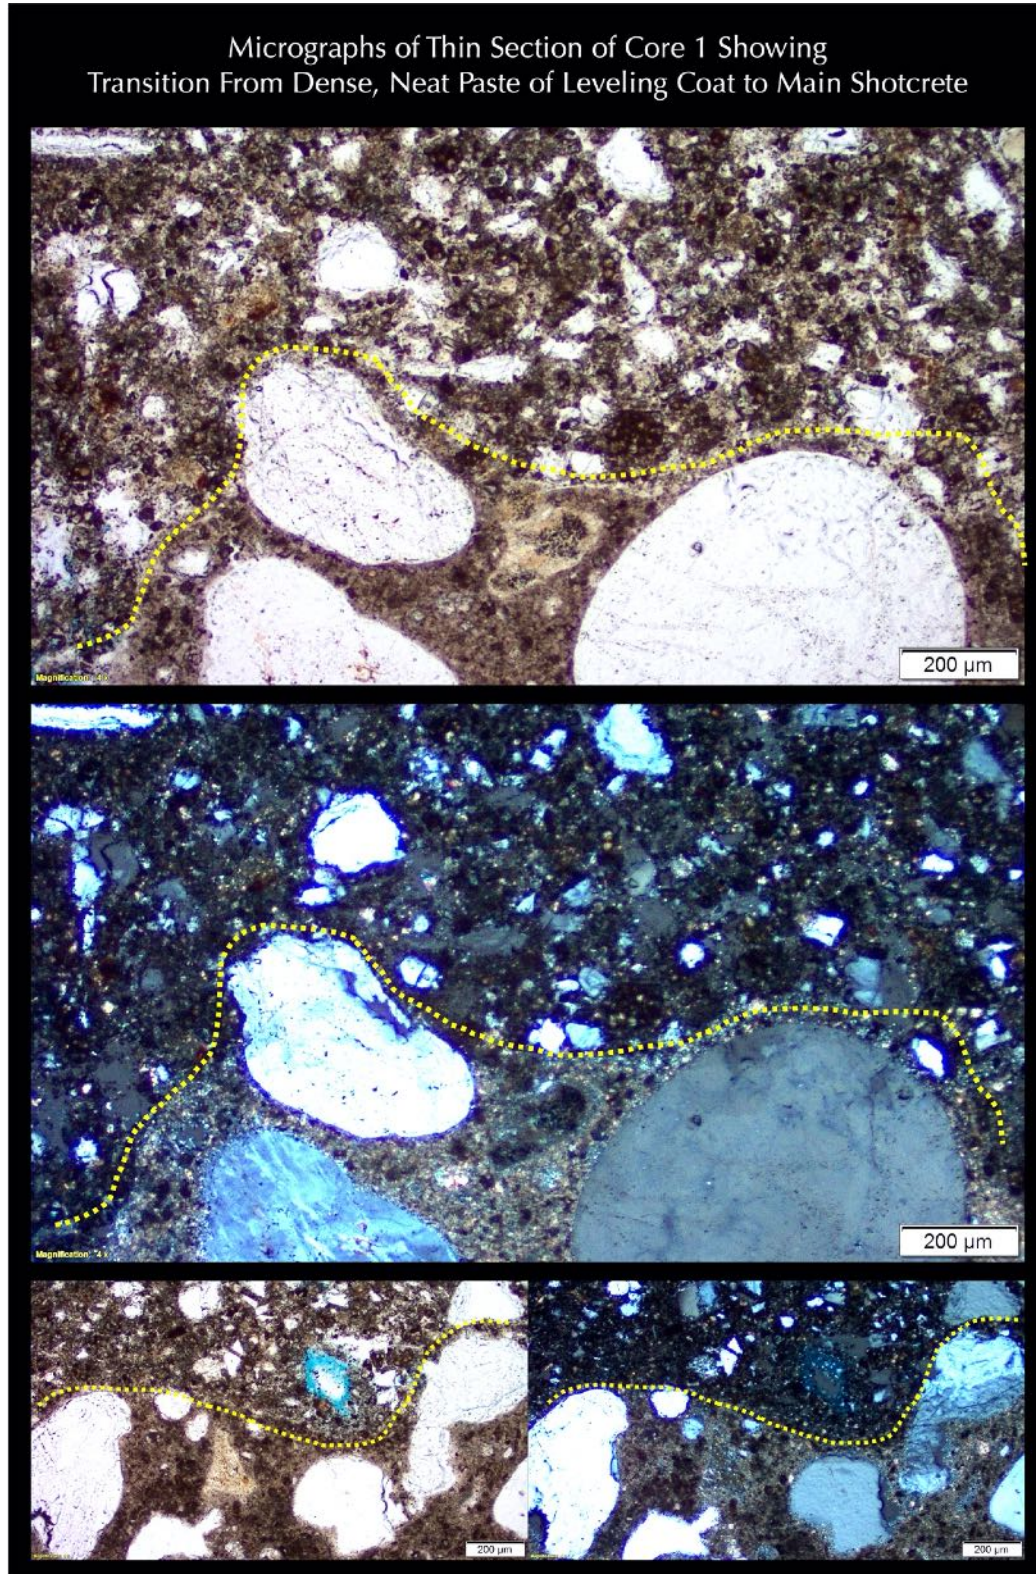
Figure 57: Micrographs of thin section of Core 1 showing the intimate bond between the thin leveling coat of dark-toned paste and very fine crushed quartz filler and underlying main shotcrete body. Notice carbonated paste of shotcrete immediately beneath the leveling coat in the middle row indicating an aerated exposure prior to the placement of leveling coat. Images were taken in plane (PPL) and cross (XPL) polarized light modes in a petrographic microscope.

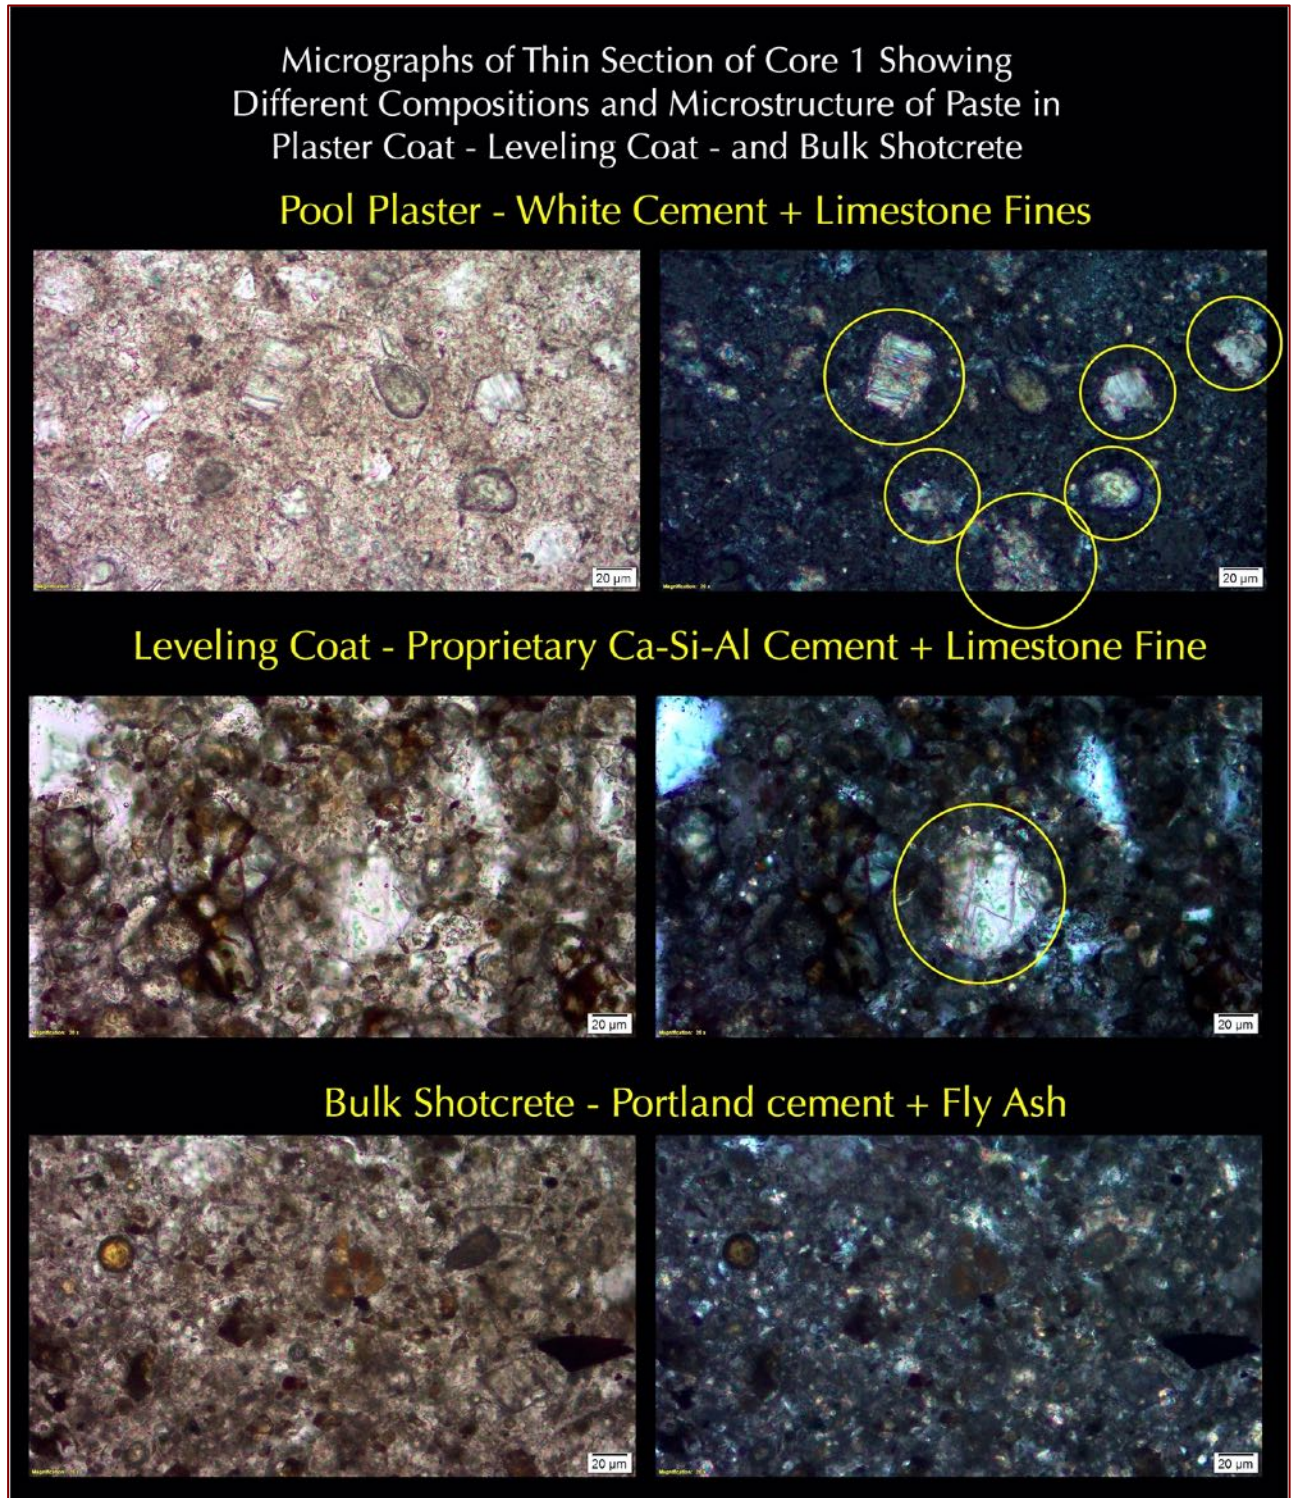
Figure 58: Micrographs of thin section of Core 1 showing the difference in compositions and microstructures of paste in: (a) pool plaster (top row) having white Portland cement and limestone fines scattered throughout a dense matrix of cement hydration products, (b) thin dark-toned leveling coat having dark brown calcium aluminoferrite phases with scattered finely crushed silica and occasional calcite fine particles (middle row), and (c) dense paste of finely ground Portland cement and minor fly ash having residual cement and spherical fly ash particles in the main shotcrete body (bottom row). Images were taken in plane (PPL, left) and corresponding cross (XPL, right) polarized light modes respectively, in a petrographic microscope.

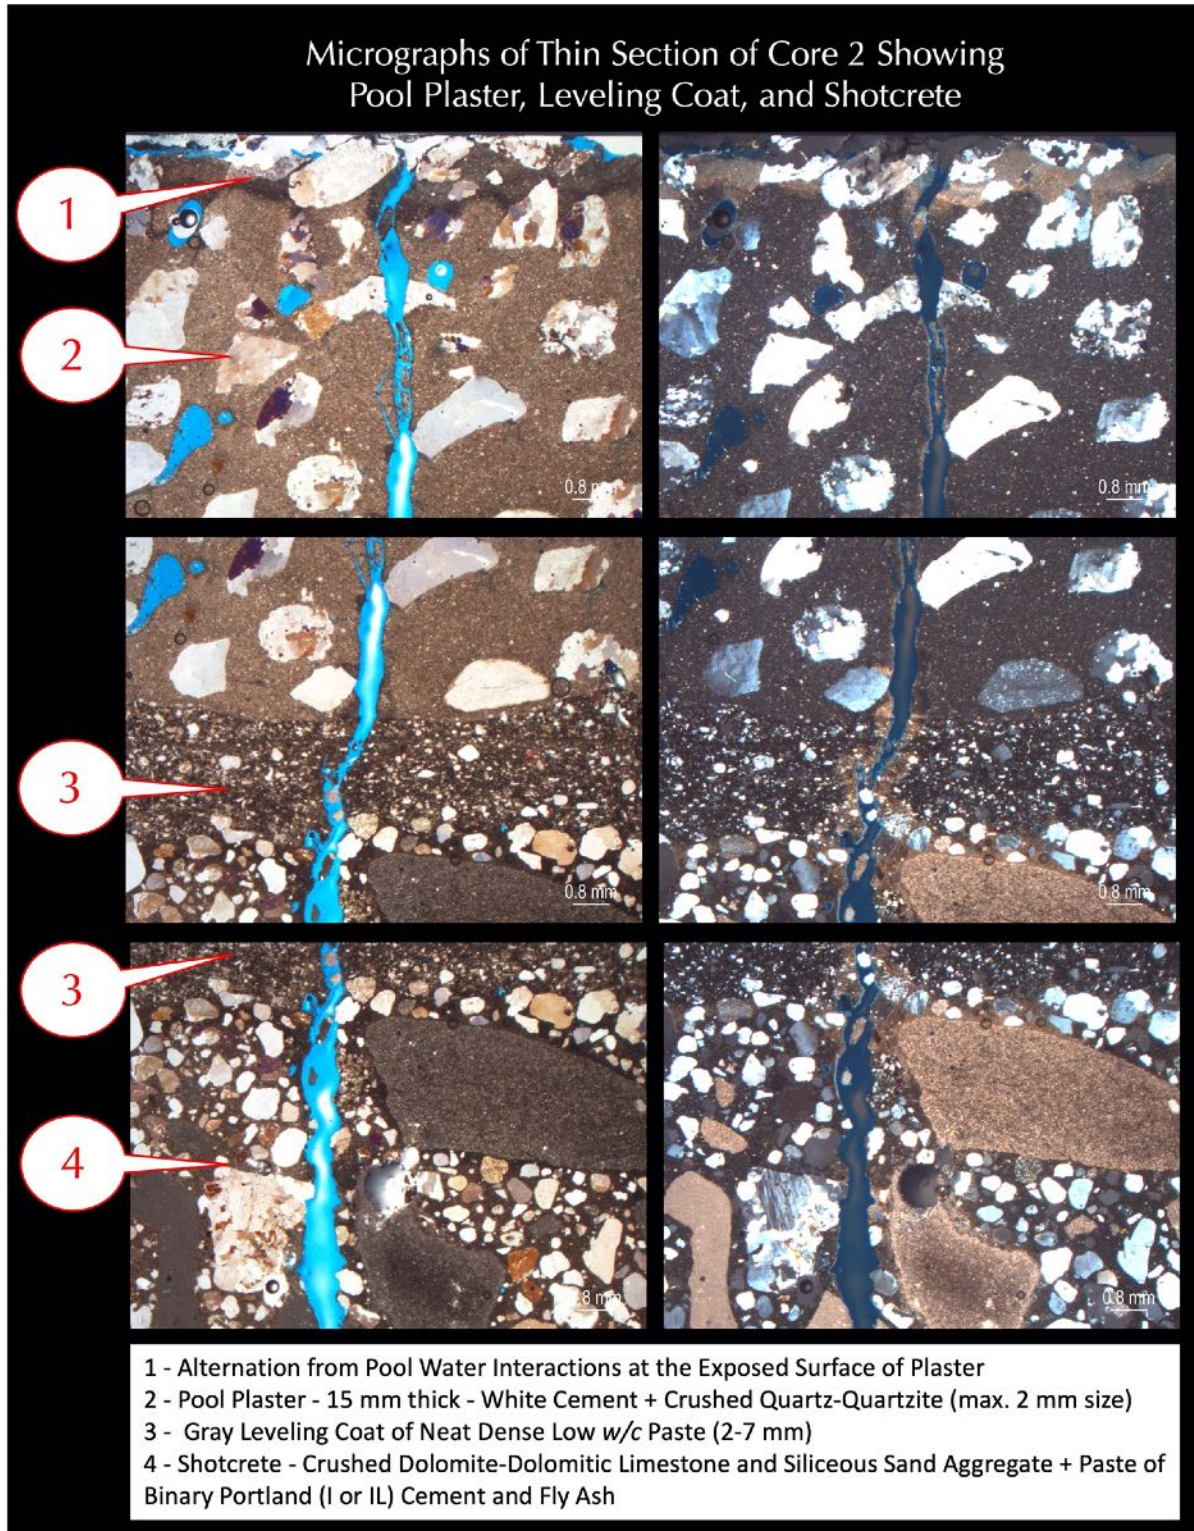
Figure 59: Micrographs of thin section of Core 2 showing: (a) a thin altered zone (Callout '1') from pool water interaction on the dense pool plaster (Callout '2') having many well-graded, well-distributed sub-rounded to angular (crushed) variably strained siliceous sand filler (2-3 mm size), (b) thin dark brown paste of leveling coat having very finely crushed silica sand and occasional limestone fines (Callout '3') in a calcium aluminate cement paste, and (c) the main shotcrete body (Callout '4') having crushed limestone and dolomitic limestone aggregate particles, natural siliceous sand aggregate, and interstitial paste with many coarse entrapped air voids. Images were taken in plane (PPL, left) and corresponding cross (XPL, right) polarized light modes respectively, in a stereozoom microscope.

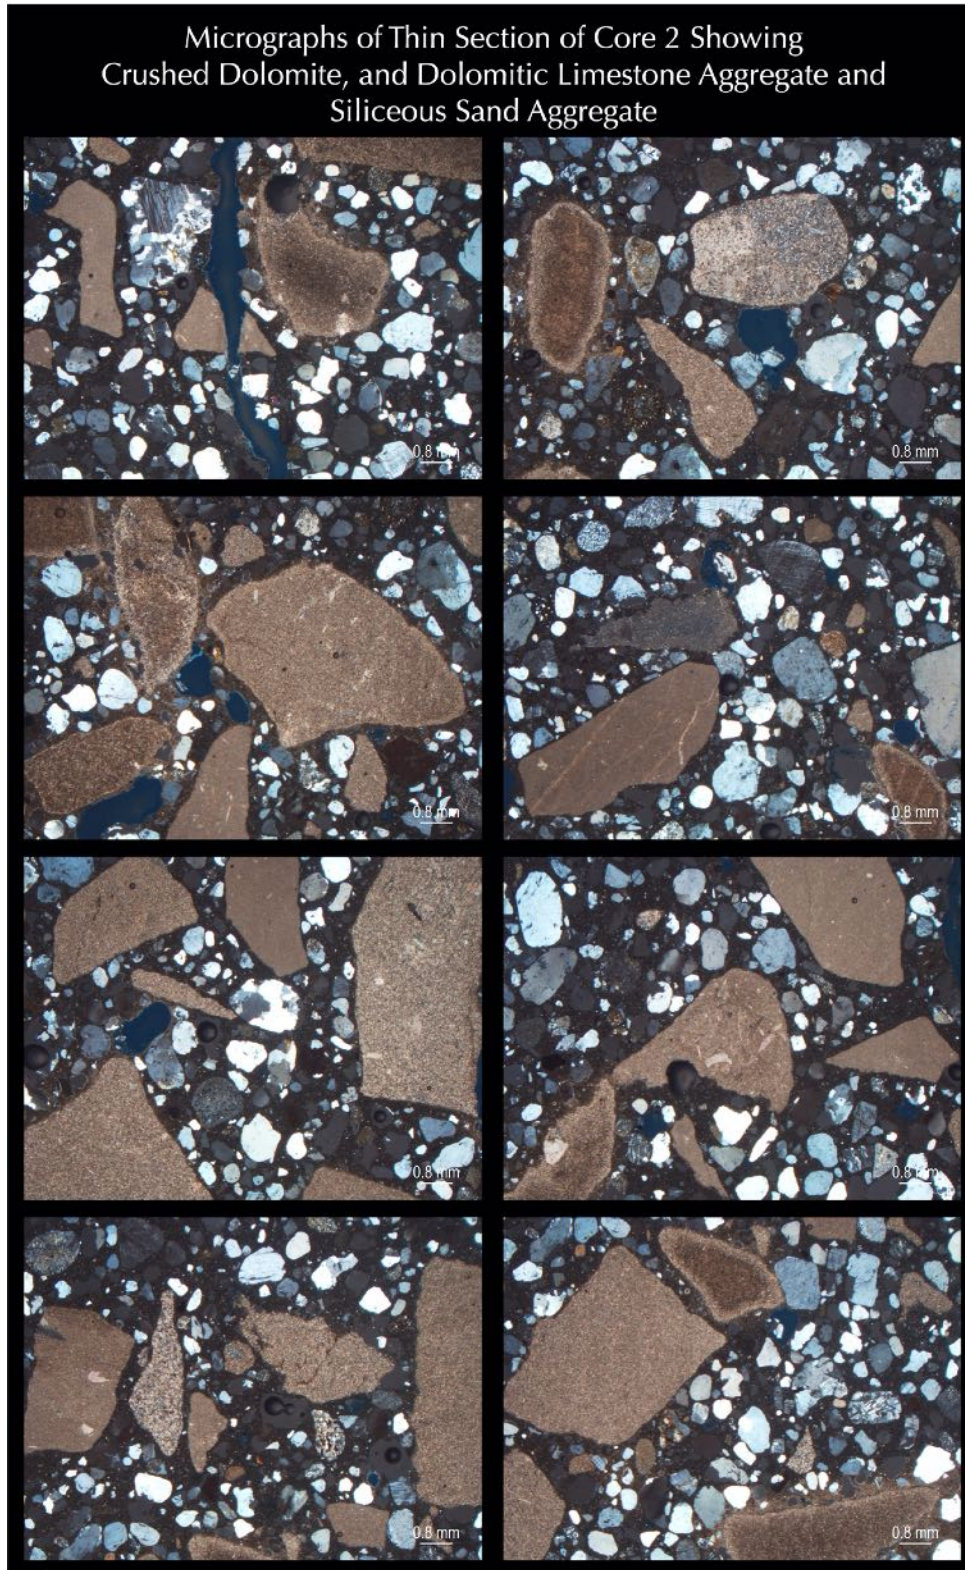
Figure 60: Micrographs of thin section of Core 2 showing: (a) the main shotcrete body having crushed limestone and dolomitic limestone aggregate particles, natural siliceous sand fine aggregate, and interstitial paste with many coarse entrapped air voids. Images were taken in cross (XPL) polarized light mode, in a stereozoom microscope.

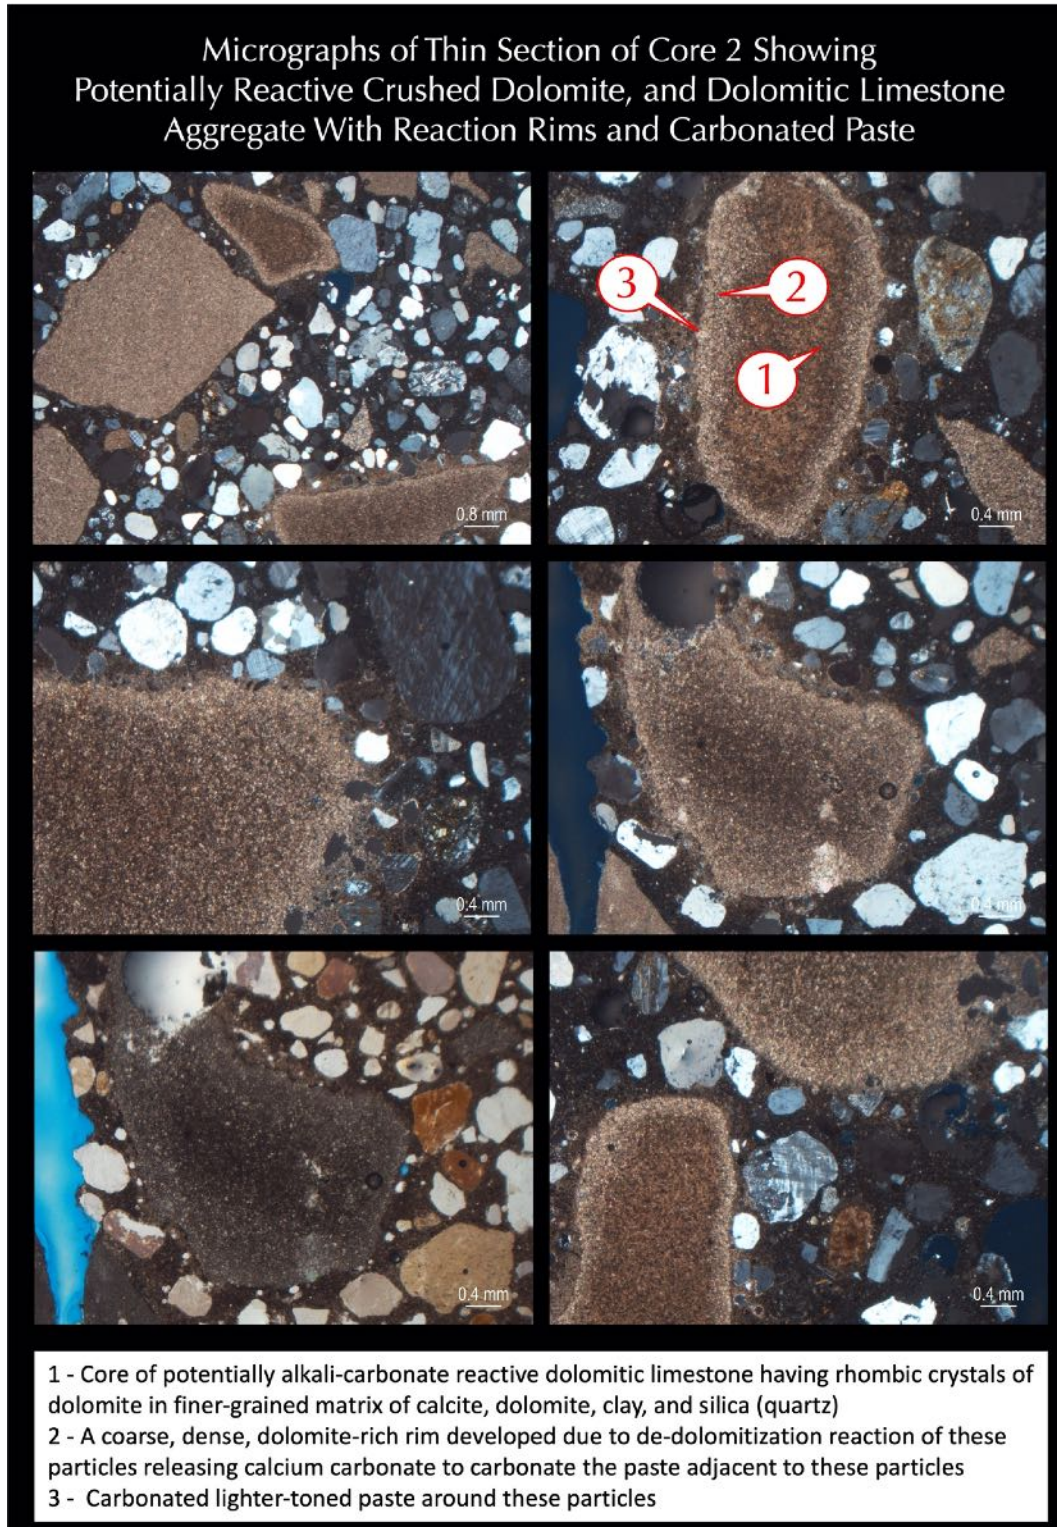
Figure 61: Micrographs of thin section of Core 2 showing many crushed limestone and dolomitic limestone coarse aggregate particles having a core of rhombic crystals of dolomite in finer grains matrix of calcite, dolomite, clay, and quartz (Callout '1'), within a dense rim of coarse dolomite rhombs (Callout '2') and an outer lighter-toned carbonated paste rim (Callout '3'), which are potentially unsound alkali-carbonate reactive dolomitic limestone particles in aggregate. Images were taken in plane (PPL) or cross (XPL) polarized light modes in a stereozoom microscope.

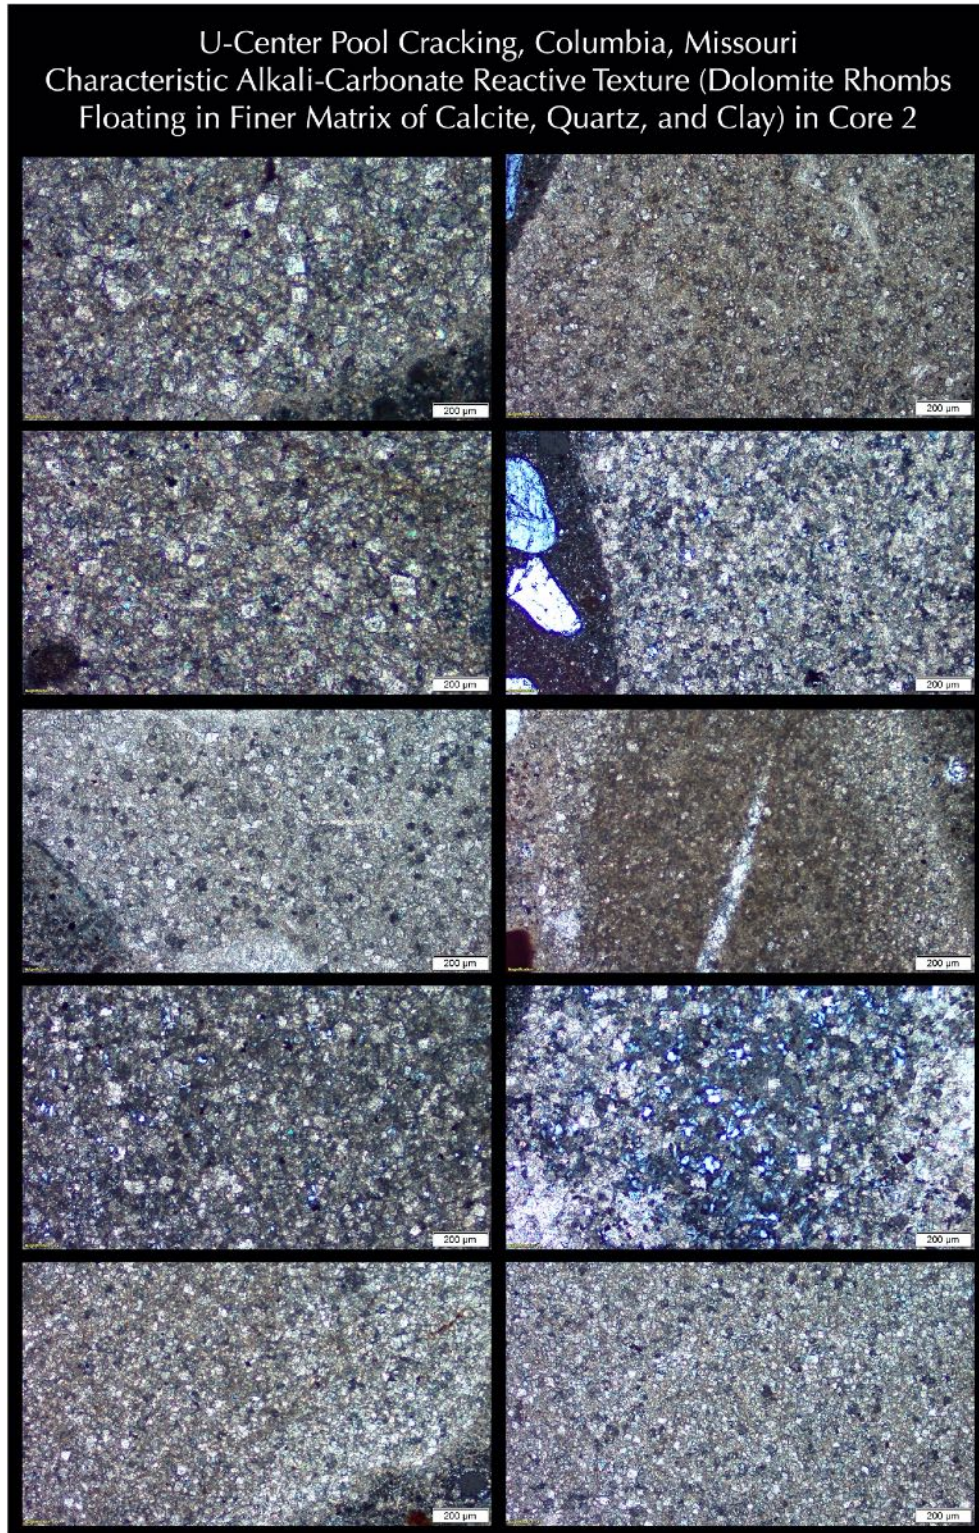
Figure 62: Micrographs of thin section of Core 2 showing characteristic texture of alkali-carbonate reactive (ACR) rocks in shotcrete in having dolomite rhombs floating in finer-grained matrix of calcite, quartz, and clay.
