## Investigation of Extensive Cracking of a Swimming Pool from Petrographic Examinations of Four Composite Cores of Pool Plaster and Shotcrete

U-Center on Turner  
625 S 4th Street  
Columbia, MO 65203

September 12, 2023  
CMC 0823176

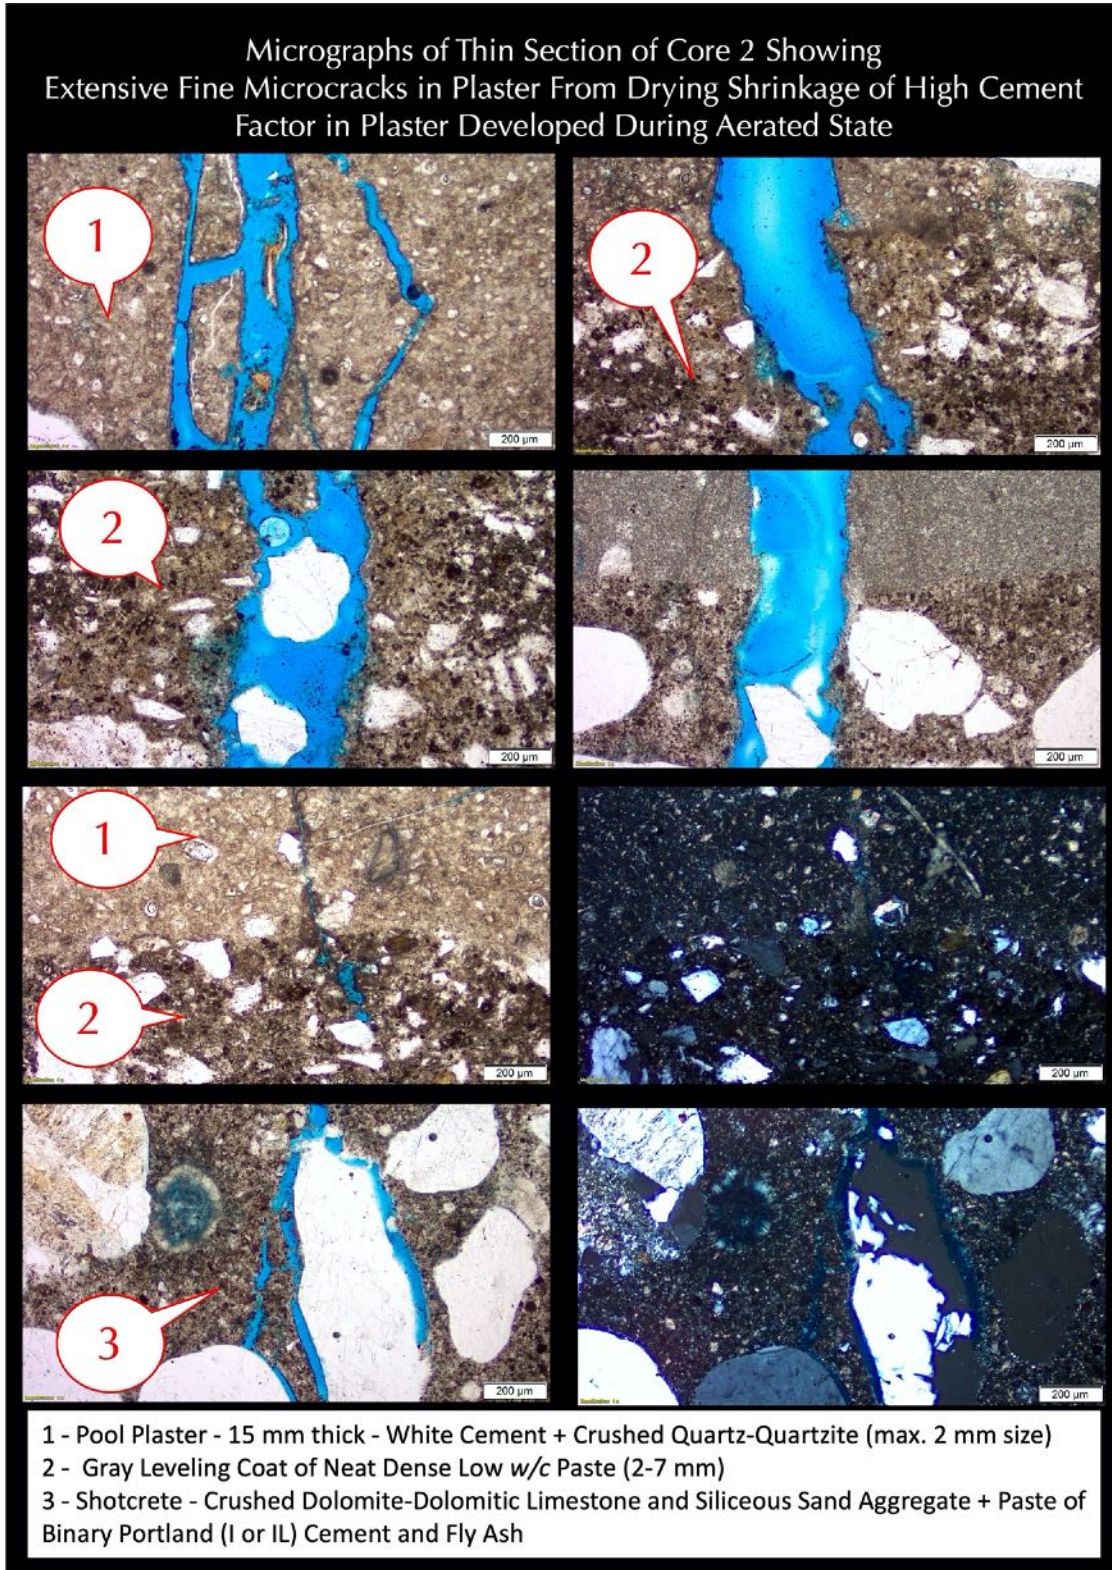
Figure 63: Micrographs of thin section of Core 2 showing microcracks extending from pool plaster through thin dark-toned intermediate leveling coat. Notice very different composition and microstructure of pool plaster and relatively darker brown thin paste of leveling coat where leveling coat have finely ground crushed quartz, quartzite particles and calcium aluminate-based cement (responsible for imparting an overall darker gray color tone). Images were taken in plane (PPL) and cross (XPL) polarized light modes in a petrographic microscope.

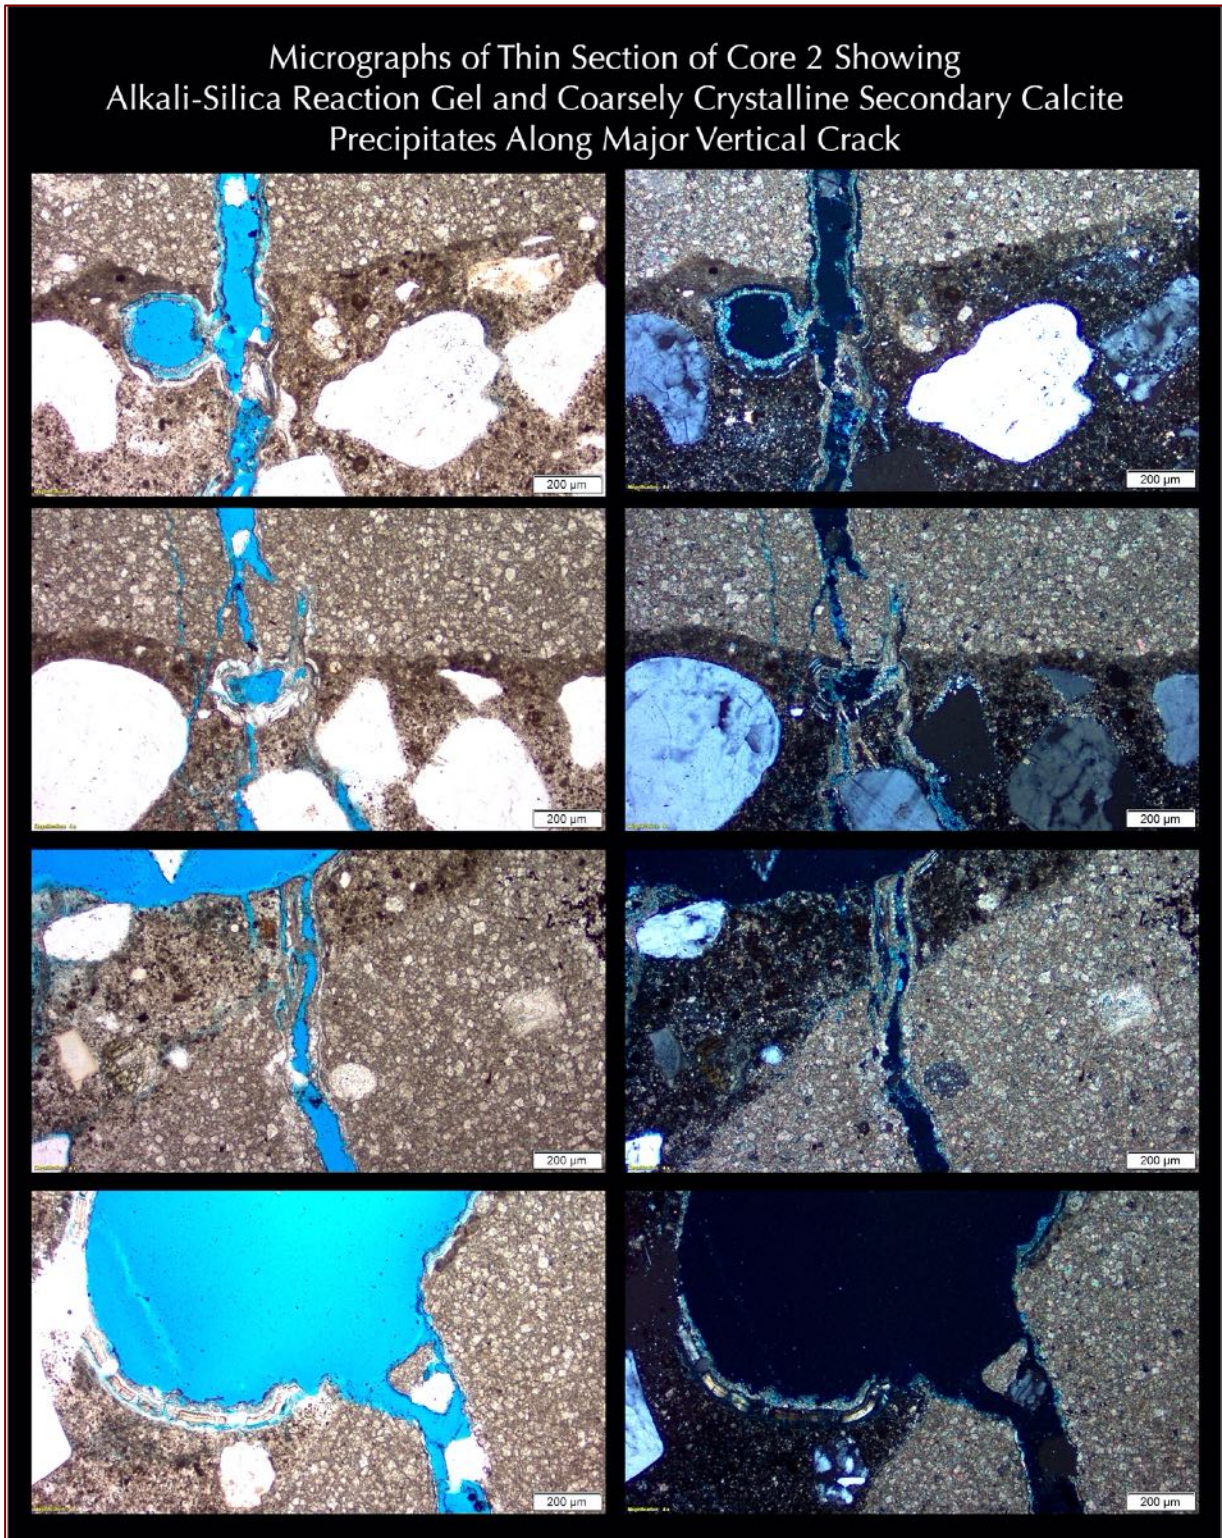
Figure 64: Evidence of alkali-silica reaction gel deposits lining walls of coarse voids where potentially reactive components may have derived from reactive silica particles in dolomitic limestone aggregate and/or reactive silica (chert, microcrystalline silica component in dolomitic limestone, strained quartzite, etc.) in aggregate. Images were taken in plane (PPL, left) and corresponding cross (XPL, right) polarized light modes respectively, in a petrographic microscope.

Along with ACR, also detected are isotropic to birefringent alkali-silica reaction gel in the walls of main vertical cracks and in some coarse voids, which are judged to be the result of alkali-silica reaction of reactive silica inclusions in some of crushed argillaceous dolomitic limestone particles and alkaline pore solutions in shotcrete.

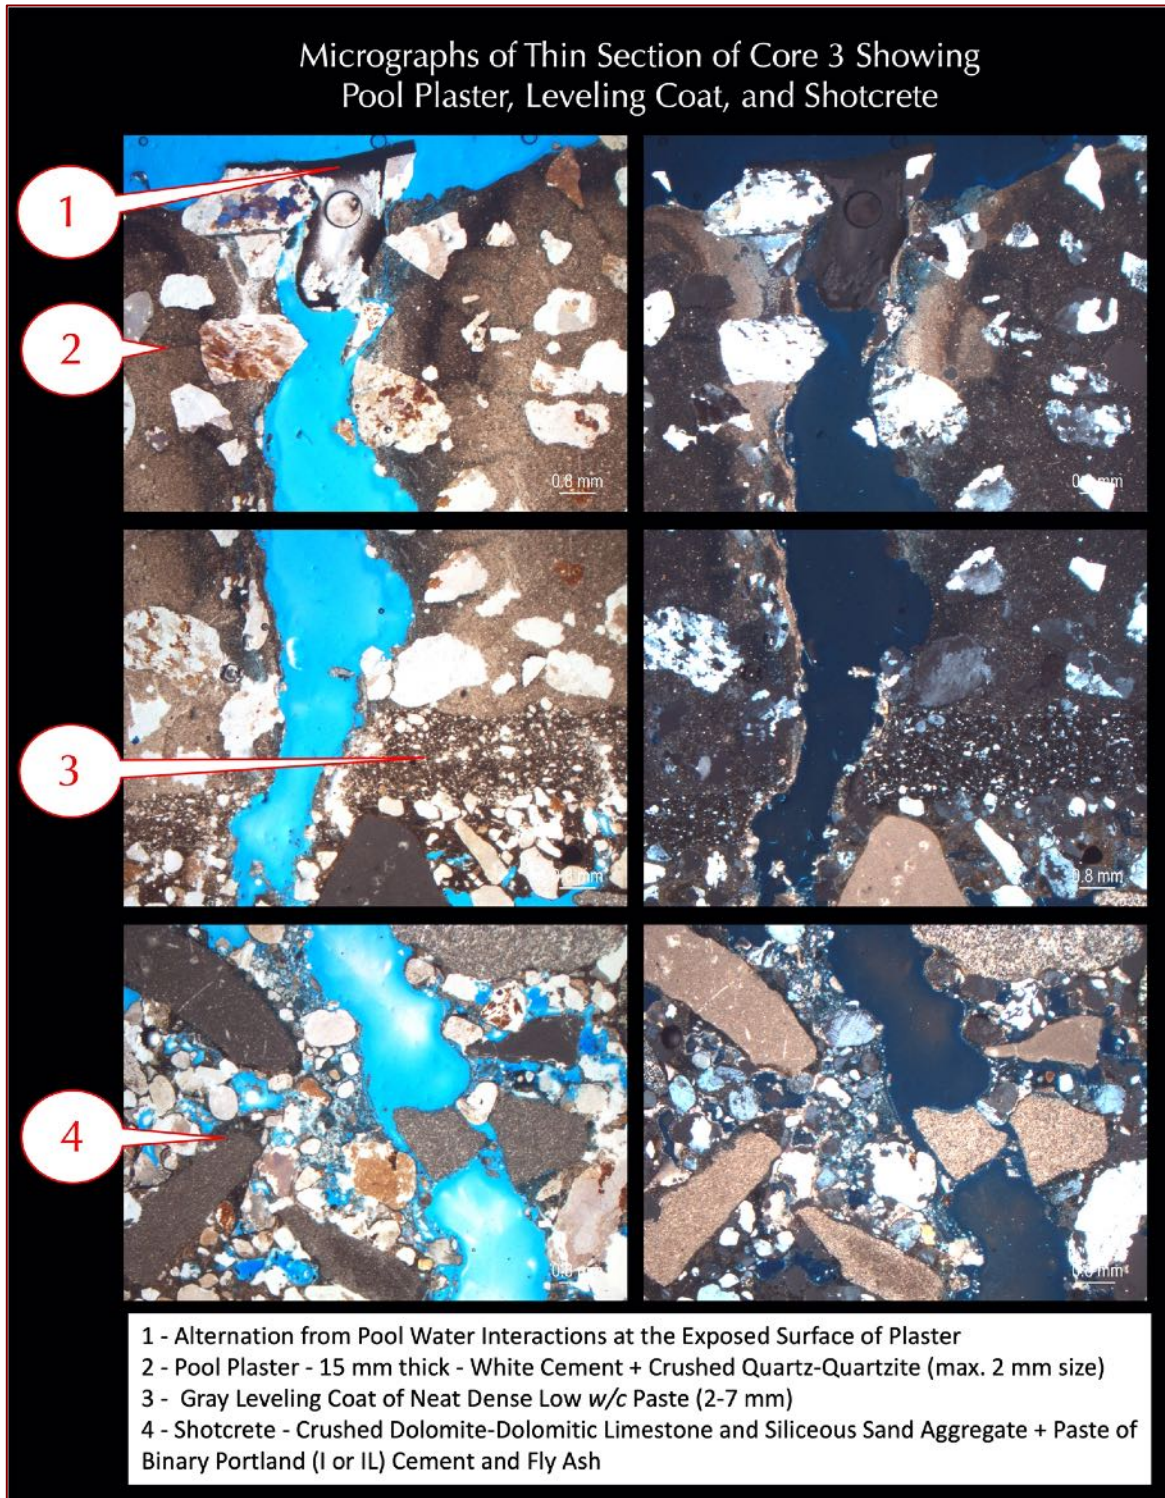
Figure 65: Micrographs of thin section of Core 3 showing: (a) a thin altered zone (Callout '1') from pool water interaction on the dense pool plaster (Callout '2') having many well-graded, well-distributed sub-rounded to angular (crushed) variably strained siliceous sand filler, (b) thin dark brown paste of leveling coat having very finely crushed silica sand and occasional limestone fines (Callout '3'), and (c) the main shotcrete body (Callout '4') having crushed dolomitic limestone aggregate particles, natural siliceous sand aggregate, and interstitial paste with many coarse voids. Images were taken in plane (PPL, left) and corresponding cross (XPL, right) polarized light modes respectively, in a stereozoom microscope.

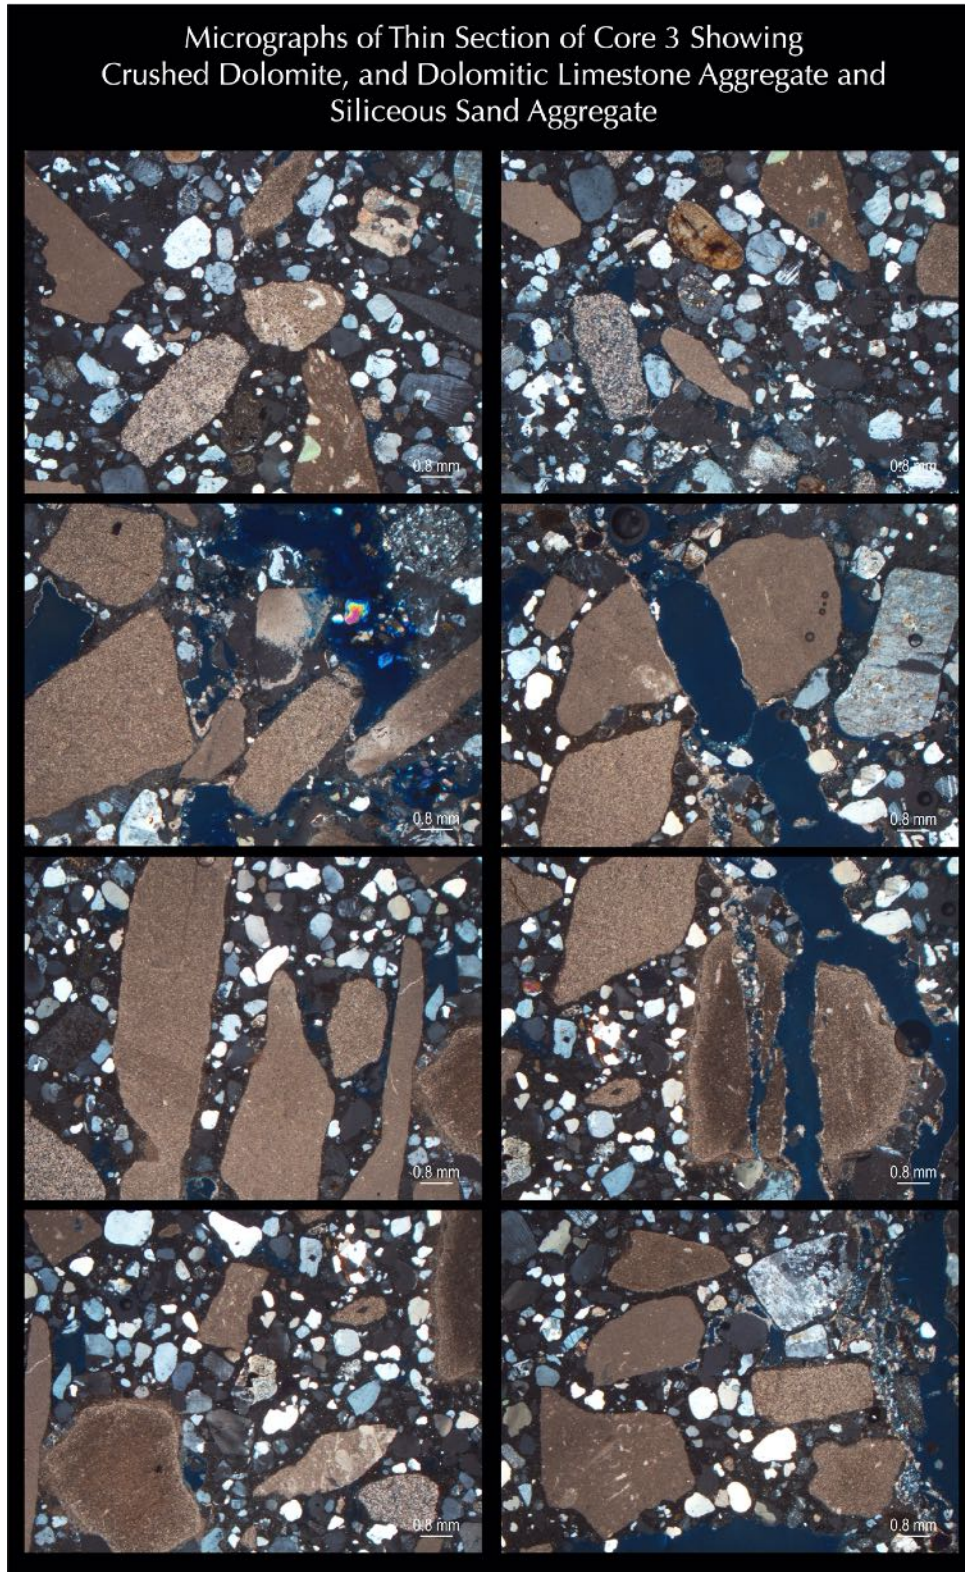
Figure 66: Micrographs of thin section of Core 3 showing: (a) the main shotcrete body having crushed limestone and dolomitic limestone aggregate particles, natural siliceous sand fine aggregate, and interstitial paste with many coarse entrapped air voids. Images were taken in cross (XPL) polarized light mode, in a stereozoom microscope.

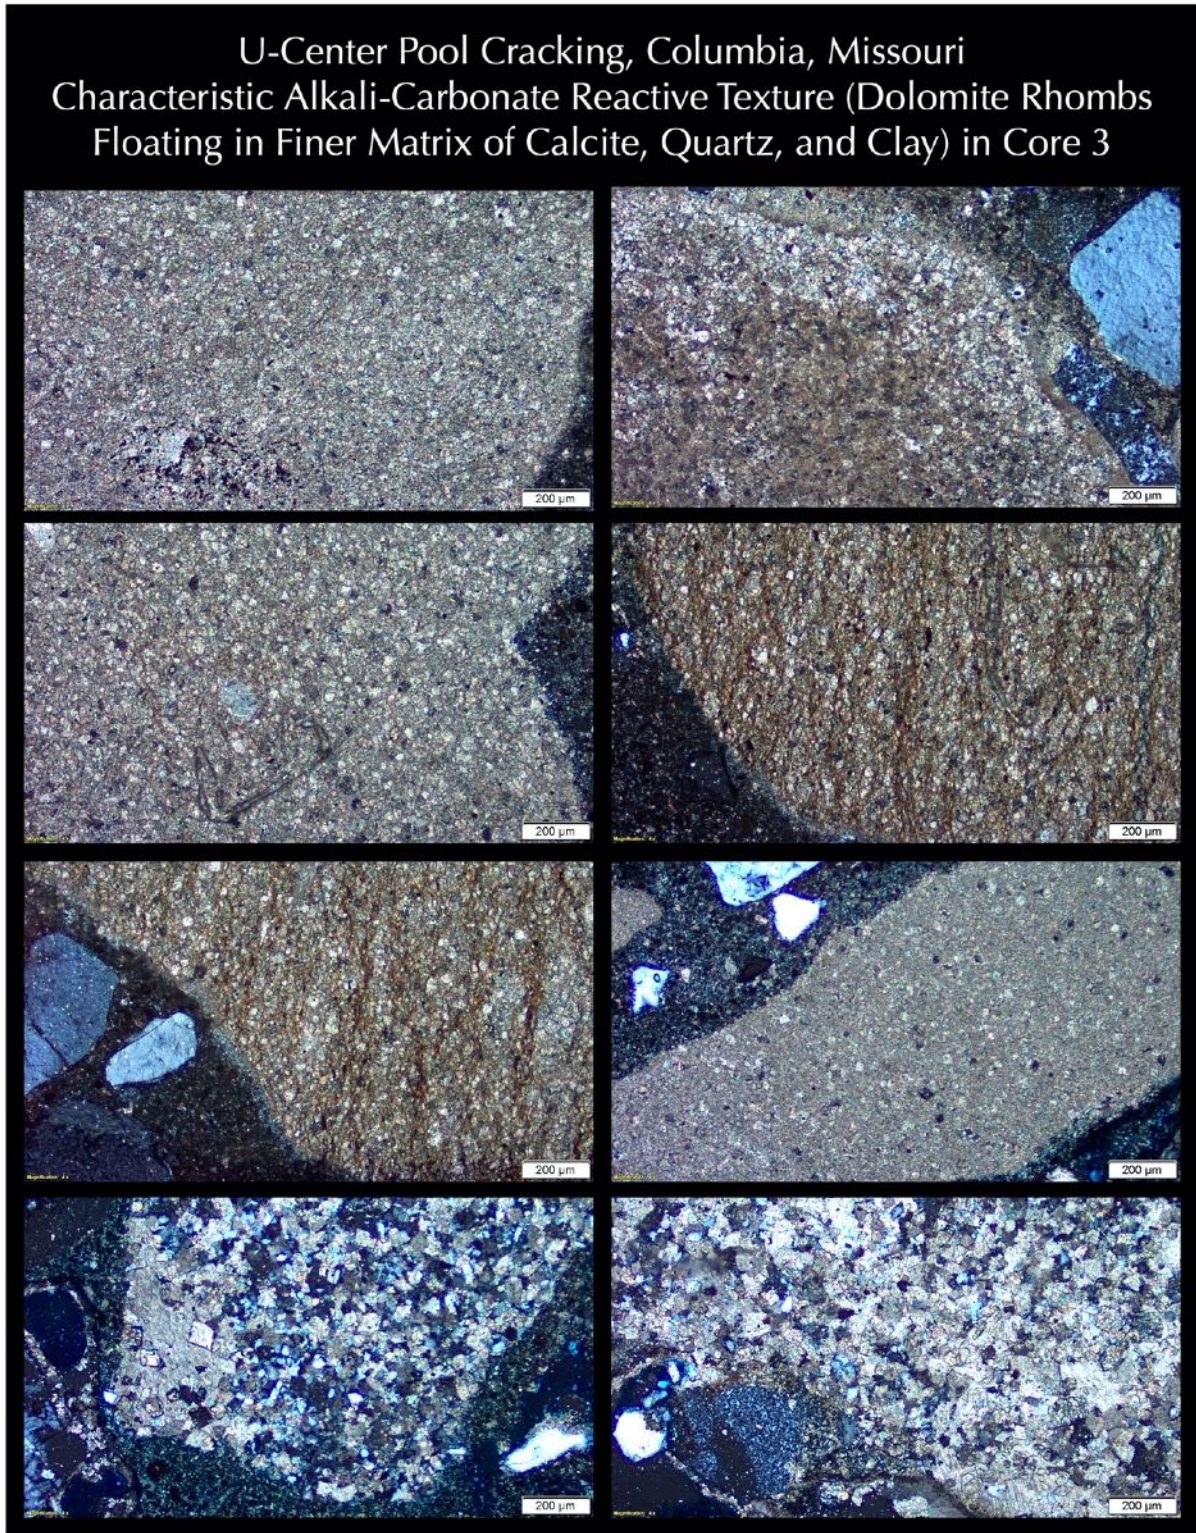
Figure 67: Micrographs of thin section of Core 3 showing characteristic texture of alkali-carbonate reactive (ACR) rocks in shotcrete in having dolomite rhombs floating in finer-grained matrix of calcite, quartz, and clay.

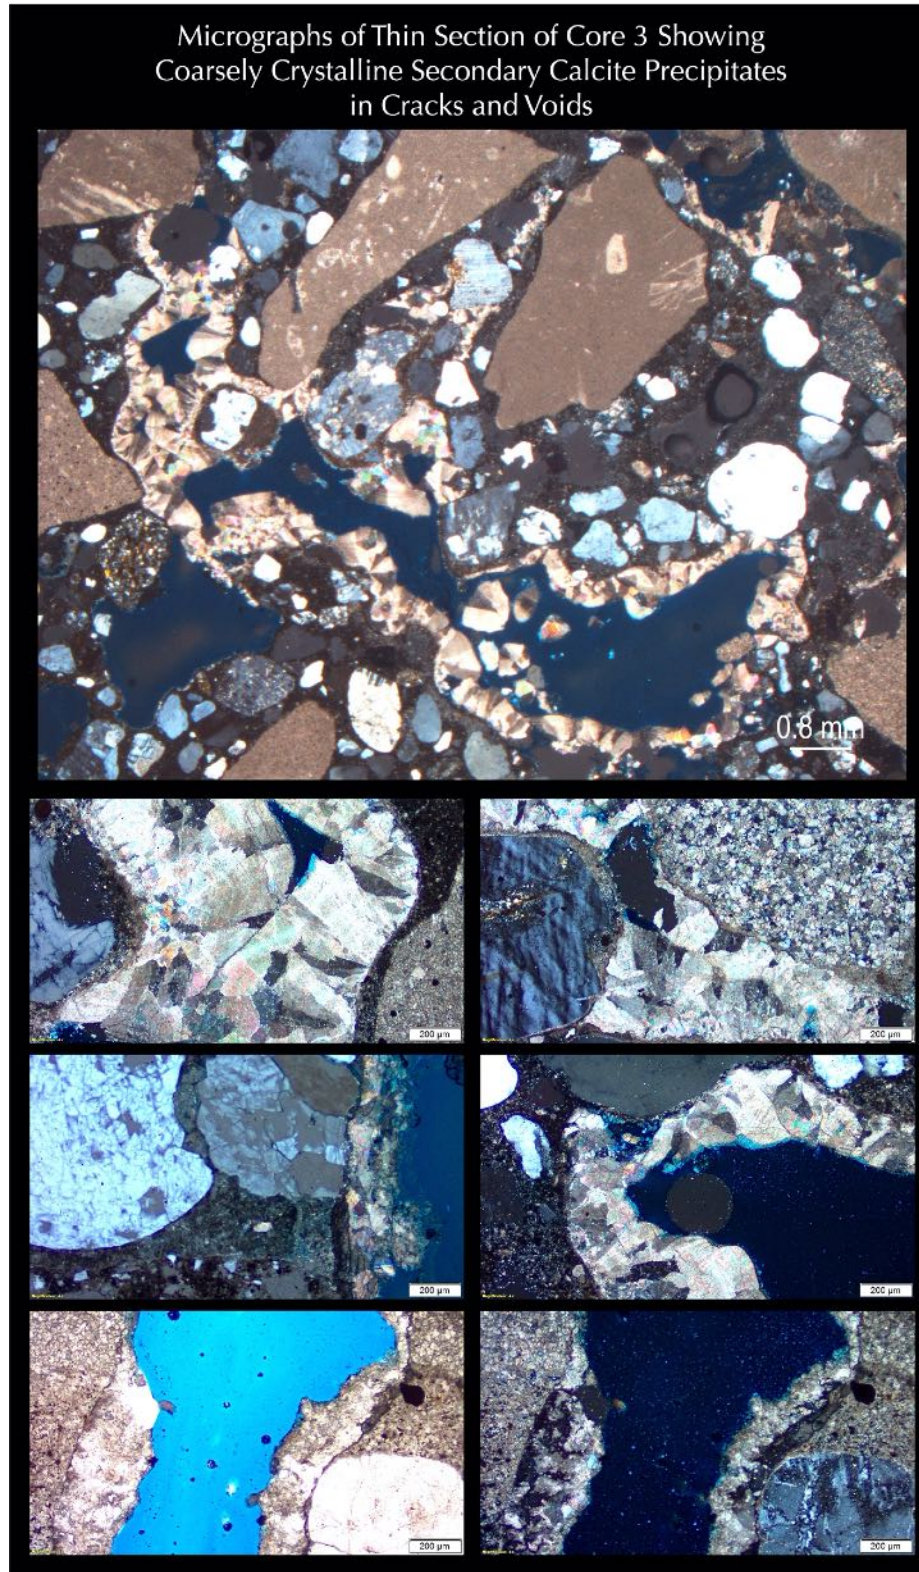
Figure 68: Micrographs of thin section of Core 3 showing coarsely crystalline secondary calcite precipitates lining the walls of coarse entrapped air voids. Images were taken in plane (PPL) or cross (XPL) polarized light modes, in a stereozoom and petrographic microscope

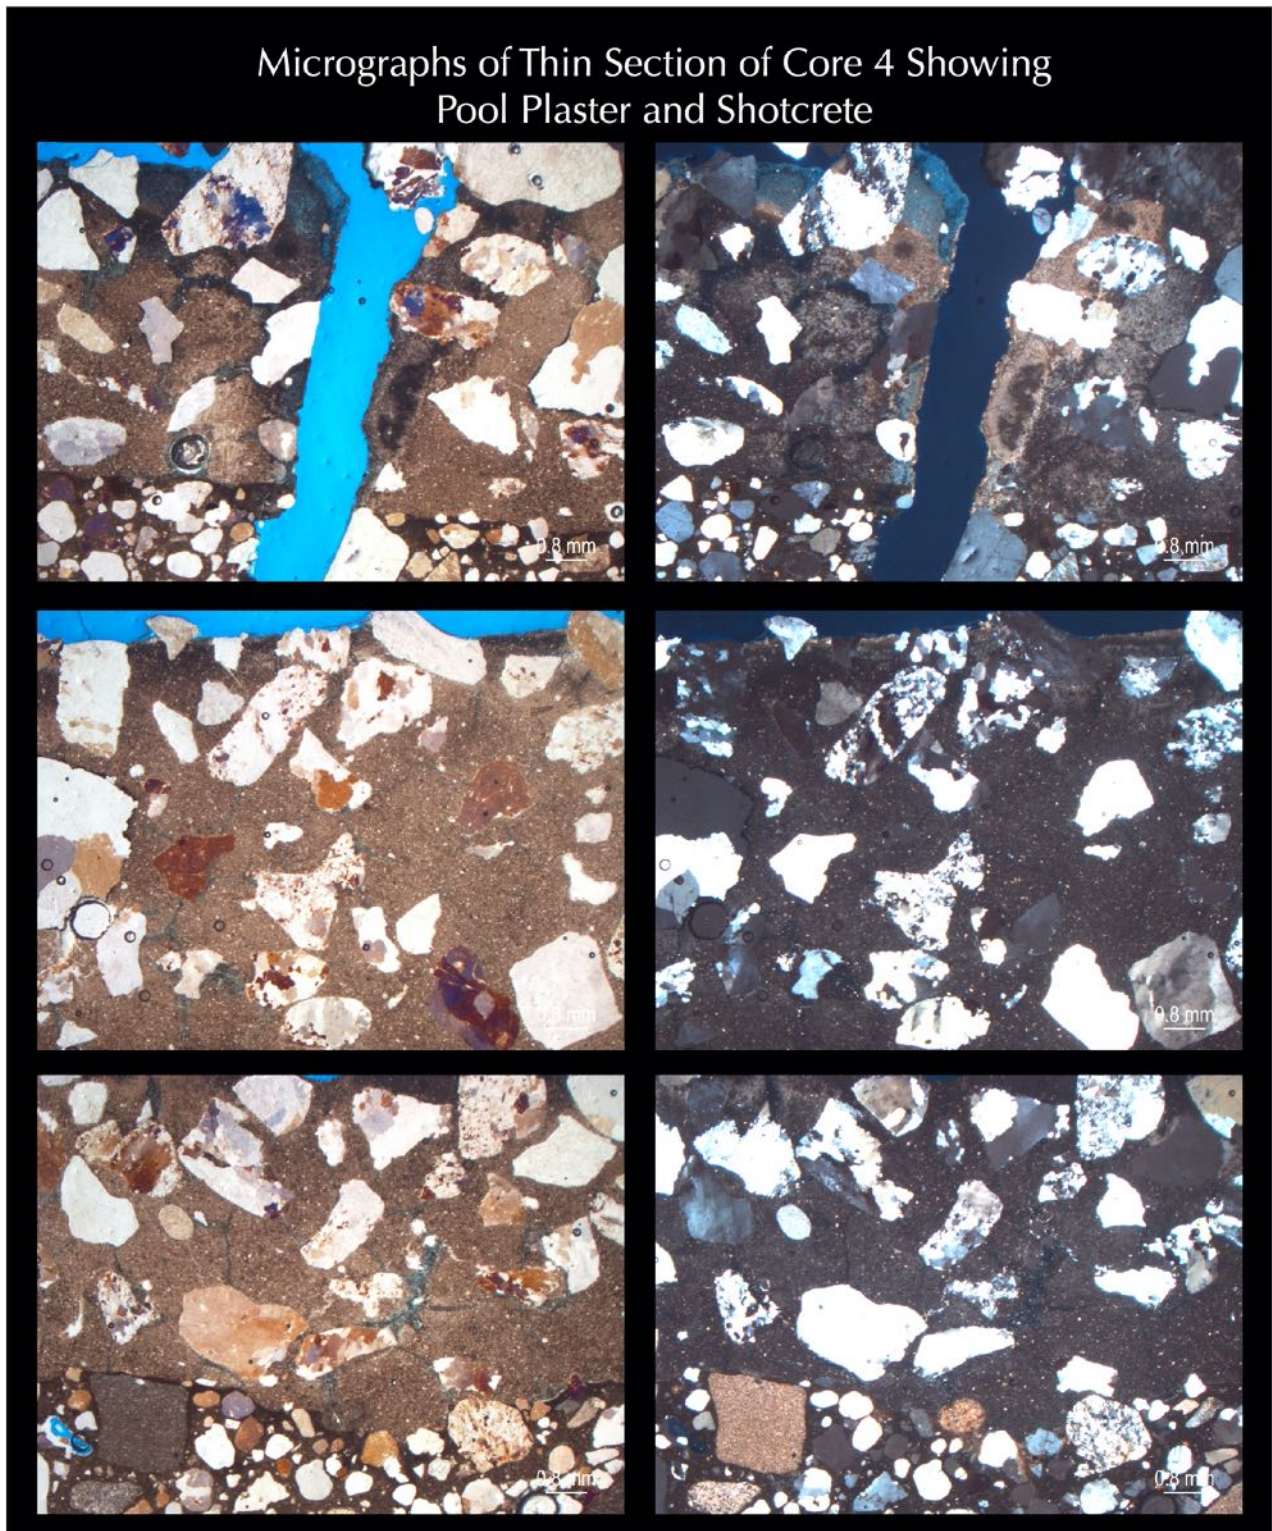
Figure 69: Micrographs of thin section of Core 4 showing: (a) a thin altered zone from pool water interaction on the dense pool plaster having many well-graded, well-distributed sub-rounded to angular (crushed) variably strained siliceous sand filler (2-3 mm size) in dense white cement paste, (b) absence of thin dark brown paste of leveling coat found in three other cores, and (c) the main shotcrete body having crushed limestone and dolomitic limestone aggregate particles, natural siliceous sand aggregate, and interstitial paste with many coarse entrapped air voids. Images were taken in plane (PPL, left) and corresponding cross (XPL, right) polarized light modes respectively, in a stereozoom microscope.

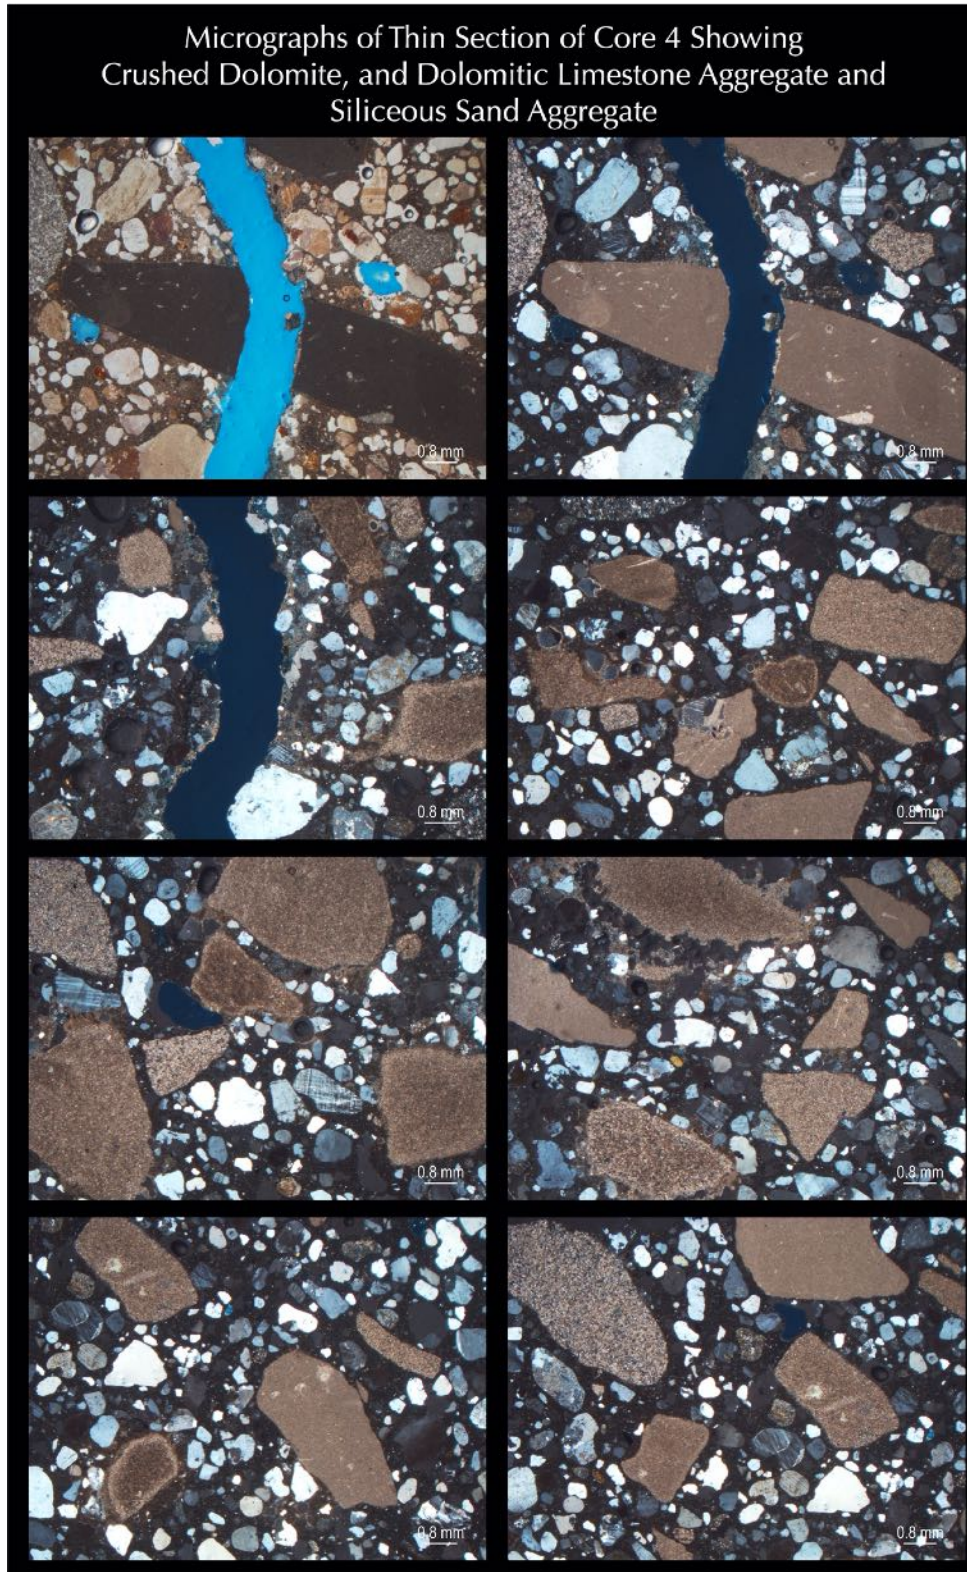
Figure 70: Micrographs of thin section of Core 4 showing: (a) the main shotcrete body having crushed limestone and dolomitic limestone aggregate particles, natural siliceous sand aggregate, and interstitial paste with many coarse entrapped air voids. Images were taken in plane (PPL) and cross (XPL) polarized light modes, in a stereozoom microscope.

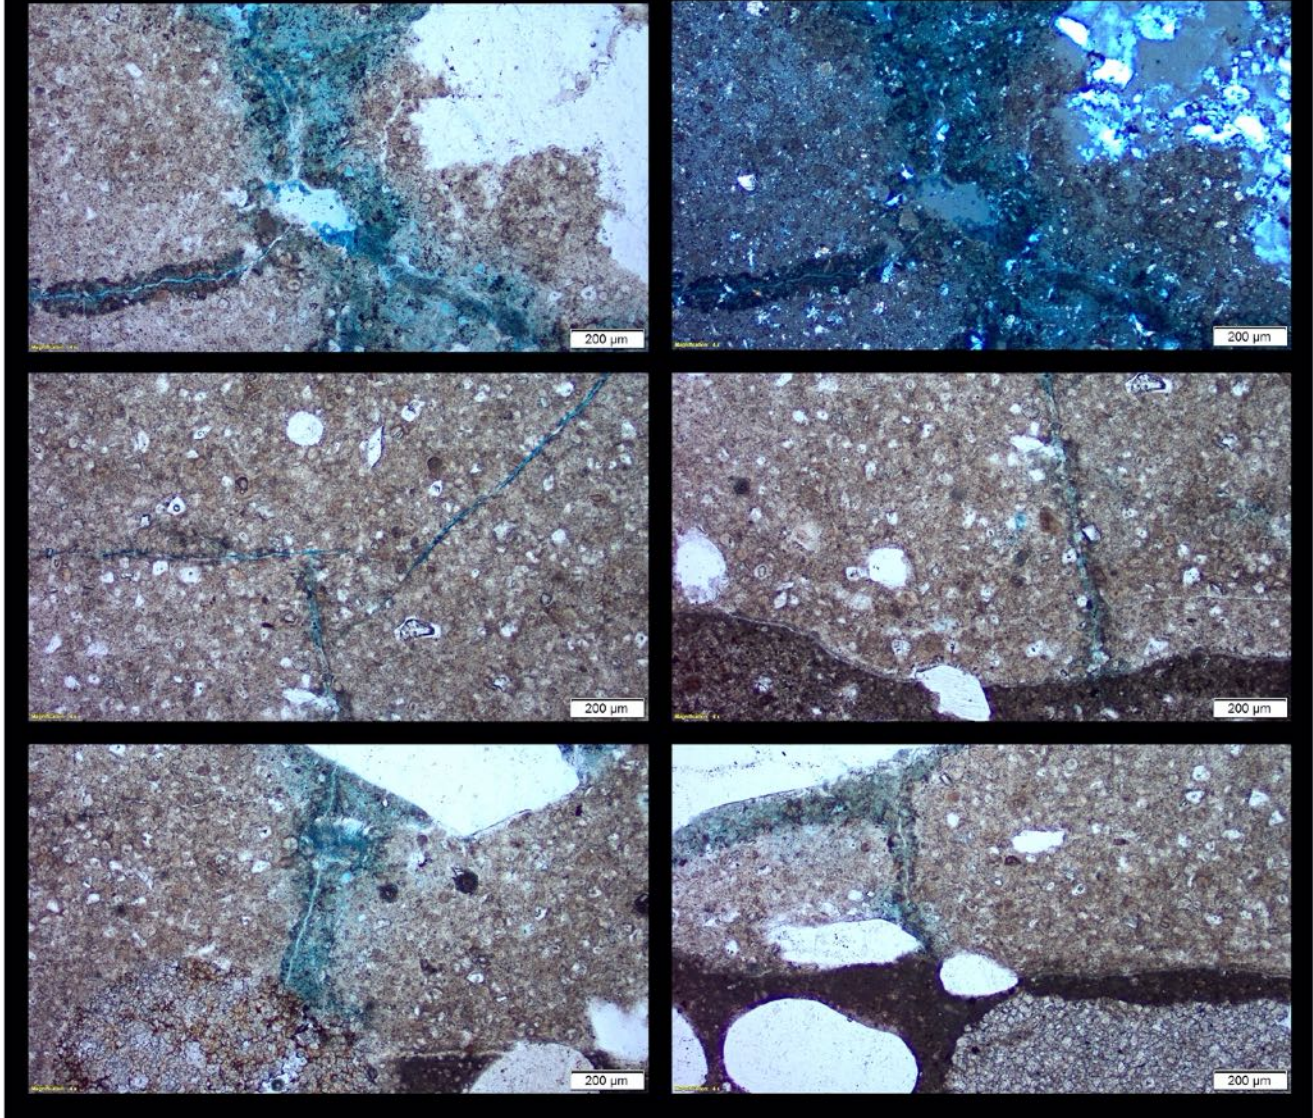
Figure 71: Micrographs of thin section of Core 4 showing extensive fine shrinkage microcracks within the white pool plaster and porous, higher w/c paste along the microcracks). Images were taken in plane (PPL) and cross (XPL) polarized light modes in a petrographic microscope.

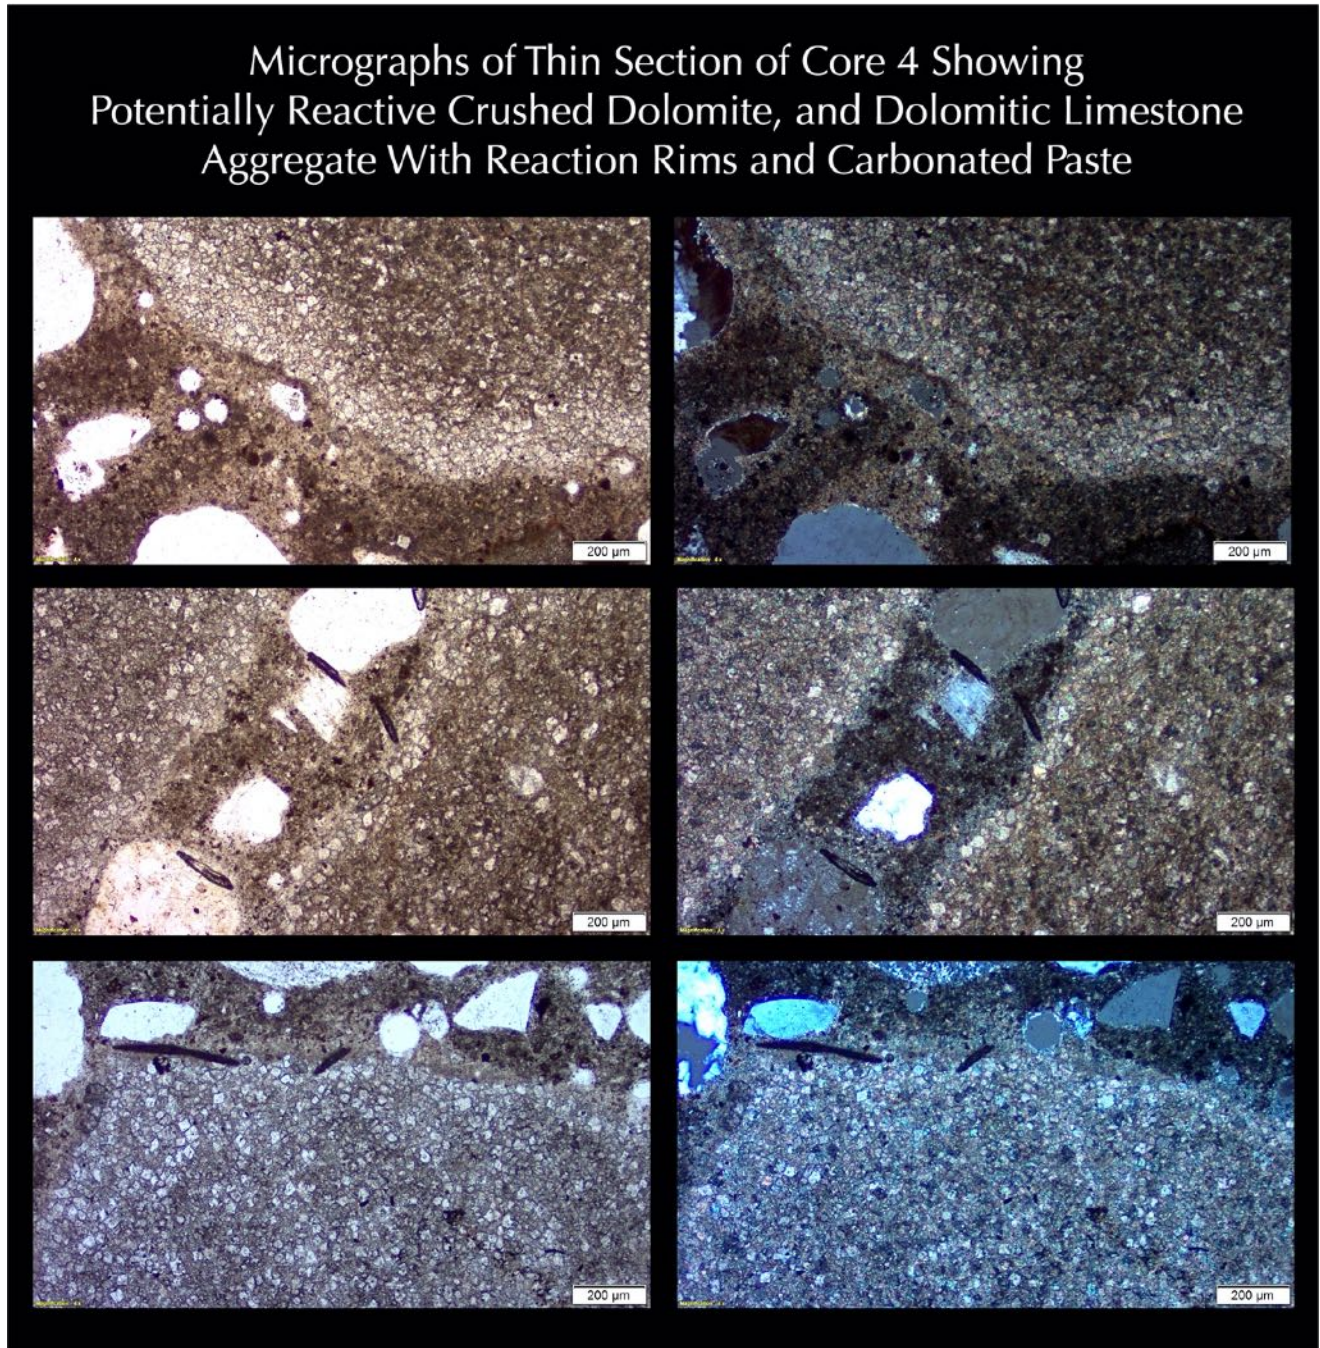
Figure 72: Micrographs of thin section of Core 4 showing many crushed dolomitic limestone aggregate particles having a core of rhombic crystals of dolomite in finer grains matrix of calcite, dolomite, clay, and quartz within a dense rim of coarse dolomite rhombs and an outer lighter-toned carbonated paste rim, which are potentially unsound alkali-carbonate reactive dolomitic limestone particles in aggregate. Images were taken in plane (PPL) or cross (XPL) polarized light modes in a petrographic microscope.

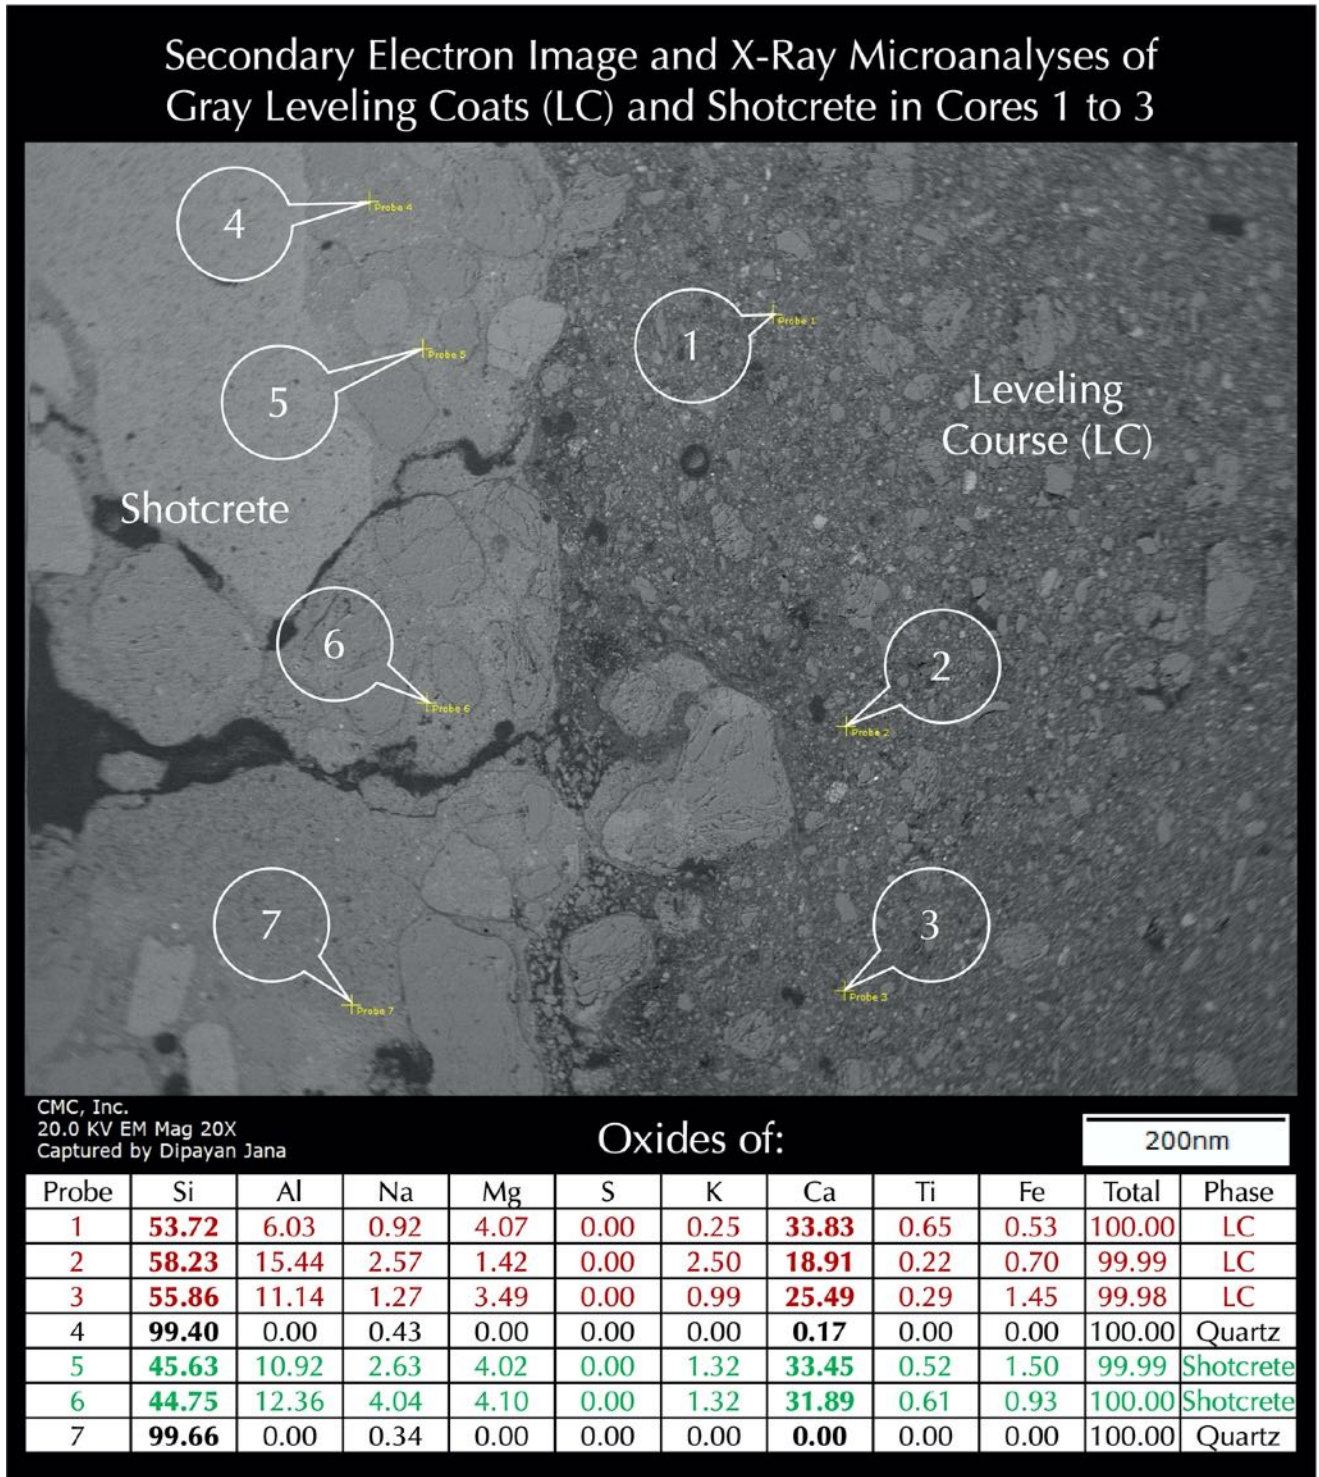
Figure 76: Backscatter electron image (top) and X-ray microanalyses at the tips of callouts of calcium aluminate based leveling course at right and main shotcrete body at left.

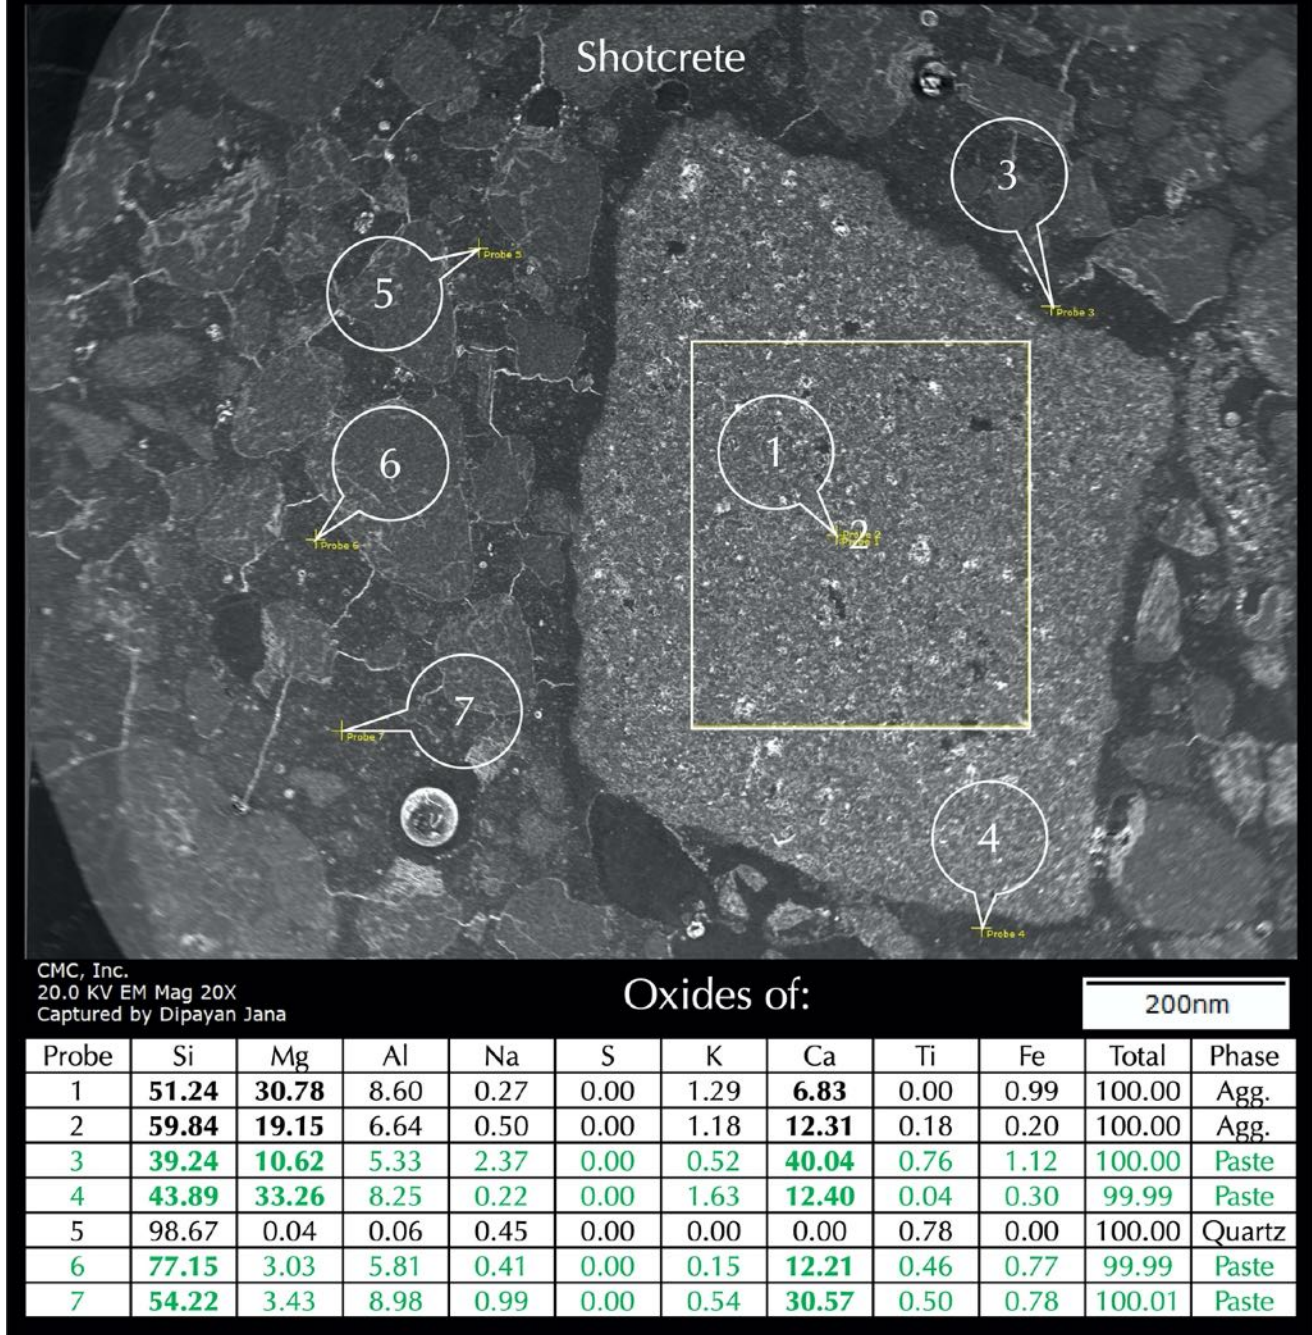
Figure 78: Secondary electron image (top) and X-ray microanalyses at the tips of callouts and within a boxed area of the main shotcrete body showing rhombic crystal of dolomite in a dolomitic limestone aggregate and surrounding paste.
