## Investigation of Extensive Cracking of a Swimming Pool from Petrographic Examinations of Four Composite Cores of Pool Plaster and Shotcrete

U-Center on Turner  
625 S 4th Street  
Columbia, MO 65203

September 12, 2023  
CMC 0823176

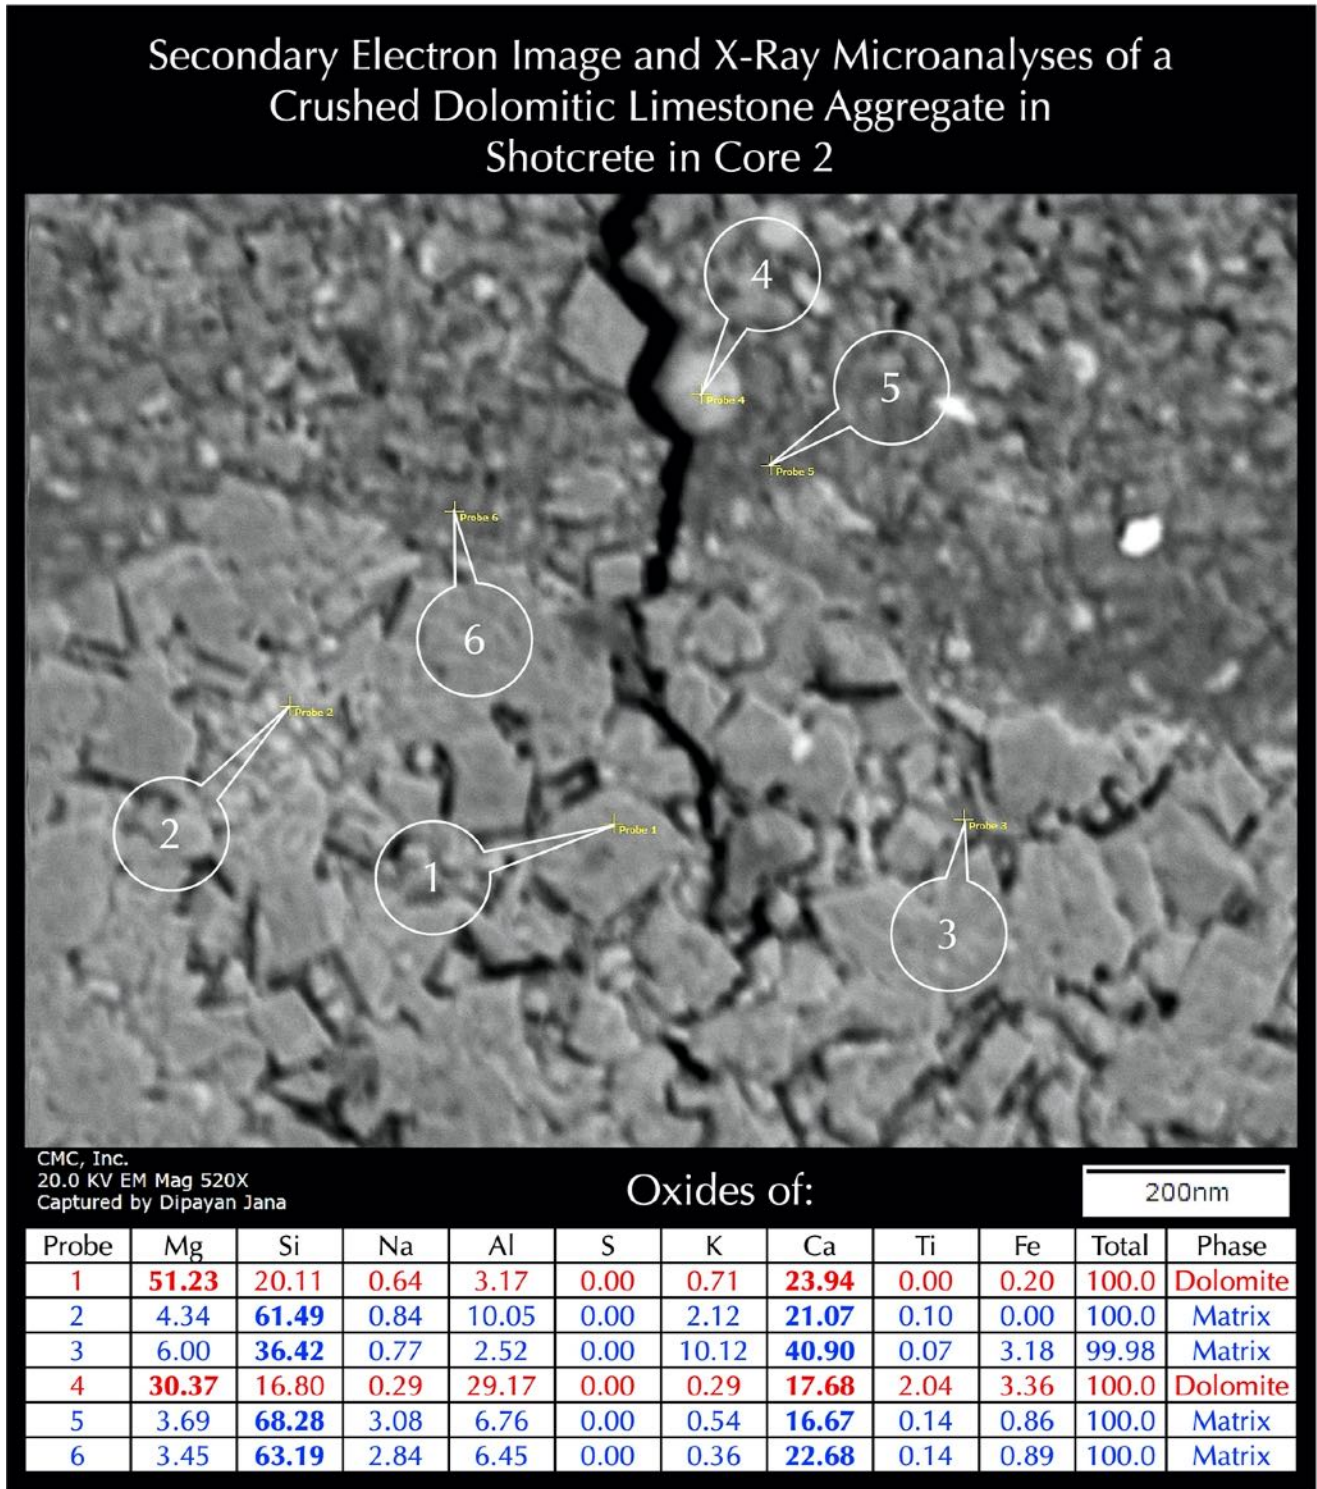
Figure 79: Secondary electron image (top) and X-ray microanalyses at the tips of callouts of main shotcrete body showing rhombic crystal of dolomite in a dolomitic limestone aggregate in shotcrete.

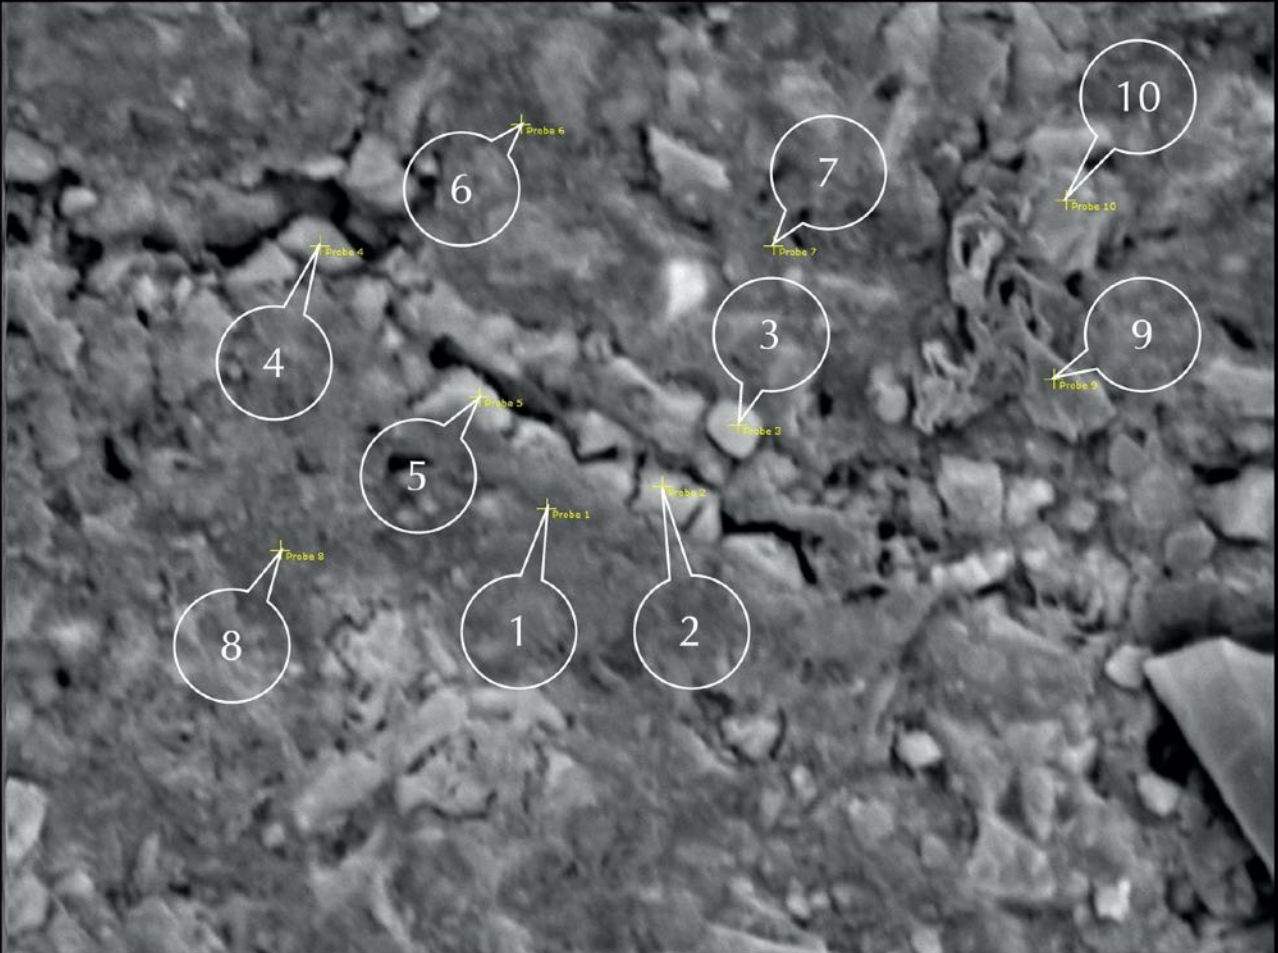
## Secondary Electron Image and X-Ray Microanalyses of a Coarsely Crystalline Calcite Precipitates along a Crack in a Crushed Dolomitic Limestone Aggregate in Shotcrete in Core 4
