CONSTRUCTION MATERIALS CONSULTANTS, INC.

Laboratory Investigation of Delamination of a Concrete Slab

RE: DELAMINATION OF CONCRETE SLAB

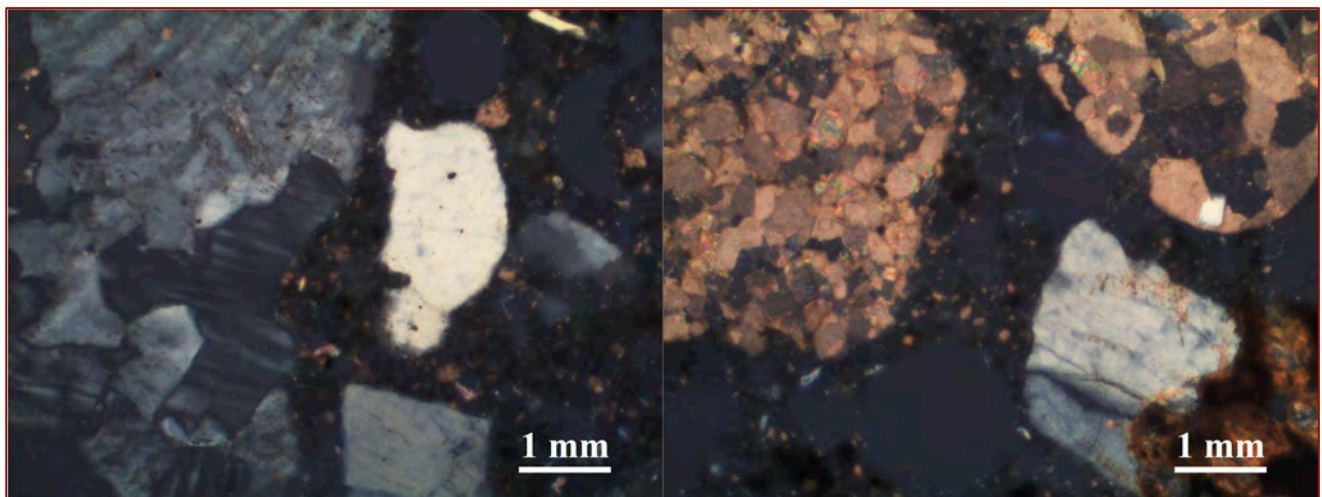
Fine aggregate is natural siliceous-calcareous sand having a nominal maximum size of 4 mm (Figures 3 and 4). Particles contain major amounts of quartz, moderate amounts of limestone-dolomite and feldspar, and subordinate amounts of sandstone, siltstone, shale, mica, mafic minerals, and ferruginous rocks. Particles are variably colored, angular to subangular, dense, hard, equidimensional to elongated, unaltered, uncoated, and uncracked. Fine aggregate particles are well-graded and well-distributed (Figures 4 and 5). There is no evidence of alkali-aggregate reaction of fine aggregate particles. Fine aggregate particles have been sound during their service in the concrete. The following photomicrographs of blue dye-mixed epoxy-impregnated thin section of the core show the crushed stone coarse aggregate and natural siliceous-calcareous sand fine aggregate particles in Core No. 3.

Figure 3: Photomicrographs of blue dye-mixed epoxy-impregnated thin section of concrete in Core No. 3 showing: (i) crushed granite coarse aggregate particles that are dense, hard, and massive textured, and, (ii) siliceous-calcareous sand fine aggregate particles.

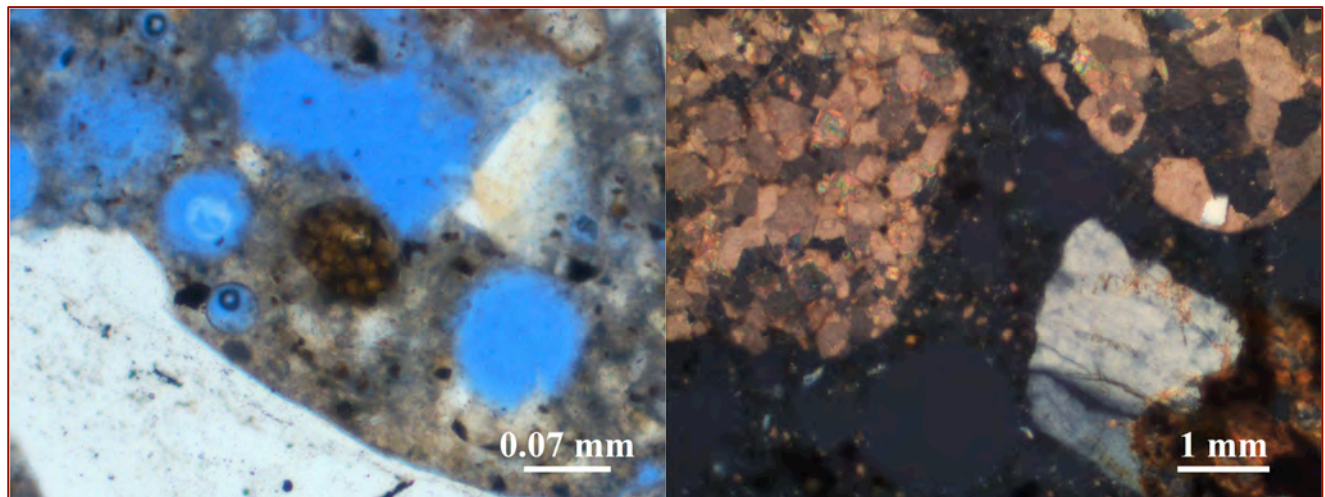
The following photomicrographs of blue dye-mixed epoxy-impregnated thin section of the core showing residual Portland cement particles and limestone fines in the overall moderately dense microstructure of paste.

Figure 6: Photomicrographs of thin section of concrete in Core No. 3 showing residual Portland cement particles and limestone fines in the overall moderately dense microstructure of paste.
